1. PARTHENON FRIEZE

1. SCULPTURE COURT UPPER GALLERY SOUTH WALL

1.1.1.1 DESCRIPTION OF THE OBJECT

TITLE: Parthenon Frieze, copy of the panel from Parthenon Frieze from Temple of Athena – Parthenon in Acropolis in Athens, Greece, between 443 and 438 B.C.

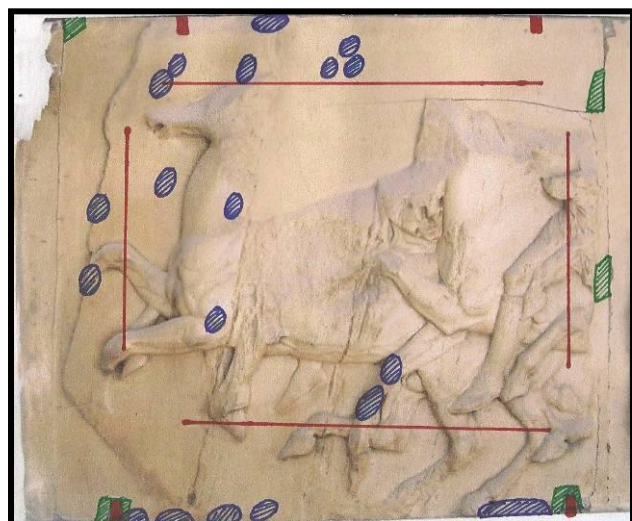
STRUCTURAL STABILITY: Fair. Open cracks running alongside joints on both sides of the panel; large crack running from dexter side of panel towards centre of the cast in its upper part.

VISIBLE PAINT LAYERS/UNSIGHTLY MARKINGS: Layer of cream-yellow paint on surface of the cast; small spots of paint splash mainly on sinister side of panel.

CHIPS AND LOSS: Missing areas associated with the cracks and around screws on both sides of the panel at its bottom edge.

Cracks

Ferrous items under plaster

Chips, abrasions, missing surfaces

Paint splashes

- All areas of raw plaster were given an application of 10% Paraloid B72 in acetone to provide an isolating layer between the original plaster and the repairs.
- Exposed metal fixings were treated with 5% Tannic Acid so as to stabilise the corrosion, and covered with a protective layer of 20% Paraloid B72 in acetone.
- Areas of loss, open joints and cracks were filled with white micro-balloons mixed with 12% Paraloid B72 in acetone. Larger areas of loss around the screws were filled with an inert filler to provide extra strength.

- All the fills were then toned out with acrylics, mixed with matting agent, to match the surrounding patina.
- Finally, the entire cast was given an application of micro-crystalline wax so as to protect the surface.

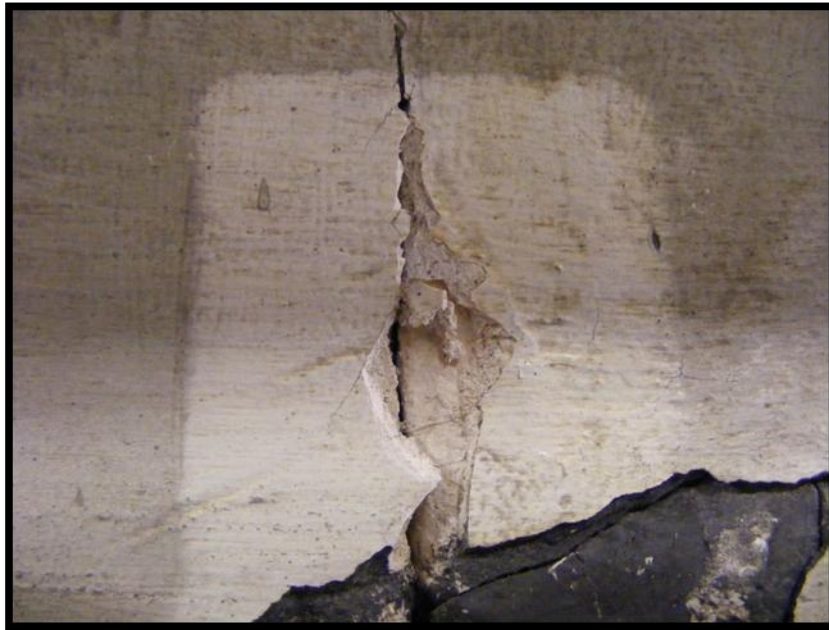
At the time of re-siting the cast collection from the Royal Scottish Academy building on Princes Street to the Edinburgh College of Art in 1913, the Parthenon Frieze panels were installed with metal fixings set into the wall. The open joints between the panels were filled with a mortar that was smeared over the adjacent edges of the panels.

A mortar analysis was carried out by Mr Bill Revie of CMC on samples of the pointing material found between the Panel 10 and 11 on Ground Floor Galley North Wall. The mortar was found to be a thick layer of lime putty, gypsum plaster and fine sand and hair, followed by a thin layer of gypsum plaster and lime putty; and finally a layer of varnish. This final layer of varnish is found over the entire two floors of the North and South Walls and yet, interestingly, for some unknown reason, it was not applied to the slabs on the East Wall.

Samples of mortar were taken for analysis

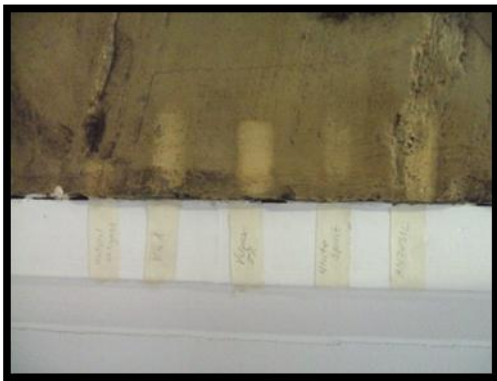
Wet Cleaning Spot Tests

- Prior to any conservation treatment, the cast was photographed. This photographic documentation was continued throughout all conservation processes.
- Initially, the cast was dry cleaned with soft brushes and Wishab Sponges with a rubber-nozzled vacuum to pick up the loose dust and dirt.
- Following a variety of wet cleaning spot tests, the surface of the panel was cleaned with 2-5% Vulpex Liquid Soap in de-ionised water, using cotton wool swabs.

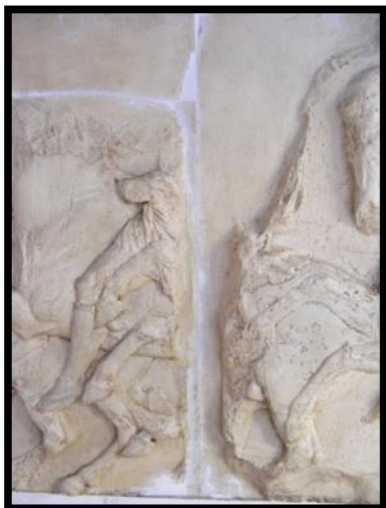
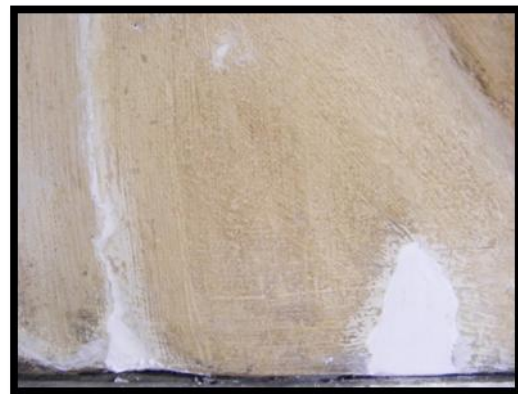
Details of fill repairs

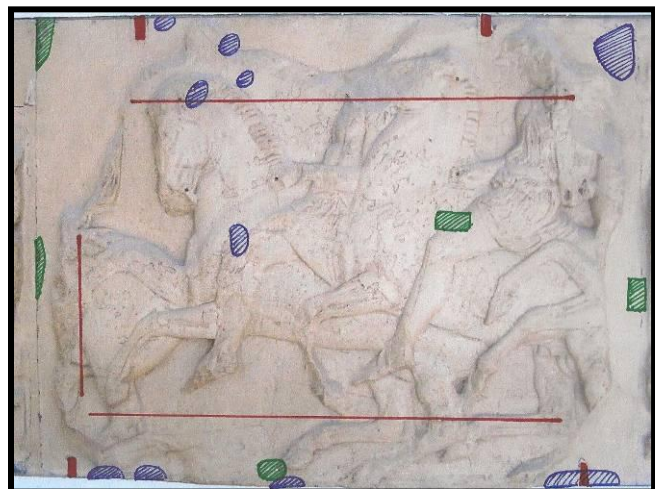
STRUCTURAL STABILITY: Fair. Open cracks running alongside joints on both sides of the panel; small cracks around fixings in corners of the panel

CHIPS AND LOSS: Missing areas associated with the cracks.

Cracks

Chips, abrasions and missing surfaces

Paint splashes

- All areas of raw plaster were given an application of 10% Paraloid B72 in acetone to provide an isolating layer between the original plaster and the repairs.
- Exposed metal fixings were treated with 5% Tannic Acid so as to stabilise the corrosion, and covered with a protective layer of 20% Paraloid B72 in acetone.
- Areas of loss, open joints and cracks were filled with white micro-balloons mixed with 12% Paraloid B72 in acetone. Larger areas of loss around the screws were filled with inert filler to provide extra strength.

- All the fills were then toned out with acrylics, mixed with matting agent, to match the surrounding patina.
- Finally, the entire cast was given an application of micro-crystalline wax so as to protect the surface.

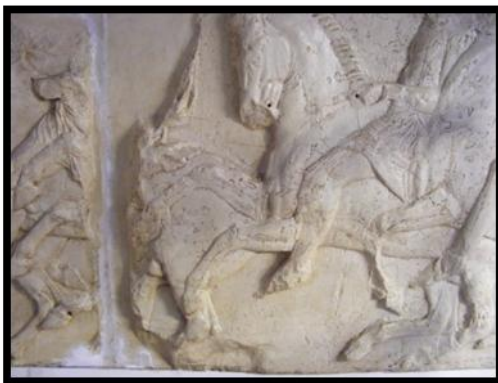
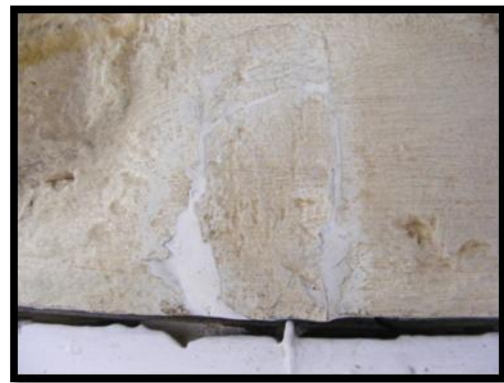
Details of fill repairs

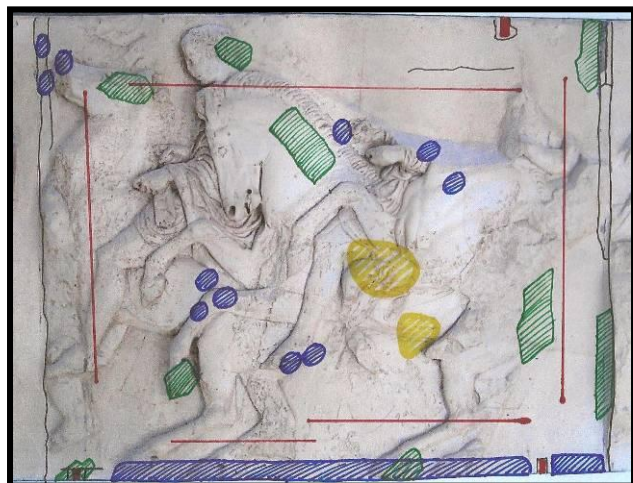
STRUCTURAL STABILITY: Fair. Open cracks running alongside joints on both sides of the panel; small cracks around fixings in corners of the panel.

CHIPS AND LOSS: Missing areas associated with the cracks, the majority of which are alongside the crack on the sinister side of the panel; missing area around metal fixing in dexter bottom corner of the cast.

Cracks

Chips, abrasions and missing surfaces

Flaking paint

- Areas of flaking paint were consolidated with 5% Primal B60A in de-ionised water.
- All areas of raw plaster were given an application of 10% Paraloid B72 in acetone to provide an isolating layer between the original plaster and the repairs.
- Exposed metal fixings were treated with 5% Tannic Acid so as to stabilise the corrosion, and covered with a protective layer of 20% Paraloid B72 in acetone.
- Areas of loss, open joints and cracks were filled with white micro-balloons with 12% Paraloid B72 in acetone. Larger areas of loss around the screws were filled with inert filler to provide extra strength.
- All the fills were then toned out with acrylics, mixed with matting agent, to match the surrounding patina.
- Finally, the entire cast was given an application of micro-crystalline wax so as to protect the surface.

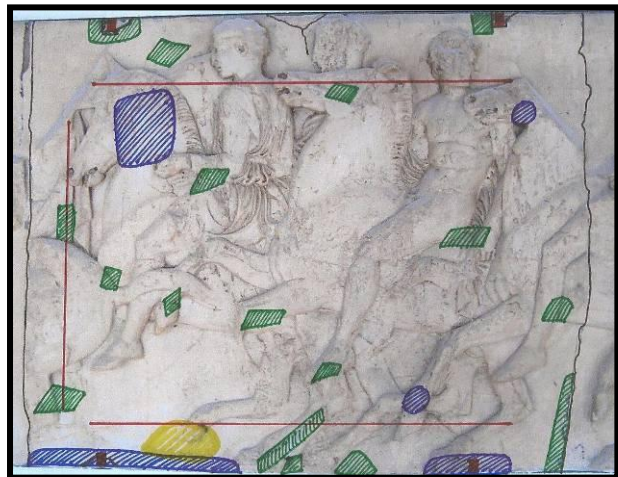
STRUCTURAL STABILITY: Fair. Open cracks running alongside joints on both sides of the panel; small cracks around fixings in corners of the panel.

CHIPS AND LOSS: Missing areas associated with the cracks, the majority of which alongside crack on sinister side of the panel; missing area around metal fixing in dexter bottom corner of the cast.

Cracks

Chips, abrasions and missing surfaces

Flaking paint

- Areas of flaking paint were consolidated with Primal B60A in de-ionised water.
- All areas of raw plaster were given an application of 10% Paraloid B72 in acetone to provide an isolating layer between the original plaster and the repairs.
- Exposed metal fixings were treated with 5% Tannic Acid so as to stabilise the corrosion, and covered with a protective layer of 20% Paraloid B72 in acetone.
- Areas of loss, open joints and cracks were filled with white micro-balloons with 12% Paraloid B72 in acetone. Larger areas of loss around the screws were filled with an inert filler to provide extra strength.
- All the fills were then toned out with acrylics, with matting agent, to match the surrounding patina.
- Finally, the entire cast was given an application of micro-crystalline wax so as to protect the surface.

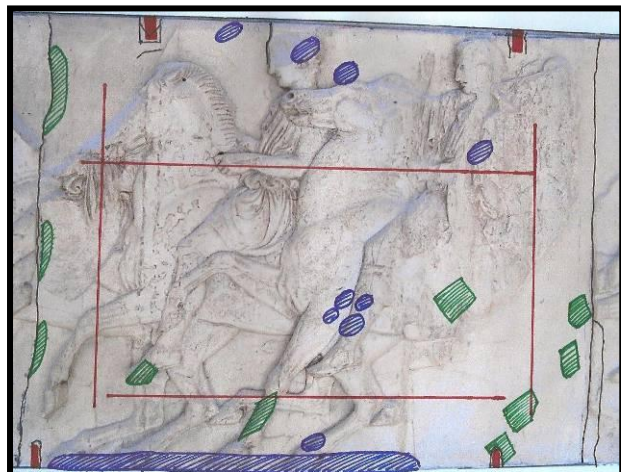
STRUCTURAL STABILITY: Fair. Open cracks running alongside joints on both sides of the panel; small cracks around fixings in corner areas of the panel

CHIPS AND LOSS: Missing areas associated with the cracks, the majority of which are alongside crack on dexter side of the panel; missing area around metal fixing and alongside the crack on lower sinister side of the cast

Cracks

Chips, abrasions and missing surfaces

Paint splashes

- All areas of raw plaster were given an application of 10% Paraloid B72 in acetone to provide an isolating layer between the original plaster and the repairs.
- Exposed metal fixings were treated with 5% Tannic Acid so as to stabilise the corrosion, and covered with a protective layer of 20% Paraloid B72 in acetone.
- Areas of loss, open joints and cracks were filled with white micro-balloons with 12% Paraloid B72 in acetone. Larger areas of loss around the screws were filled with an inert filler to provide extra strength.
- All the fills were then toned out with acrylics, with matting agent, to match the surrounding patina.
- Finally, the entire cast was given an application of micro-crystalline wax so as to protect the surface.

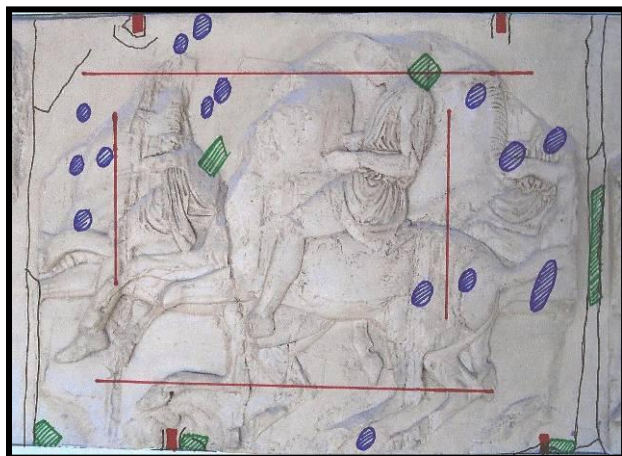
STRUCTURAL STABILITY: Fair. Open cracks running alongside joints on both sides of the panel; small cracks around fixings in corner areas of the panel

CHIPS AND LOSS: Missing areas associated with the cracks, the majority of which are alongside the crack on sinister side of the panel; missing area around metal fixing on sinister side of the cast

Cracks

Chips, abrasions and missing surfaces

Paint splashes

- All areas of raw plaster were given an application of 10% Paraloid B72 in acetone to provide an isolating layer between the original plaster and the repairs.

- Exposed metal fixings were treated with 5% Tannic Acid so as to stabilise the corrosion, and covered with a protective layer of 20% Paraloid B72 in acetone.

- Areas of loss, open joints and cracks were filled with white micro-balloons with 12% Paraloid B72 in acetone. Larger areas of loss around the screws were filled with an inert filler to provide extra strength.

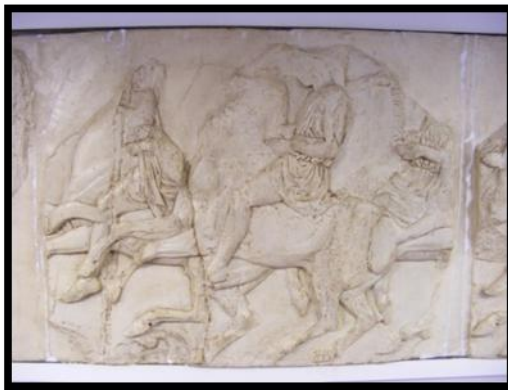
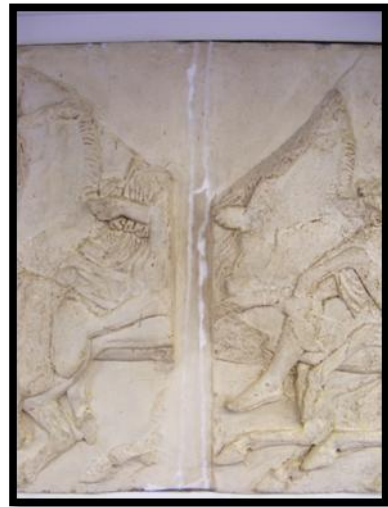
Panel during work on fills

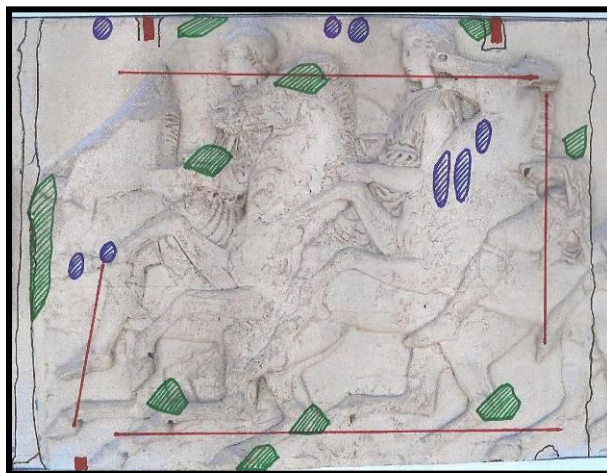
STRUCTURAL STABILITY: Fair. Open cracks running alongside joints on both sides of the panel; small cracks around fixings in corner areas of the panel.

CHIPS AND LOSS: Missing areas associated with the cracks, the majority of which are alongside the crack on sinister side of the panel; missing area around metal fixing on sinister side of the cast.

Cracks

Chips, abrasions and missing surfaces

Paint splashes

- All areas of raw plaster were given an application of 10% Paraloid B72 in acetone to provide an isolating layer between the original plaster and the repairs.
- Exposed metal fixings were treated with 5% Tannic Acid so as to stabilise the corrosion, and covered with a protective layer of 20% Paraloid B72 in acetone.
- Areas of loss, open joints and cracks were filled with white micro-balloons with 12% Paraloid B72 in acetone. Larger areas of loss around the screws were filled with an inert filler to provide extra strength.

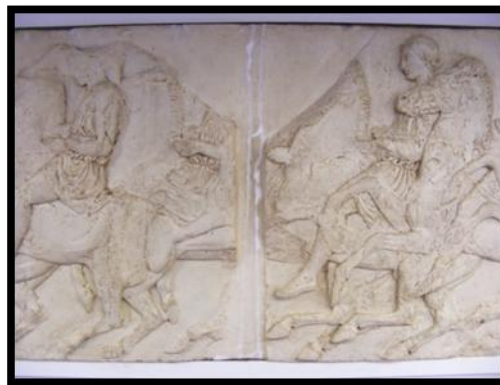
Panel during work on fills

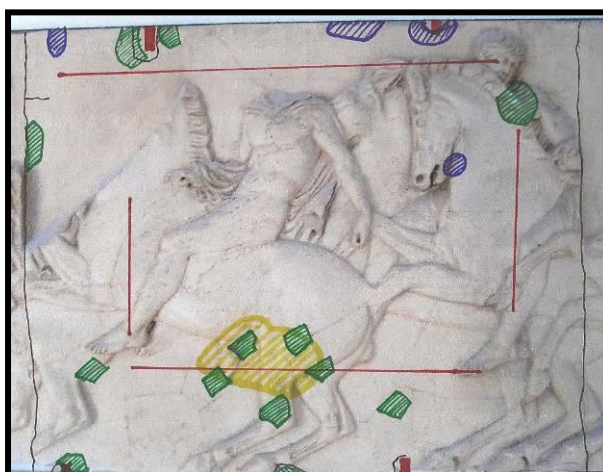
STRUCTURAL STABILITY: Fair. Open cracks running alongside joints on both sides of the panel; small cracks around fixings in corner areas of the panel.

CHIPS AND LOSS: Missing areas associated with the cracks; missing area around metal fixing.

Cracks

Chips, abrasions and missing surfaces

Flaking paint

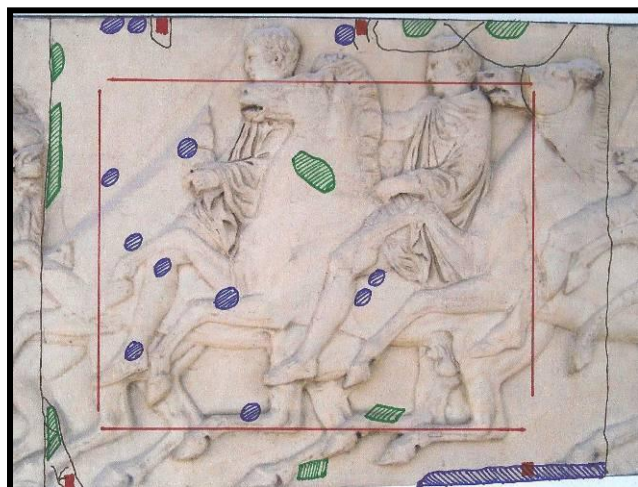
Cracks

Paint splashes

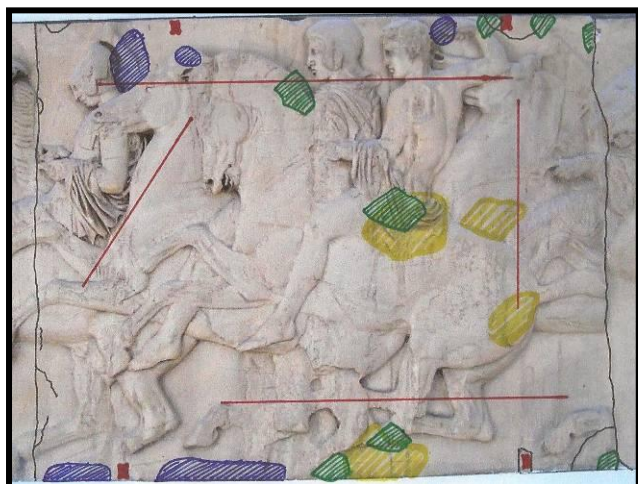
Flaking paint

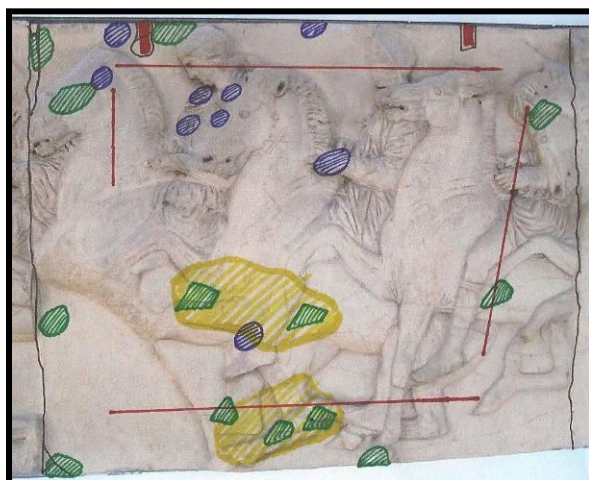
Flaking paint

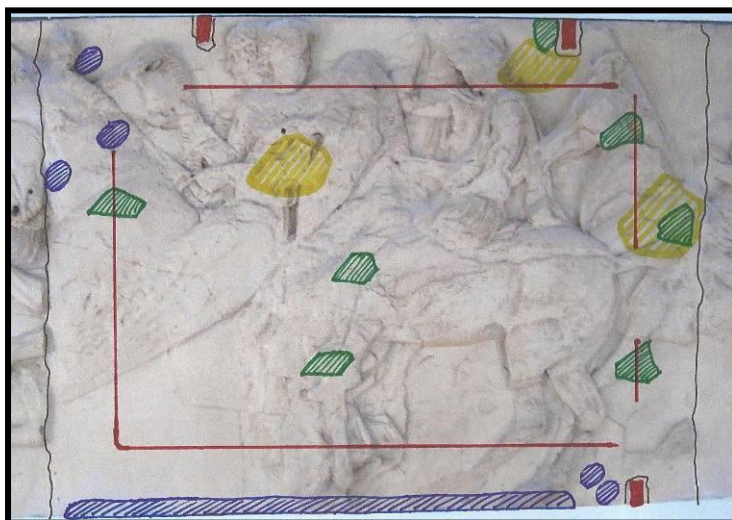
Flaking paint

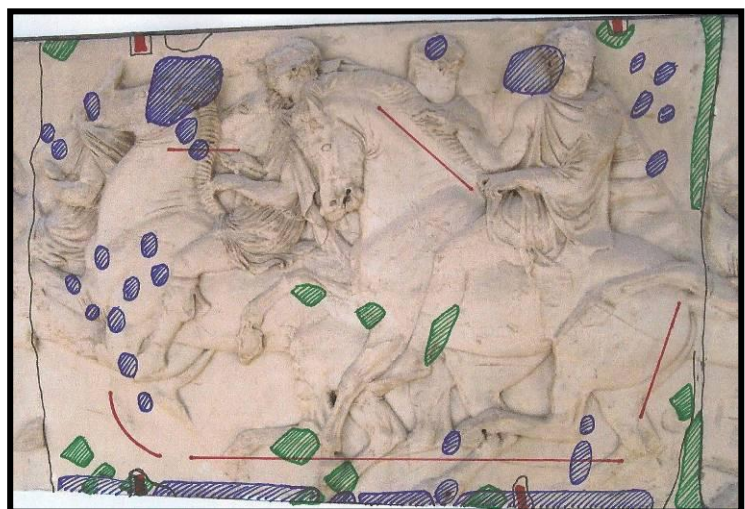
Paint splashes

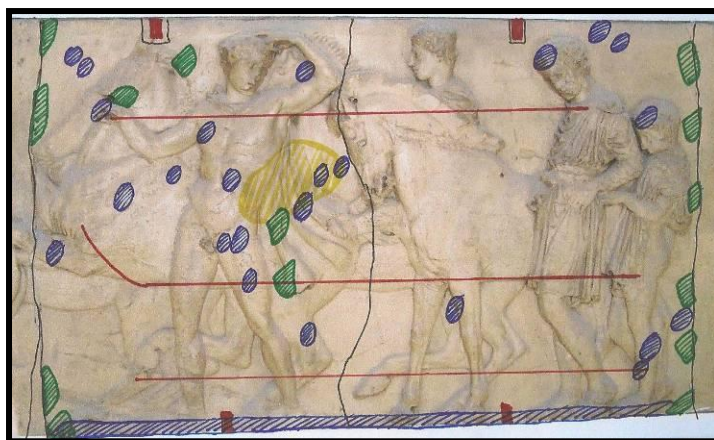
Flaking paint

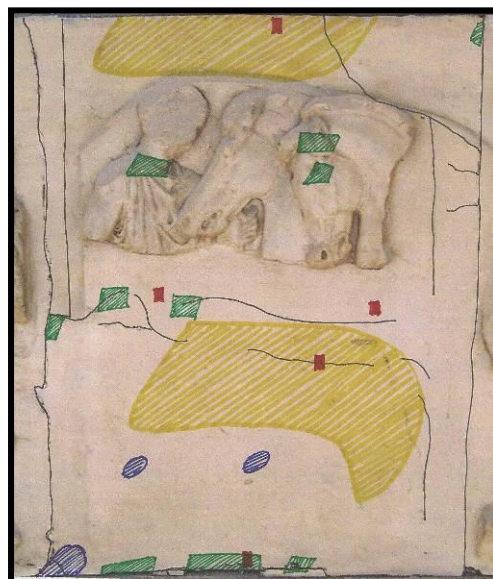
Flaking paint

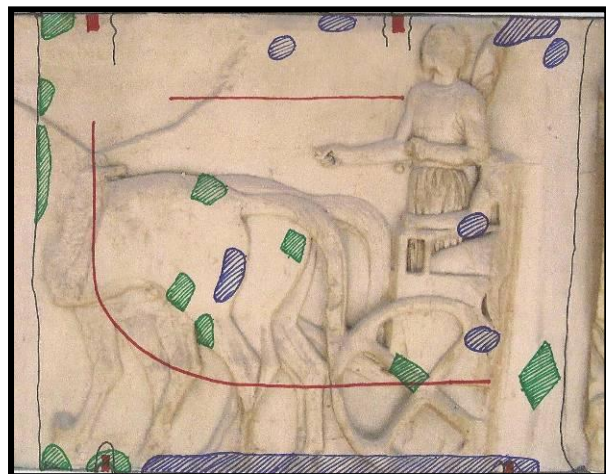
Paint splashes

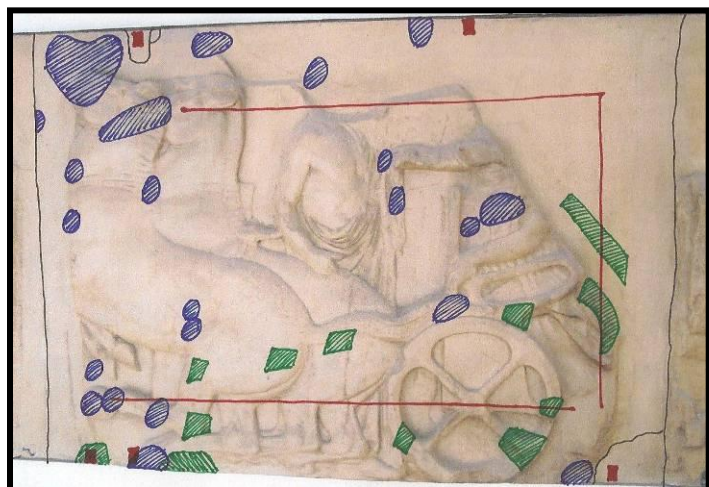
Paint splashes

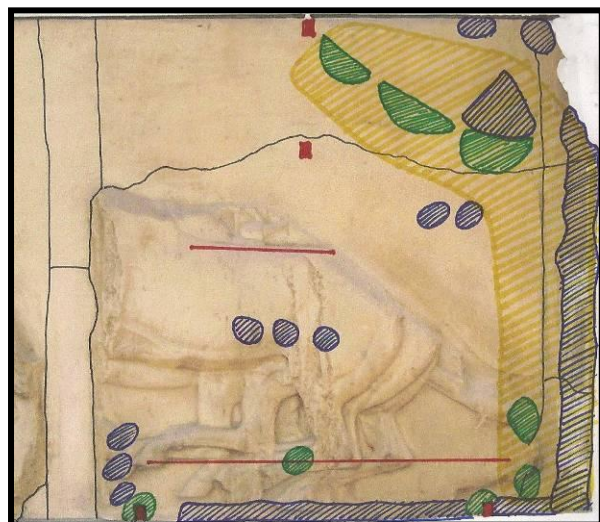
Flaking paint
