1.2 SCULPTURE COURT UPPER GALLERY NORTH WALL

TITLE: Parthenon Frieze, copy of panel from the Frieze at temple of Athena in Acropolis, Athens, Greece (443 – 438 BC).

TYPE OF OBJECT: Relief, plaster cast with a metal structure inside, attached to the wall with 3 metal fixings.

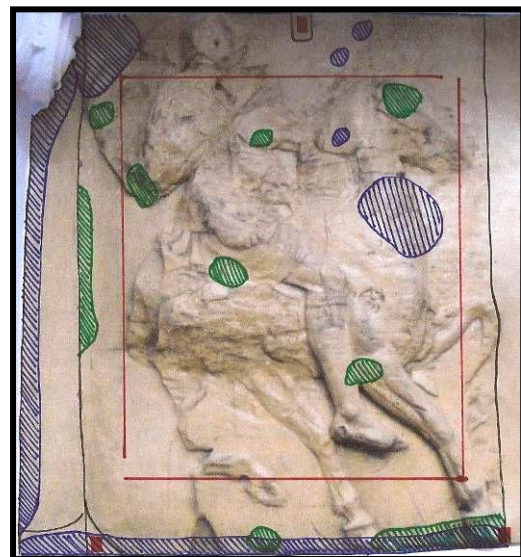
PANEL 1

STRUCTURAL STABILITY: Fair. Open cracks running alongside joints on both sides of the panel; cracks around fixing on top of the panel.

SURFACE DUST AND DIRT: Severe, 100% coverage.

VISIBLE PAINT LAYERS/UNSIGHTLY MARKINGS: Layer of cream-yellow paint/varnish on surface of the cast; small spots of paint splashes scattered on surface of the panel mainly on its dexter and bottom edges.

CHIPS AND LOSS: Missing areas associated with the cracks.

Cracks

Ferrous items under plaster

Chips, abrasions, missing surfaces

Paint splashes

- All areas of raw plaster were given an application of 10% Paraloid B72 in acetone to provide an isolating layer between the original plaster and the repairs.
- Exposed metal fixings were treated with 5% Tannic Acid so as to stabilise the corrosion, and covered with a protective layer of 20% Paraloid B72 in acetone.
- Areas of loss, open joints and cracks were filled with white micro-balloons with 12% Paraloid B72 in acetone. Larger areas of loss around the screws were filled with an inert filler to provide extra strength.
- All the fills were then toned out with acrylics, mixed with matting agent, to match the surrounding patina.
- Finally, the entire cast was given an application of micro-crystalline wax so as to protect the surface.

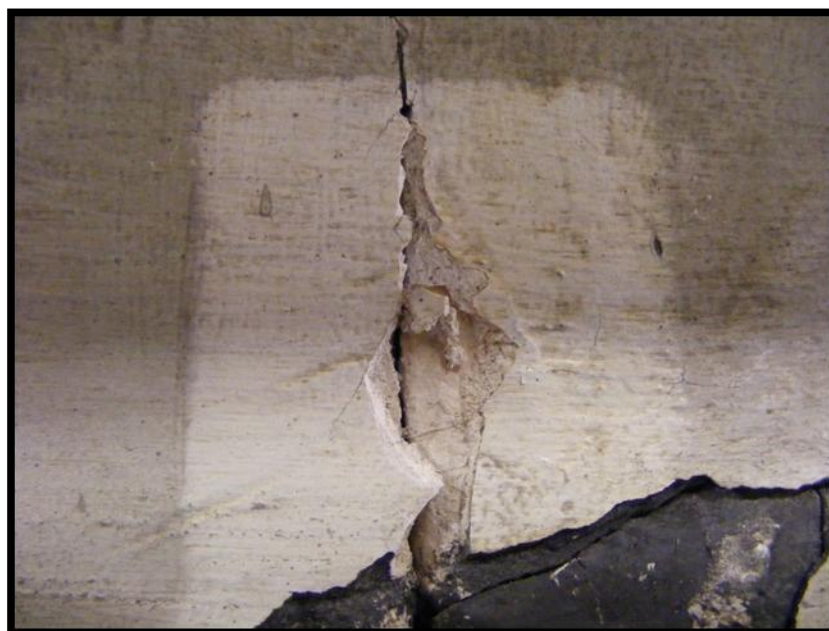
At the time of re-siting the cast collection from the Royal Scottish Academy building on Princes Street to the Edinburgh College of Art in 1913, the Parthenon Frieze panels were installed with metal fixings set into the wall. The open joints between the panels were filled with a mortar that was smeared over the adjacent edges of the panels.

A mortar analysis was carried out by Mr Bill Revie of CMC on samples of the pointing material found between the Panel 10 and 11 on Ground Floor Galley North Wall. The mortar was found to be a thick layer of lime putty, gypsum plaster and fine sand and hair, followed by a thin layer of gypsum plaster and lime putty; and finally a layer of varnish. This final layer of varnish is found over the entire two floors of the North and South Walls and yet, interestingly, for some unknown reason, it was not applied to the slabs on the East Wall.

Samples of mortar were taken for analysis

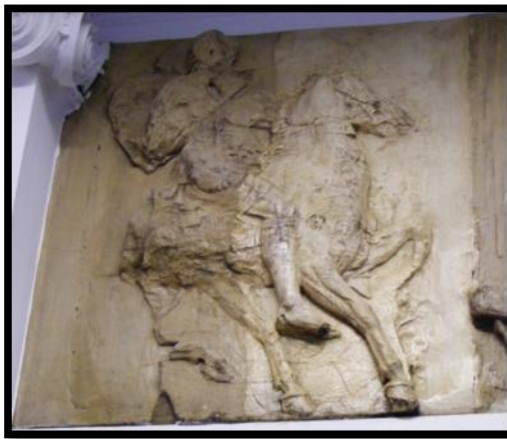
Cast during wet cleaning

- Prior to any conservation treatment, the cast was photographed. This photographic documentation was continued throughout all conservation processes.
- Initially, the cast was dry cleaned with soft brushes and Wishab Sponges with a rubber-nozzled vacuum to pick up loose dust and dirt.
- Following a variety of wet cleaning spot tests, the surface of the panel was cleaned with 2-5% Vulpex Liquid Soap in de-ionised water, using cotton wool swabs.

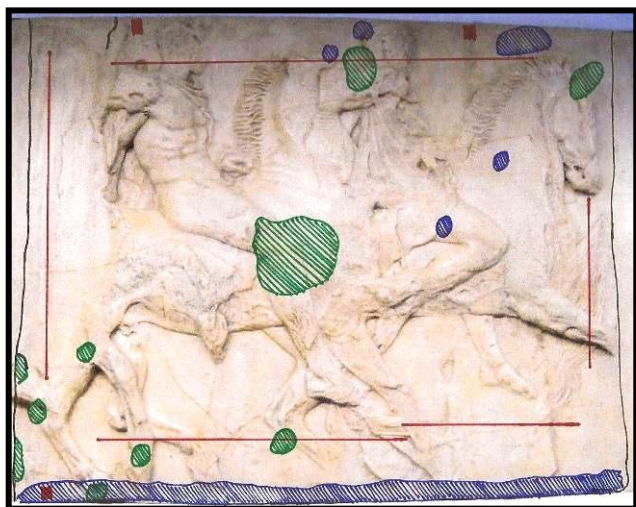
STRUCTURAL STABILITY: Fair. Open cracks running alongside joints on both sides of the panel.

CHIPS AND LOSS: Missing areas associated with the cracks.

Cracks

Chips, abrasions, missing surfaces

Paint splashes

- All areas of raw plaster were given an application of 10% Paraloid B72 in acetone to provide an isolating layer between the original plaster and the repairs.
- Exposed metal fixings were treated with 5% Tannic Acid so as to stabilise the corrosion, and covered with a protective layer of 20% Paraloid B72 in acetone.
- Areas of loss, open joints and cracks were filled with white micro-balloons with 12% Paraloid B72 in acetone. Larger areas of loss around the screws were filled with an inert filler to provide extra strength.
- All the fills were then toned out with acrylics, mixed with matting agent, to match the surrounding patina.
- Finally, the entire cast was given an application of micro-crystalline wax so as to protect the surface.

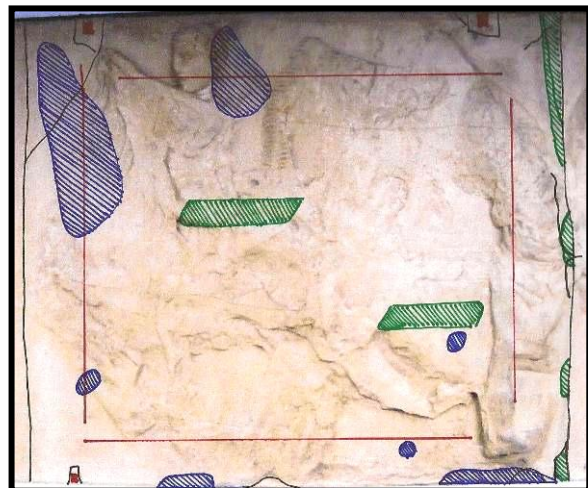
STRUCTURAL STABILITY: Fair. Open cracks running alongside joints on both sides of the panel small cracks around fixings in corners of the cast.

CHIPS AND LOSS: Missing areas associated with the cracks, especially alongside crack at the sinister side of the panel.

ABRASIONS: Missing surface plaster and paint layer in two areas in middle of the panel.

Cracks

Chips, abrasions, missing surfaces

Paint splashes

- All areas of raw plaster were given an application of 10% Paraloid B72 in acetone to provide an isolating layer between the original plaster and the repairs.
- Exposed metal fixings were treated with 5% Tannic Acid so as to stabilise the corrosion, and covered with a protective layer of 20% Paraloid B72 in acetone.
- Areas of loss, open joints and cracks were filled with white micro-balloons with 12% Paraloid B72 in acetone. Larger areas of loss around the screws were filled with an inert filler to provide extra strength.
- All the fills were then toned out with acrylics, mixed with matting agent, to match the surrounding patina.
- Finally, the entire cast was given an application of micro-crystalline wax so as to protect the surface.

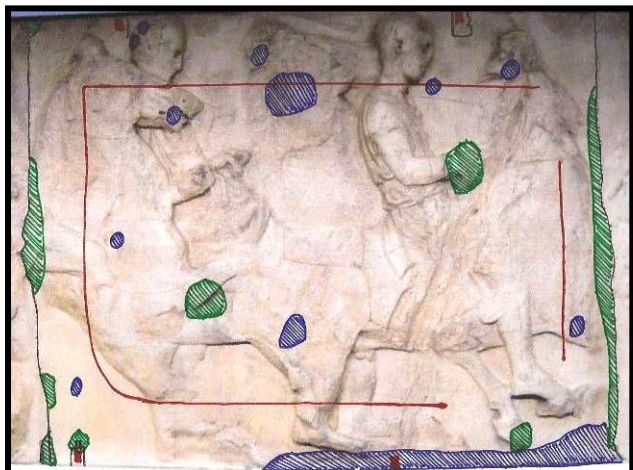
STRUCTURAL STABILITY: Fair. Open cracks running alongside joints on both sides of the panel; small cracks around fixings in two corners of the cast.

CHIPS AND LOSS: Missing areas associated with the cracks; large missing area on the hand of a rider on sinister side.

ABRASIONS: Missing surface plaster and paint layer in two areas in middle of the panel.

Cracks

Chips, abrasions, missing surfaces

Paint splashes

- All areas of raw plaster were given an application of 10% Paraloid B72 in acetone to provide an isolating layer between the original plaster and the repairs.
- Exposed metal fixings were treated with 5% Tannic Acid so as to stabilise the corrosion, and covered with a protective layer of 20% Paraloid B72 in acetone.
- Areas of loss, open joints and cracks were filled with white micro-balloons with 12% Paraloid B72 in acetone. Larger areas of loss around the screws were filled with an inert filler to provide extra strength.
- All the fills were then toned out with acrylics, mixed with matting agent, to match the surrounding patina.
- Finally, the entire cast was given an application of micro-crystalline wax so as to protect the surface.

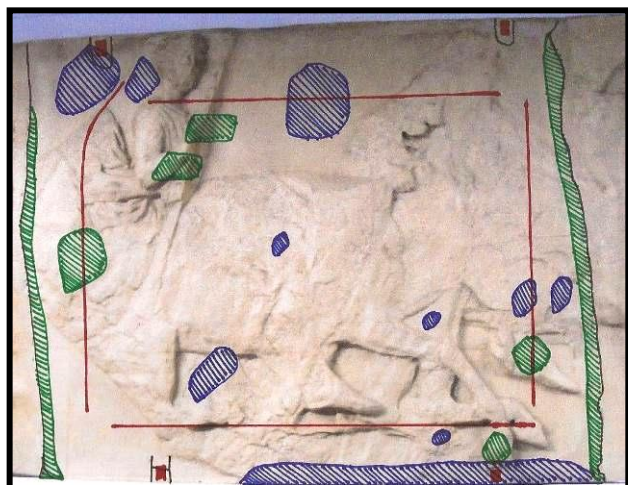
STRUCTURAL STABILITY: Fair. Open cracks running alongside joints on both sides of the panel; small cracks around fixings in three corners of the cast.

CHIPS AND LOSS: Missing areas associated with the cracks.

Cracks

Chips, abrasions, missing surfaces

Paint splashes

- All areas of raw plaster were given an application of 10% Paraloid B72 in acetone to provide an isolating layer between the original plaster and the repairs.
- Exposed metal fixings were treated with 5% Tannic Acid so as to stabilise the corrosion, and covered with a protective layer of 20% Paraloid B72 in acetone.
- Areas of loss, open joints and cracks were filled with white micro-balloons with 12% Paraloid B72 in acetone. Larger areas of loss around the screws were filled with an inert filler to provide extra strength.
- All the fills were then toned out with acrylics, mixed with matting agent, to match the surrounding patina.
- Finally, the entire cast was given an application of micro-crystalline wax so as to protect the surface.

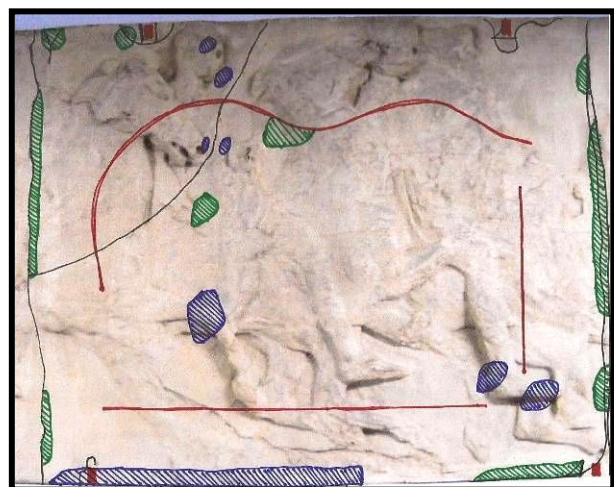
STRUCTURAL STABILITY: Fair. Open cracks running alongside joints on both sides of the panel and at top dexter corner; small cracks around fixings in three corners of the cast.

CHIPS AND LOSS: Missing areas associated with the cracks.

Cracks

Chips, abrasions, missing surfaces

Paint splashes

- Following wet cleaning spot tests, the surface of the panel was cleaned with 2-5% Vulpex Liquid Soap in de-ionised water, using cotton wool swabs.
- All areas of raw plaster were given an application of 10% Paraloid B72 in acetone to provide an isolating layer between the original plaster and the repairs.

- Exposed metal fixings were treated with 5% Tannic Acid so as to stabilise the corrosion, and covered with a protective layer of 20% Paraloid B72 in acetone.

- Areas of loss, open joints and cracks were filled with white micro-balloons with 12% Paraloid B72 in acetone. Larger areas of loss around the screws were filled with an inert filler to provide extra strength.

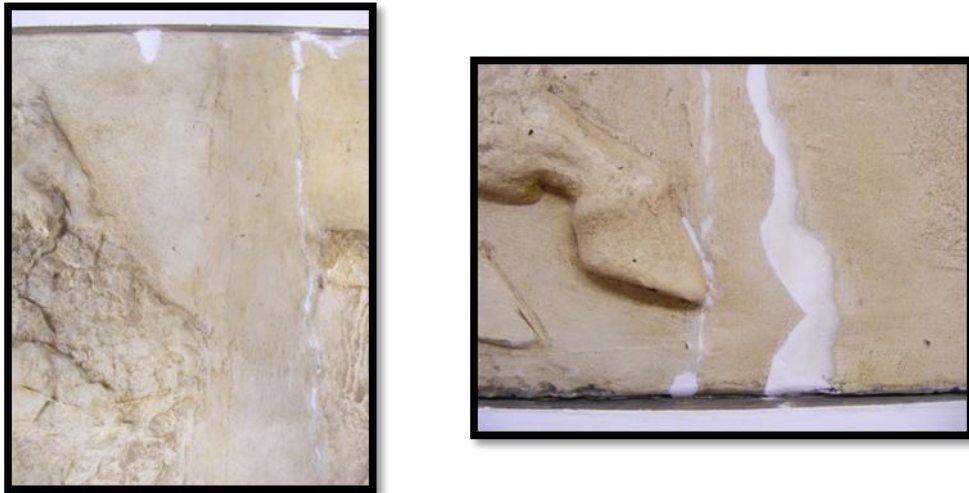
Details of fill repairs

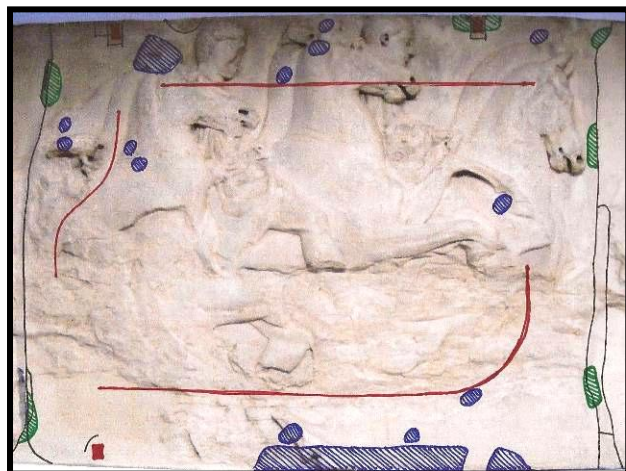
STRUCTURAL STABILITY: Fair. Open cracks running alongside joints on both sides of the panel; large crack running from dexter side of panel towards centre of the cast in its upper part.

CHIPS AND LOSS: Missing areas associated with the cracks and around screws on both sides of the panel at its lower edge.

Cracks

Chips, abrasions, missing surfaces

Paint splashes

- All areas of raw plaster were given an application of 10% Paraloid B72 in acetone to provide an isolating layer between the original plaster and the repairs.
- Exposed metal fixings were treated with 5% Tannic Acid so as to stabilise the corrosion, and covered with a protective layer of 20% Paraloid B72 in acetone.
- Areas of loss, open joints and cracks were filled with white micro-balloons mixed with 12% Paraloid B72 in acetone. Larger areas of loss around the screws were filled with an inert filler to provide extra strength.

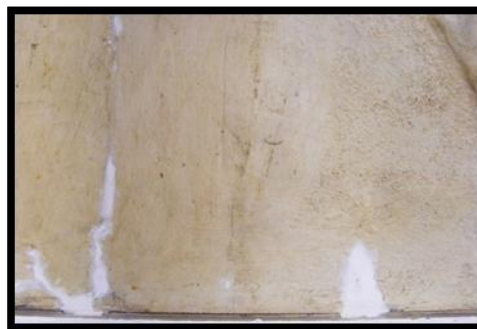
Details of fill repairs

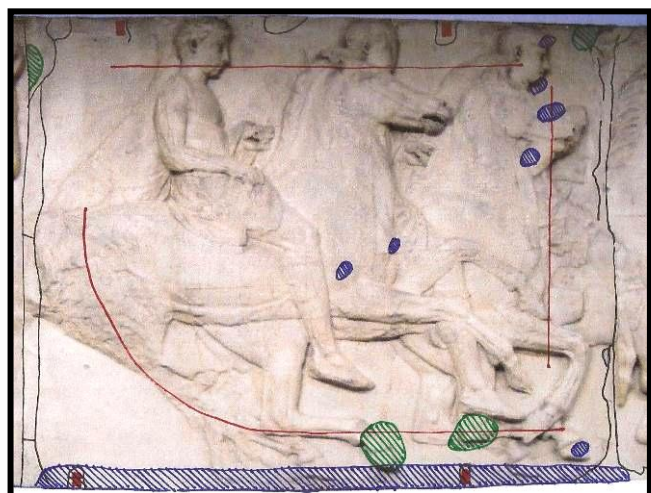
STRUCTURAL STABILITY: Fair. Open cracks running alongside joints on both sides of the panel; small cracks around fixings in three corners of the cast.

CHIPS AND LOSSES: Missing areas associated with the cracks.

Cracks

Chips, abrasions, missing surfaces

Paint splashes

- All areas of raw plaster were given an application of 10% Paraloid B72 in acetone to provide an isolating layer between the original plaster and the repairs.
- Exposed metal fixings were treated with 5% Tannic Acid so as to stabilise the corrosion, and covered with a protective layer of 20% Paraloid B72 in acetone.
- Areas of loss, open joints and cracks were filled with white micro-balloons mixed with 12% Paraloid B72 in acetone. Larger areas of loss around the screws were filled with an inert filler to provide extra strength.

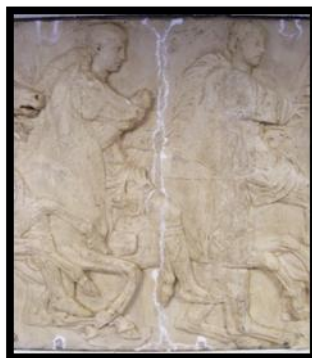
Details of fill repairs

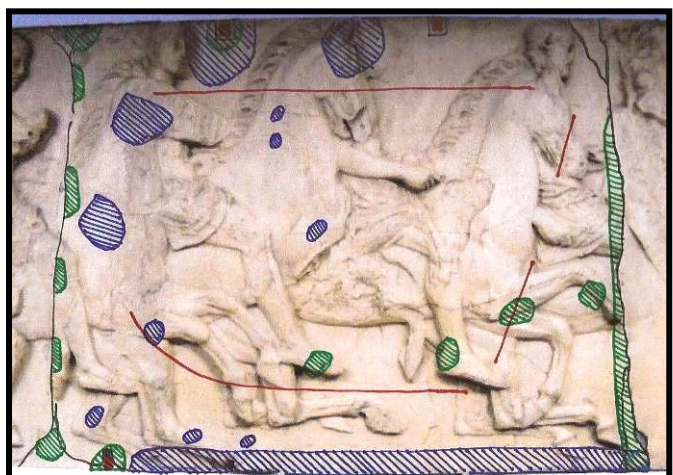
Cracks

Paint splashes

- All areas of raw plaster were given an application of 10% Paraloid B72 in acetone to provide an isolating layer between the original plaster and the repairs.
- Exposed metal fixings were treated with 5% Tannic Acid so as to stabilise the corrosion, and covered with a protective layer of 20% Paraloid B72 in acetone.
- Areas of loss, open joints and cracks were filled with white micro-balloons mixed with 12% Paraloid B72 in acetone. Larger areas of loss around the screws were filled with an inert filler to provide extra strength.

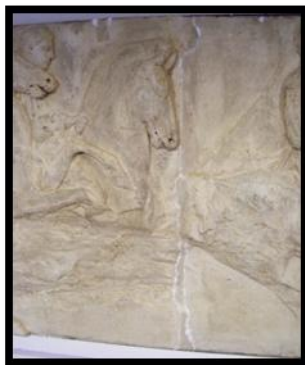
Details of fill repairs

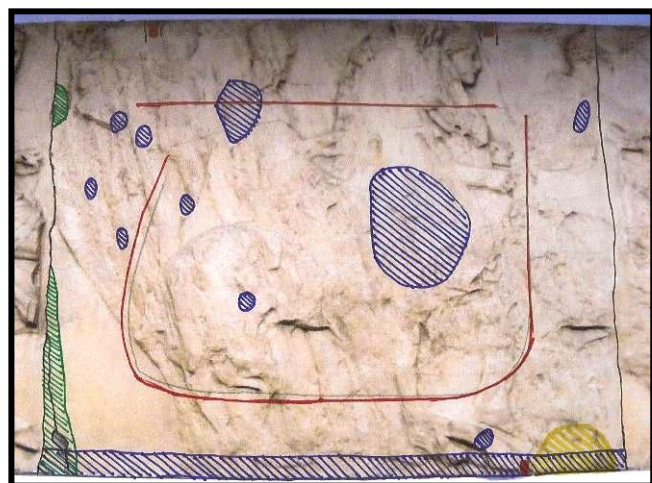
Cracks

Paint splashes

Flaking paint

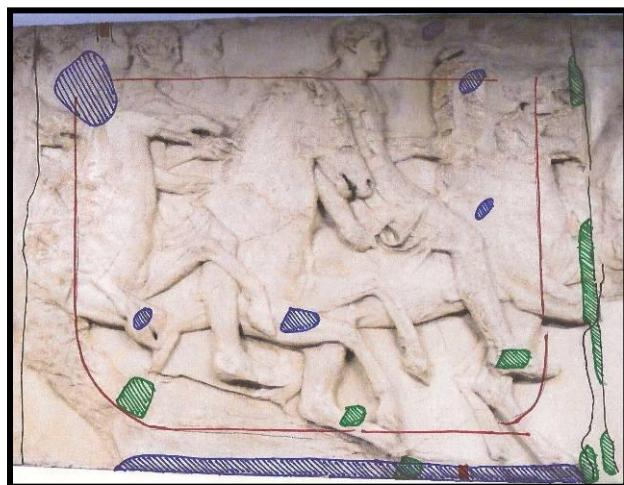
Paint splashes

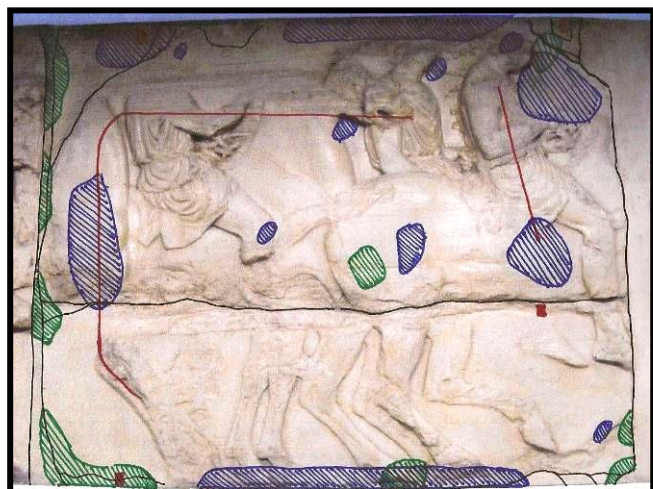
Paint splashes

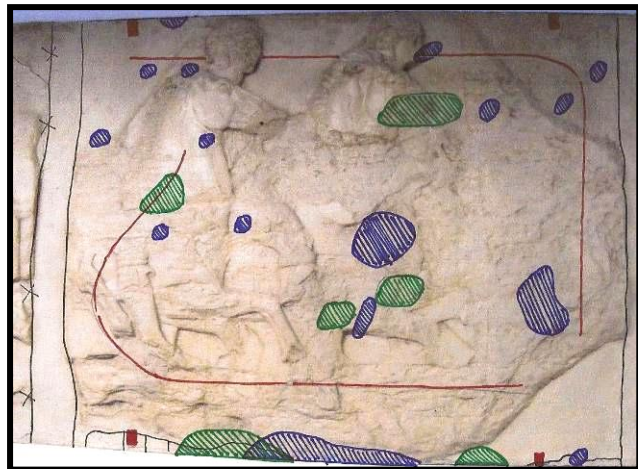
Paint splashes

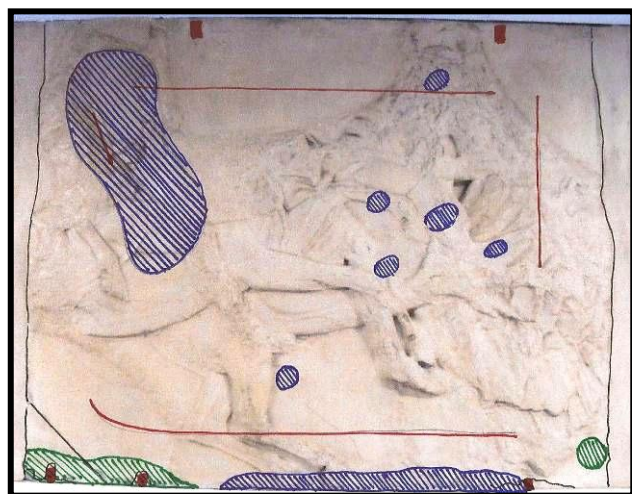
Paint splashes

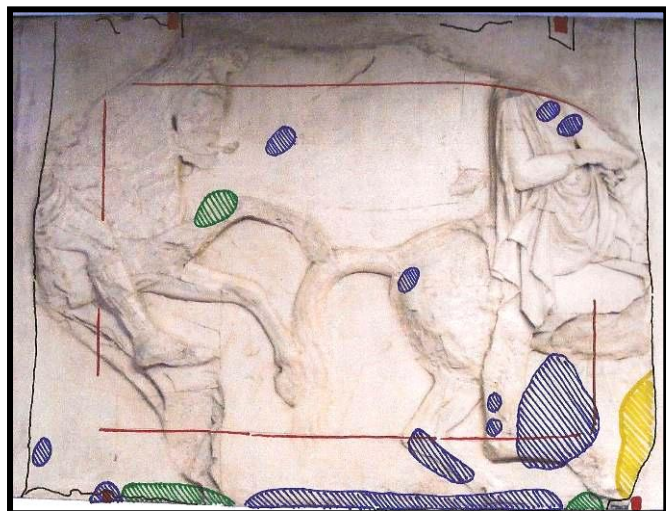
Flaking paint

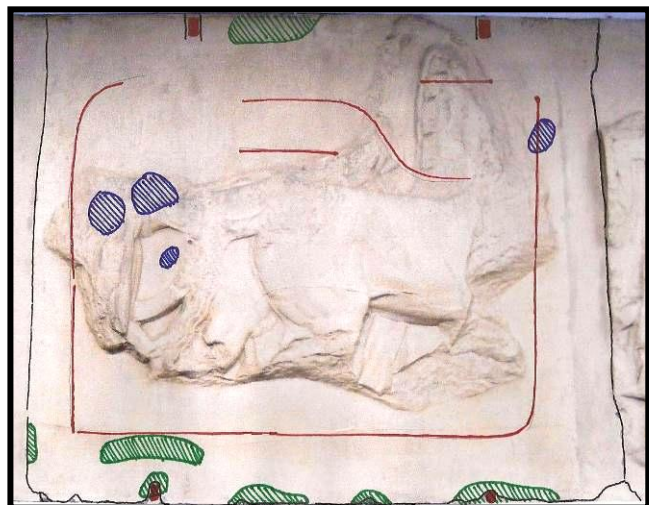
Paint splashes

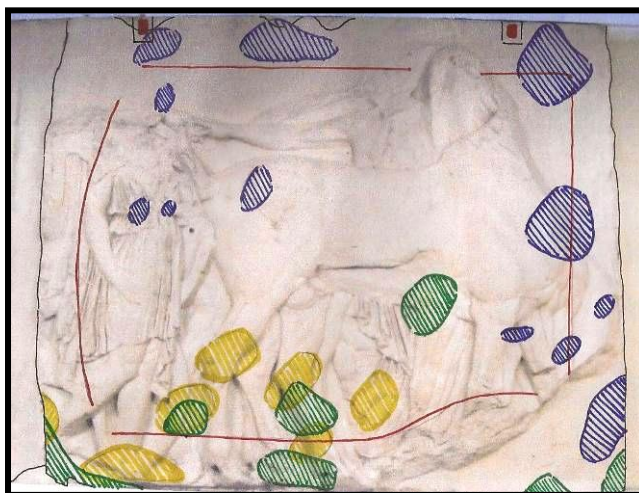
Flaking paint

- Areas of flaking paint were consolidated with 5% Primal B60A in de-ionised water.
- All areas of raw plaster were given an application of 10% Paraloid B72 in acetone to provide an isolating layer between the original plaster and the repairs.
- Exposed metal fixings were treated with 5% Tannic Acid so as to stabilise the corrosion, and covered with a protective layer of 20% Paraloid B72 in acetone.
- Areas of loss, open joints and cracks were filled with white micro-balloons mixed with 12% Paraloid B72 in acetone. Larger areas of loss around the screws were filled with an inert filler to provide extra strength.

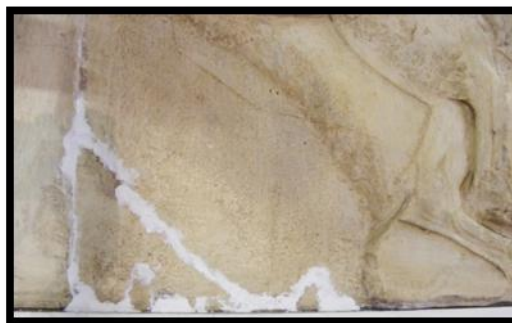
Panel during work on fills
