1. PARTHENON FRIEZE

1.3 SCULPTURE COURT LOWER GALLERY SOUTH WALL

PANEL 1

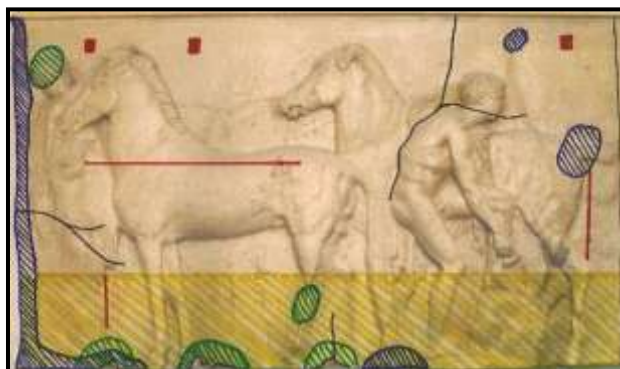
STRUCTURAL STABILITY: Fair. Open crack running alongside joint on sinister side of the panel; crack running from dexter side towards centre of the cast, and from the top towards centre of the panel on its sinister side; small cracks around fixings at lower edge.

VISIBLE PAINT LAYERS/UNSIGHTLY MARKINGS: Layer of cream-yellow paint/varnish on surface of the cast; the surface polychrome is discoloured and damaged on lower part of the panel probably by strip of lights which used to run just under the Frieze alongside the South and North walls on the Ground Floor Gallery; small spots of paint splash mainly at dexter and at lower edge of the panel; flaking and missing paint area on lower part of the panel.

CHIPS AND LOSS: Missing areas associated with the cracks and around screws at lower edge of the panel.

Cracks

Ferrous items under plaster

Chips, abrasions, missing surfaces

Paint splashes

Flaking paint

- Areas of flaking paint were consolidated with 5% Primal B60A in de-ionised water.
- All areas of raw plaster were given an application of 10% Paraloid B72 in acetone to provide an isolating layer between the original plaster and the repairs.
- Exposed metal fixings were treated with 5% Tannic Acid so as to stabilise the corrosion, and covered with a protective layer of 20% Paraloid B72 in acetone.
- Areas of loss, open joints and cracks were filled with white micro-balloons mixed with 12% Paraloid B72 in acetone. Larger areas of loss around the screws were filled with an inert filler to provide extra strength.
- All the fills and areas of discoloured paint were then toned out with acrylics, mixed with matting agent, to match the surrounding patina.
- Finally, the entire cast was given an application of micro-crystalline wax so as to protect the surface.

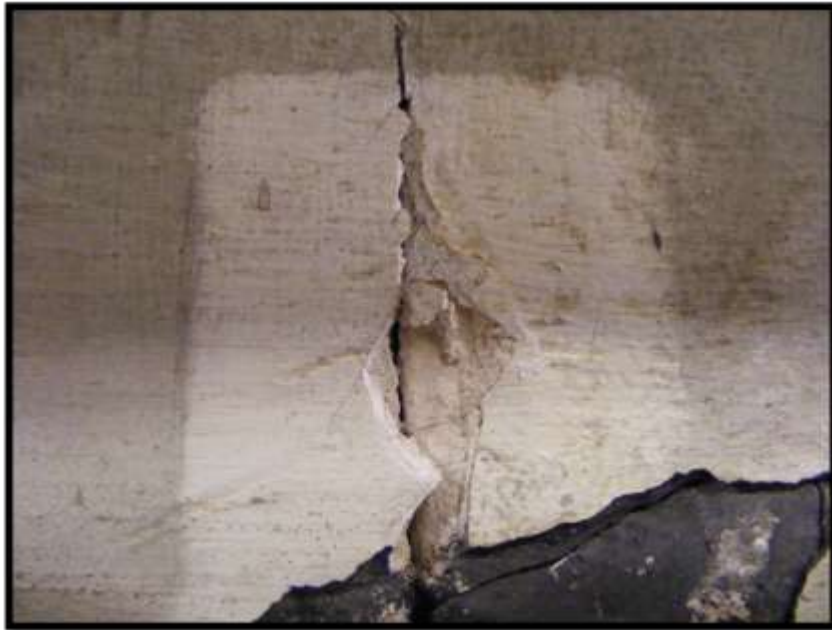
A mortar analysis was carried out by Mr Bill Revie of CMC on samples of the pointing material found between the Panel 10 and 11 on Ground Floor Galley North Wall. The mortar was found to be a thick layer of lime putty, gypsum plaster and fine sand and hair, followed by a thin layer of gypsum plaster and lime putty; and finally a layer of varnish. This final layer of varnish is found over the entire two floors of the North and South Walls and yet, interestingly, for some unknown reason, it was not applied to the slabs on the East Wall.

Samples of mortar were taken for analysis

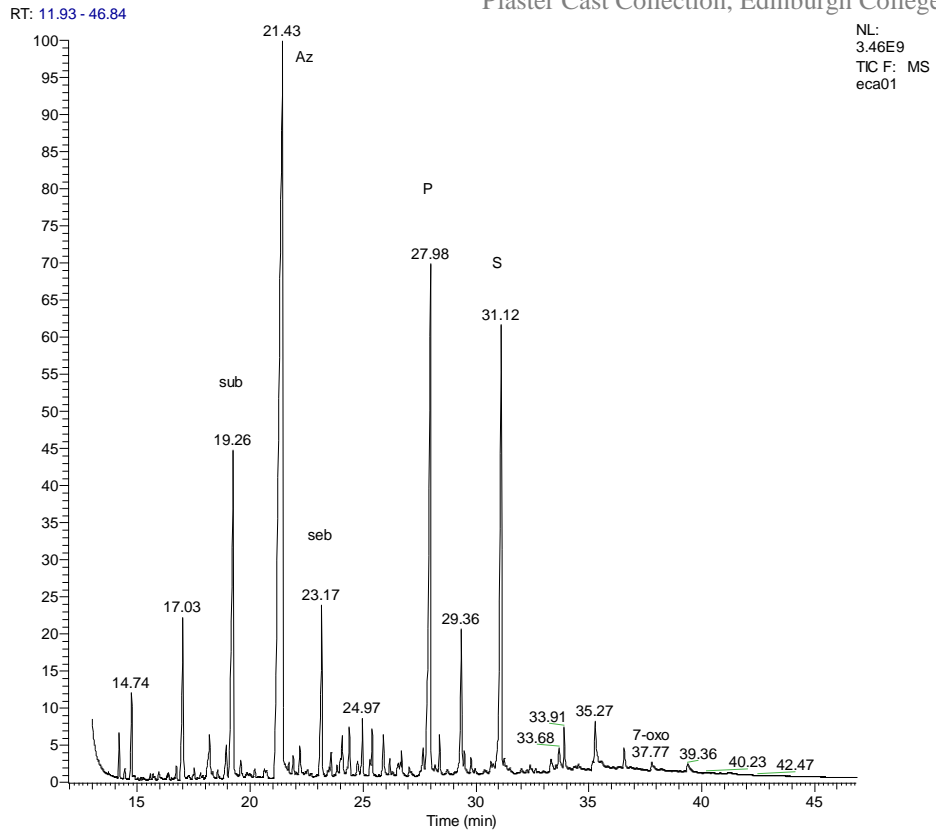
Thus there is no evidence to indicate that sample ECA 01 PF 1 of 2 Satir contains shellac, though it does contain some coniferous resin such as pine resin and it also contains, mainly, heat bodied linseed oil, probably in the paint layers and possibly also in the organic material within the plaster.

Chromatogram of sample 1 from Panel 1, showing oil/resin analysis; seb = dimethyl sebacate, Az = dimethyl azelate, sub = dimethyl suberate, P = methyl palmitate, S = methyl stearate

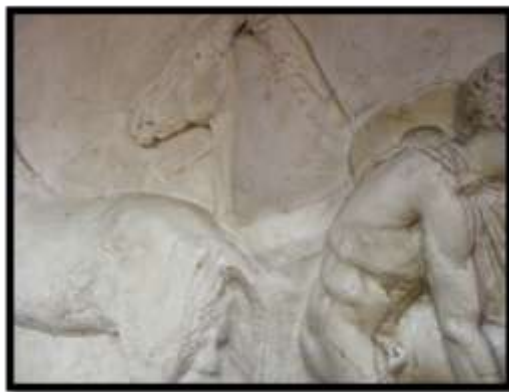
Cast during wet cleaning

- Prior to any conservation treatment, the cast was photographed. This photographic documentation was continued throughout all conservation processes.
- Initially, the cast was dry cleaned with soft brushes and Wishab Sponges with a rubber-nozzled vacuum to pick up the loose dust and dirt.
- Following wet cleaning spot tests on **Panel 1 on Upper Gallery South Wall**, the surface of the cast was cleaned with 2-5% Vulpex Liquid Soap in de-ionised water, using cotton wool swabs.

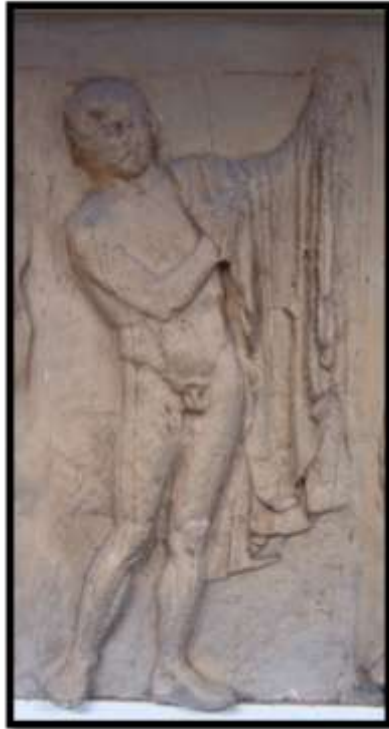
Panel before conservation

STRUCTURAL STABILITY: Fair. Open cracks running alongside joints on both sides of the panel.

VISIBLE PAINT LAYERS/UNSIGHTLY MARKINGS: Layer of cream-yellow paint/varnish on surface of the cast; surface polychrome is discoloured and damaged on lower part of the panel probably by strip of lights which used to run just under Frieze alongside South and North walls on Ground Floor Gallery; small spots of paint splash on upper section of the panel; flaking and missing paint area on lower part of the panel.

CHIPS AND LOSS: Missing areas associated with the cracks.

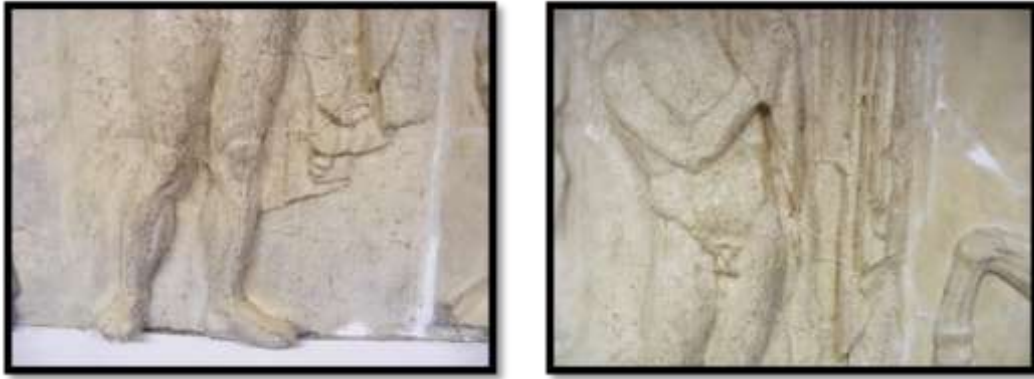
Details of fill repairs

- Areas of flaking paint were consolidated with 5% Primal B60A in de-ionised water.
- All areas of raw plaster were given an application of 10% Paraloid B72 in acetone to provide an isolating layer between the original plaster and the repairs.
- Exposed metal fixings were treated with 5% Tannic Acid so as to stabilise the corrosion, and covered with a protective layer of 20% Paraloid B72 in acetone.
- Areas of loss, open joints and cracks were filled with white micro-balloons mixed with 12% Paraloid B72 in acetone. Larger areas of loss around the screws were filled with inert filler to provide extra strength.

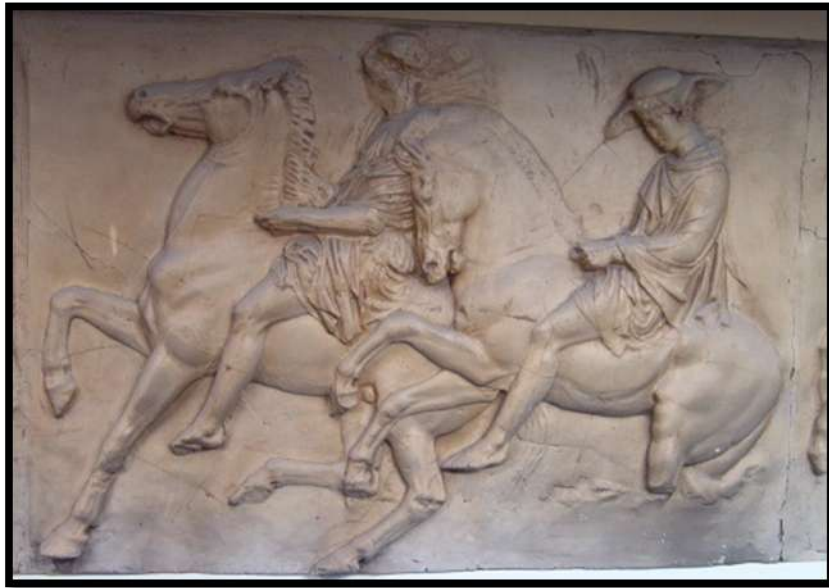
Panel before conservation

STRUCTURAL STABILITY: Stable. Open cracks running alongside joints on both sides of the panel and in middle section of dexter side of the cast; cracks around fixings in top sinister corner of the panel.

VISIBLE PAINT LAYERS/UNSIGHTLY MARKINGS: Layer of cream-yellow paint/varnish on surface of the cast; surface polychrome is discoloured and damaged on lower part of the panel probably by strip of lights which used to run just under Frieze alongside South and North walls of the Ground Floor Gallery; small spots of paint splash on lower section of the panel; flaking and missing paint area on lower part of the panel.

CHIPS AND LOSSES: Missing areas associated with the cracks.

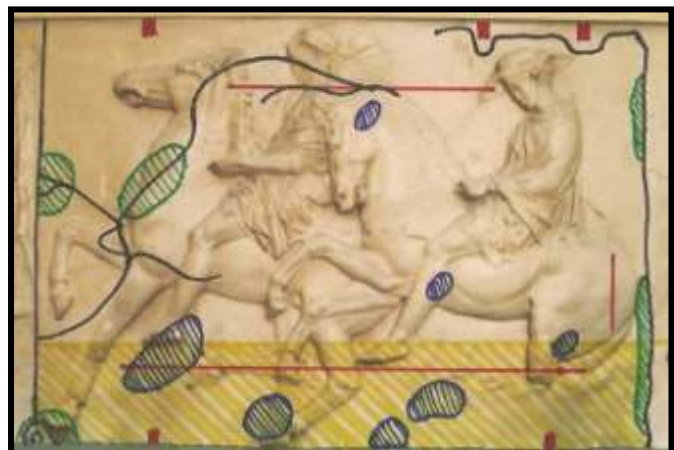
Cracks

Chips, abrasions and missing surfaces

Flaking paint

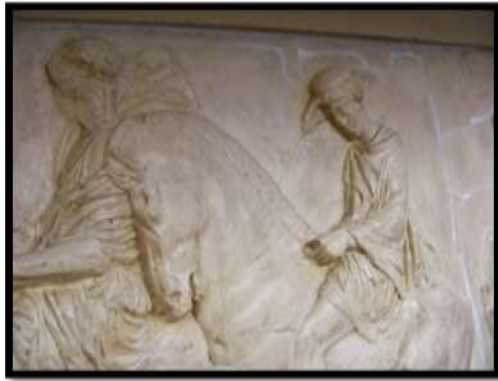
Details of fill repairs

- Areas of flaking paint were consolidated with 5% Primal B60A in de-ionised water.
- All areas of raw plaster were given an application of 10% Paraloid B72 in acetone to provide an isolating layer between the original plaster and the repairs.
- Exposed metal fixings were treated with 5% Tannic Acid so as to stabilise the corrosion, and covered with a protective layer of 20% Paraloid B72 in acetone.
- Areas of loss, open joints and cracks were filled with white micro-balloons with 12% Paraloid B72 in acetone. Larger areas of loss around the screws were filled with an inert filler to provide extra strength.

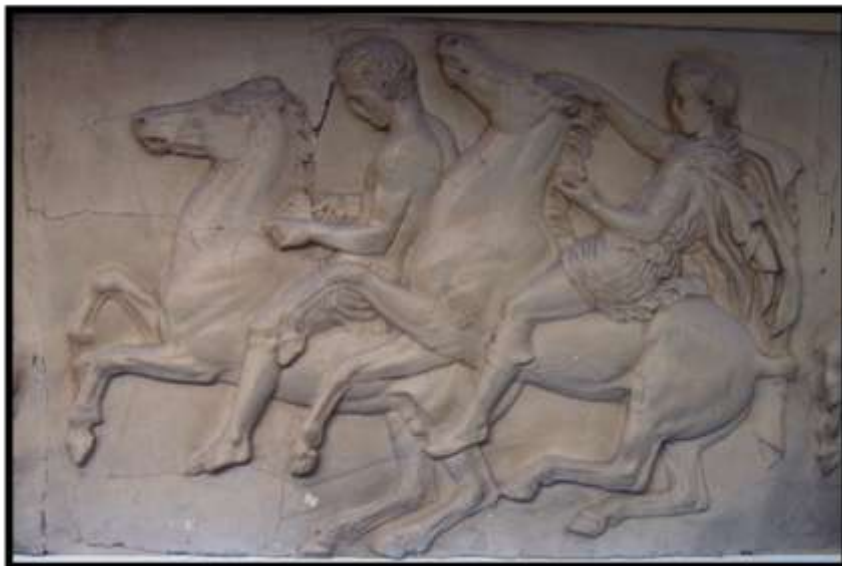
Panel before conservation

STRUCTURAL STABILITY: Stable. Open cracks running alongside joints on both sides of the panel and from dexter edge towards middle of the cast.

VISIBLE PAINT LAYERS/UNSIGHTLY MARKINGS: Layer of cream-yellow paint/varnish on surface of the cast; surface polychrome is discoloured and damaged on lower part of the panel probably by the strip of lights which used to run just under the Frieze along the South and North walls of the Ground Floor Gallery; small spots of paint splash scattered on surface of the panel; flaking and missing paint area on lower part of the panel.

CHIPS AND LOSS: Missing areas associated with the cracks.

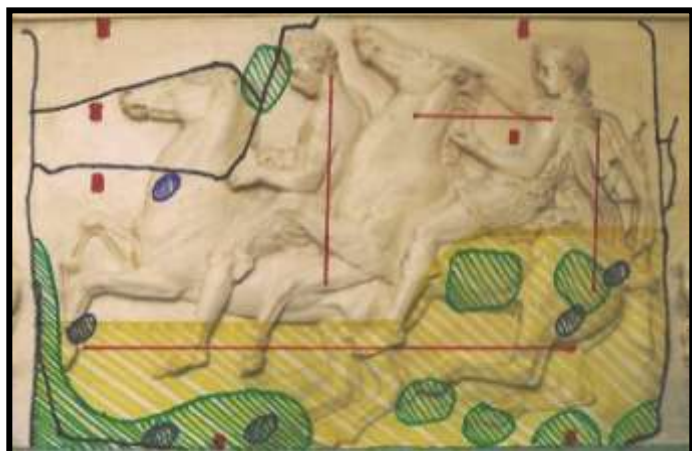
Cracks

Chips, abrasions and missing surfaces

Flaking paint

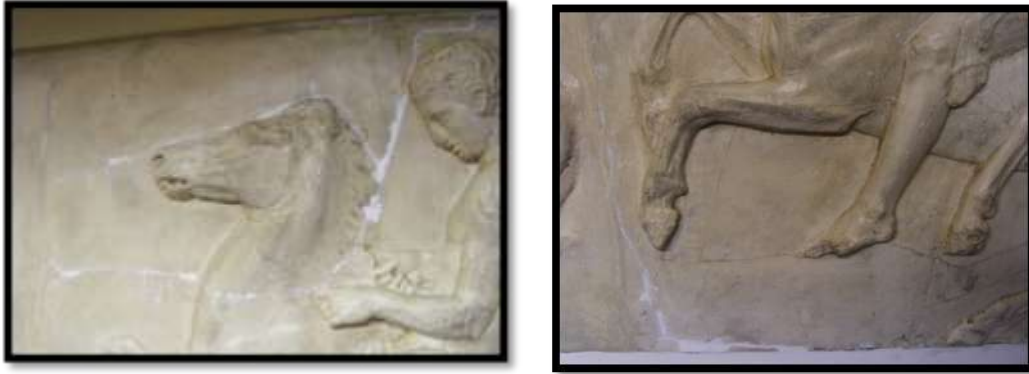
Details of fill repairs

- Areas of flaking paint were consolidated with 5% Primal B60A in de-ionised water.
- All areas of raw plaster were given an application of 10% Paraloid B72 in acetone to provide an isolating layer between the original plaster and the repairs.
- Exposed metal fixings were treated with 5% Tannic Acid so as to stabilise the corrosion, and covered with a protective layer of 20% Paraloid B72 in acetone.
- Areas of loss, open joints and cracks were filled with white micro-balloons with 12% Paraloid B72 in acetone. Larger areas of loss around the screws were filled with an inert filler to provide extra strength.

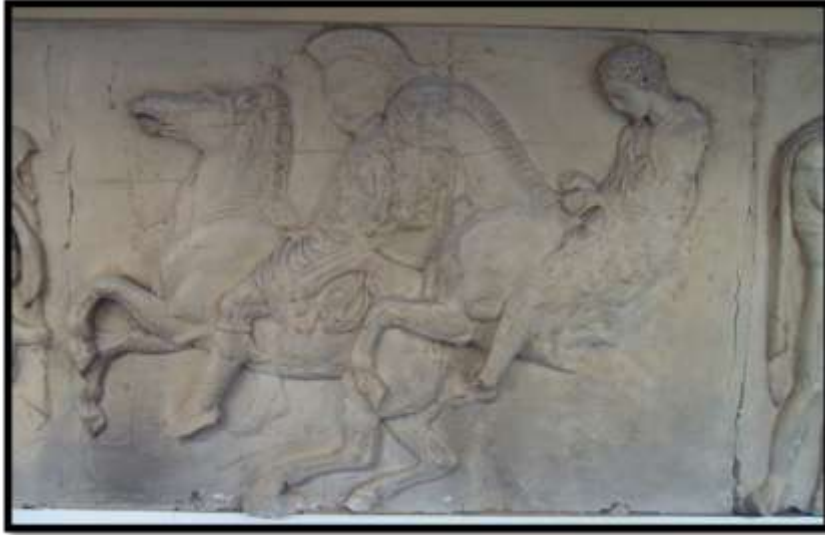
Panel before conservation

STRUCTURAL STABILITY: Fair. Open cracks running alongside joints on both sides of the panel; small cracks around fixings by top and lower edge of the panel

VISIBLE PAINT LAYERS/UNSIGHTLY MARKINGS: Layer of cream-yellow paint/varnish on surface of the cast; surface polychrome is discoloured and damaged on lower part of the panel probably by the strip of lights which used to run just under Frieze along the South and North walls of the Ground Floor Gallery; flaking and missing paint area on lower part of the panel.

CHIPS AND LOSSES: Missing areas associated with the cracks.

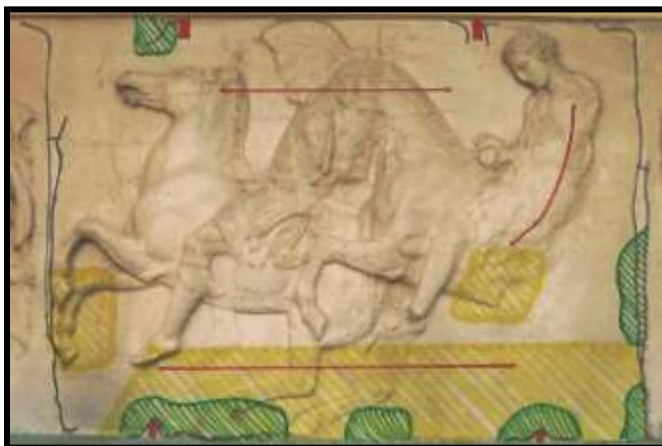
Cracks

Chips, abrasions and missing surfaces

Flaking paint

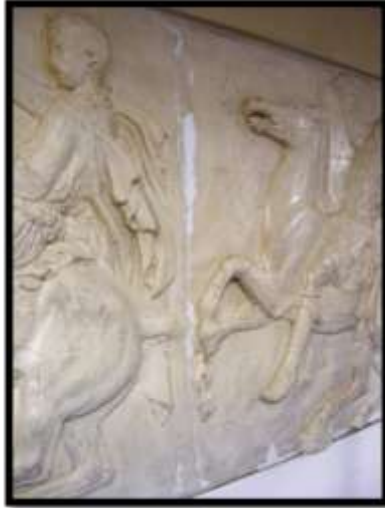
Details of fill repairs

- Areas of flaking paint were consolidated with 5% Primal B60A in de-ionised water.
- All areas of raw plaster were given an application of 10% Paraloid B72 in acetone to provide an isolating layer between the original plaster and the repairs.
- Exposed metal fixings were treated with 5% Tannic Acid so as to stabilise the corrosion, and covered with a protective layer of 20% Paraloid B72 in acetone.
- Areas of loss, open joints and cracks were filled with white micro-balloons with 12% Paraloid B72 in acetone. Larger areas of loss around the screws were filled with an inert filler to provide extra strength.

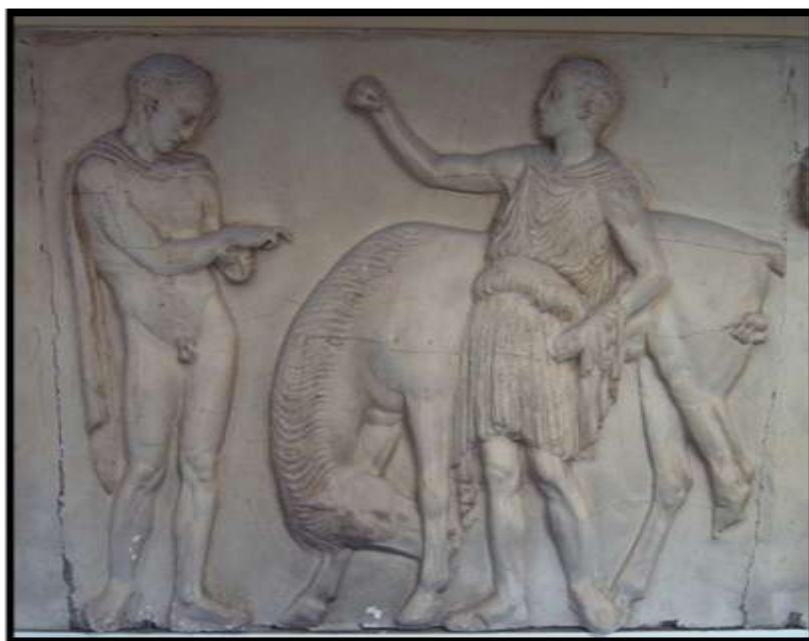
Panel before conservation

STRUCTURAL STABILITY: Fair. Open cracks running alongside joints on both sides of the panel and alongside top edge; small cracks around fixings at top and lower edges of the panel

VISIBLE PAINT LAYERS/UNSIGHTLY MARKINGS: Layer of cream-yellow paint/varnish on surface of the cast; surface polychrome is discoloured and damaged on lower part of the panel probably by the strip of lights which used to run just under Frieze along the South and North walls of the Ground Floor Gallery; small spots of paint splash scattered on the surface of the panel mainly on its sinister side; flaking and missing paint area on lower part of the panel.

CHIPS AND LOSS: Missing areas associated with the cracks.

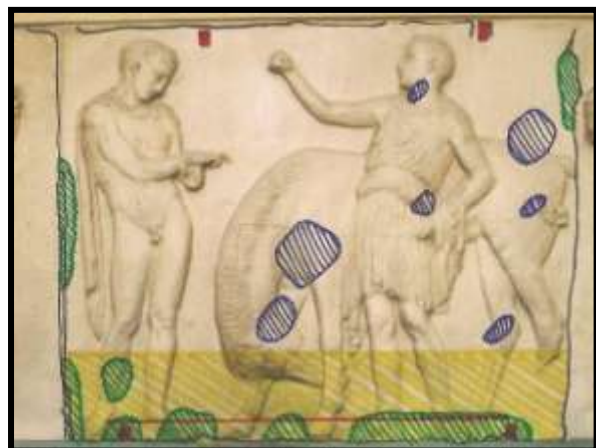
Cracks

Chips, abrasions and missing surfaces

Flaking paint

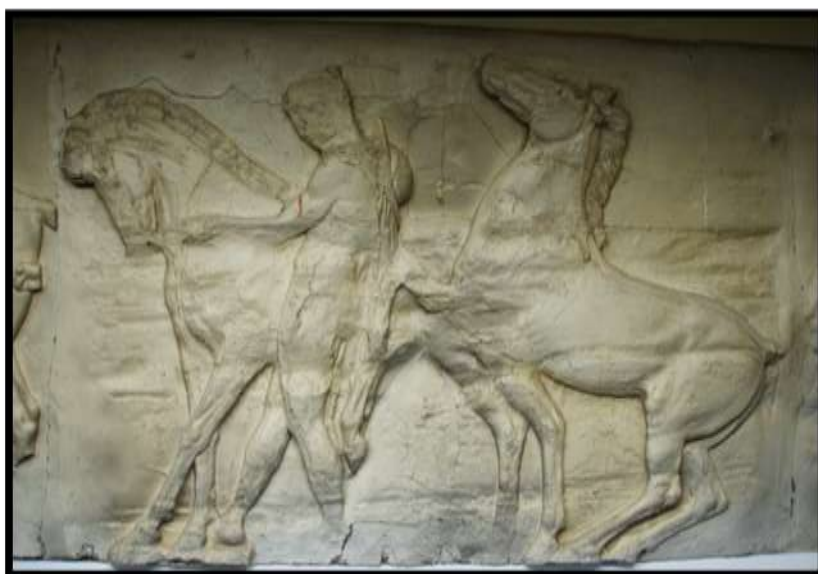
Panel before conservation

STRUCTURAL STABILITY: Stable. Open cracks running alongside joints on both sides of the panel and from dexter edge towards middle of the cast in upper part; small cracks around fixings by lower edge of panel.

VISIBLE PAINT LAYERS/UNSIGHTLY MARKINGS: Layer of cream-yellow paint/varnish on surface of the cast; surface polychrome is discoloured and damaged on lower part of the panel probably by the strip of lights which used to run just under the Frieze along the South and North walls of the Ground Floor Gallery; small spots of paint splash scattered on surface of the panel; flaking and missing paint area on lower part of the panel.

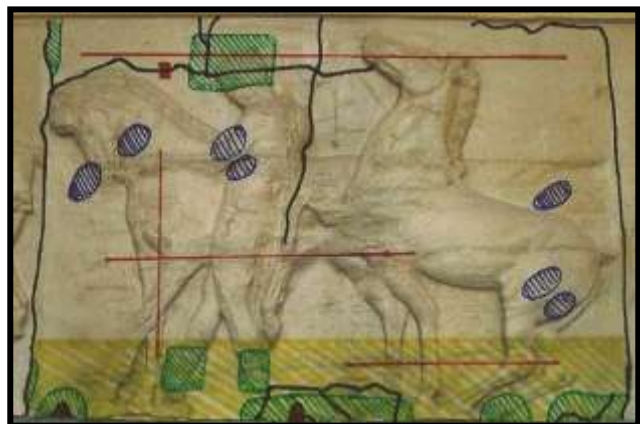
Cracks

Chips, abrasions and missing surfaces

Paint splashes

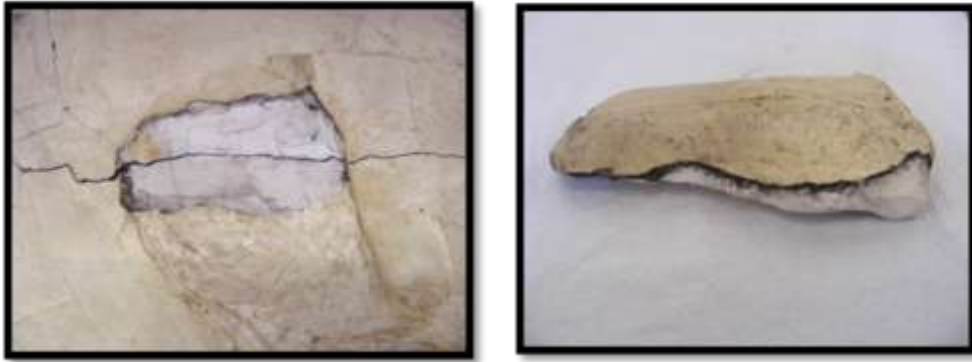
Details of repair

- Areas of flaking paint were consolidated with 5% Primal B60A in de-ionised water.
- All areas of raw plaster were given an application of 10% Paraloid B72 in acetone to provide an isolating layer between the original plaster and the repairs.
- Exposed metal fixings were treated with 5% Tannic Acid so as to stabilise the corrosion, and covered with a protective layer of 20% Paraloid B72 in acetone.
- Areas of loss, open joints and cracks were filled with white micro-balloons with 12% Paraloid B72 in acetone. Larger areas of loss around the screws were filled with an inert filler to provide extra strength.
- The loose top of the figure's head was reattached with polyester resin.

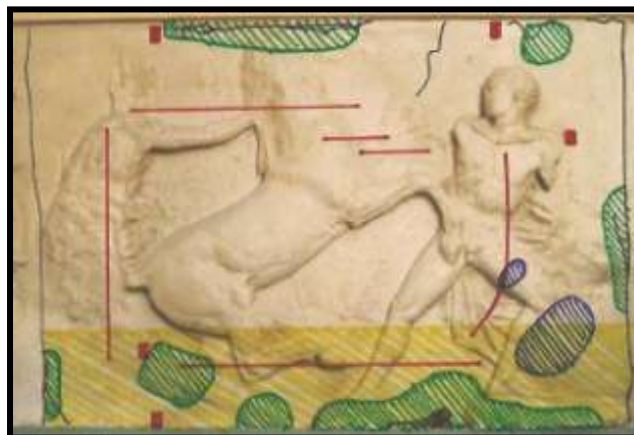
Cracks

Flaking paint

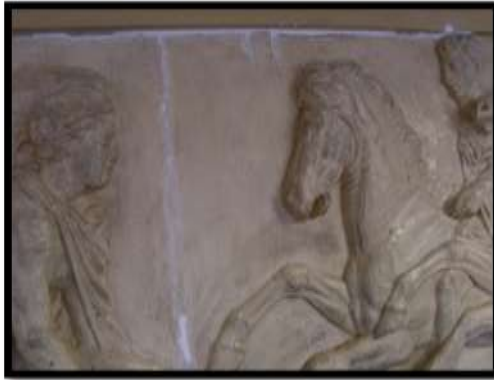
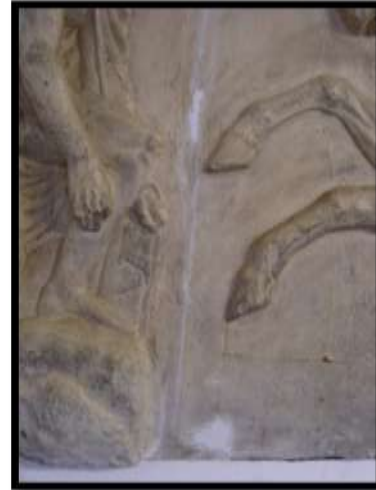
Details of fill repairs

- Areas of flaking paint were consolidated with 5% Primal B60A in de-ionised water.
- All areas of raw plaster were given an application of 10% Paraloid B72 in acetone to provide an isolating layer between the original plaster and the repairs.
- Exposed metal fixings were treated with 5% Tannic Acid so as to stabilise the corrosion, and covered with a protective layer of 20% Paraloid B72 in acetone.
- Areas of loss, open joints and cracks were filled with white micro-balloons with 12% Paraloid B72 in acetone. Larger areas of loss around the screws were filled with an inert filler to provide extra strength.

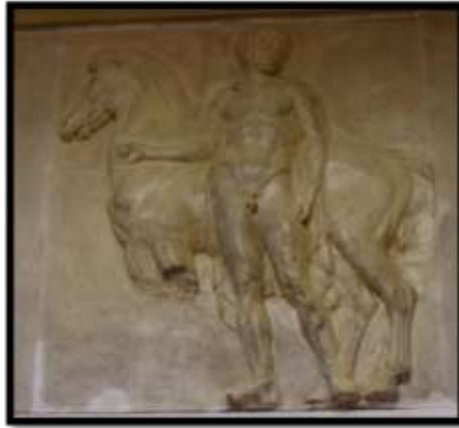
Panel during works on fills

- Areas of flaking paint were consolidated with 5% Primal B60A in de-ionised water.
- All areas of raw plaster were given an application of 10% Paraloid B72 in acetone to provide an isolating layer between the original plaster and the repairs.
- Exposed metal fixings were treated with 5% Tannic Acid so as to stabilise the corrosion, and covered with a protective layer of 20% Paraloid B72 in acetone.
- Areas of loss, open joints and cracks were filled with white micro-balloons with 12% Paraloid B72 in acetone. Larger areas of loss around the screws were filled with an inert filler to provide extra strength.

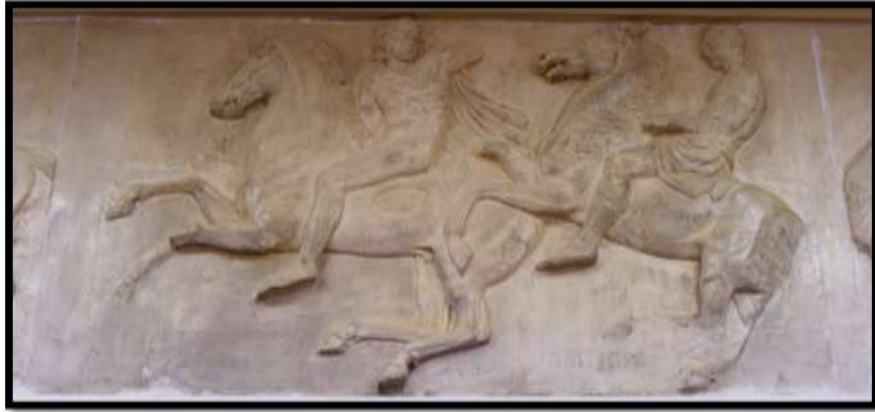
Panel during fill repairs

- Areas of flaking paint were consolidated with 5% Primal B60A in de-ionised water.
- All areas of raw plaster were given an application of 10% Paraloid B72 in acetone to provide an isolating layer between the original plaster and the repairs.
- Exposed metal fixings were treated with 5% Tannic Acid so as to stabilise the corrosion, and covered with a protective layer of 20% Paraloid B72 in acetone.
- Areas of loss, open joints and cracks were filled with white micro-balloons with 12% Paraloid B72 in acetone. Larger areas of loss around the screws were filled with an inert filler to provide extra strength.

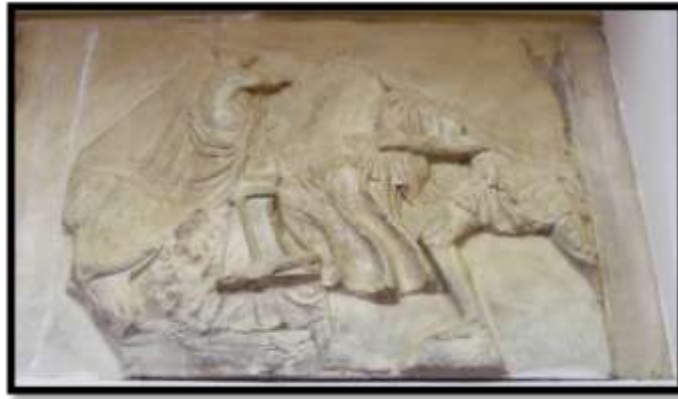
Panel during fill repairs
