1. PARTHENON FRIEZE

1.4 SCULPTURE COURT LOWER GALLERY NORTH WALL

PANEL 1

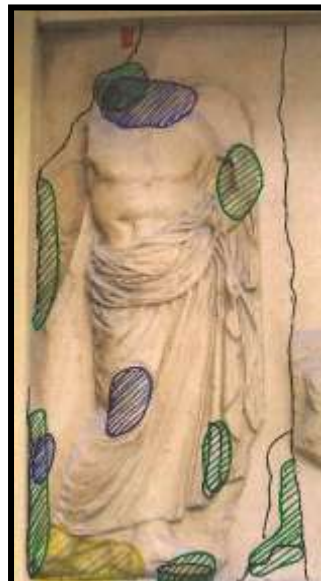
STRUCTURAL STABILITY: Fair. Open crack running alongside joint on both sides of the panel; small cracks at lower sinister corner.

VISIBLE PAINT LAYERS/UNSIGHTLY MARKINGS: Layer of cream-yellow paint/varnish on surface of the cast; the surface polychrome is discoloured and damaged on lower part of the panel probably by the strip lights which used to run under the Frieze along the South and North walls of the Ground Floor Gallery; small spots of paint splash scattered on the surface of the cast; area of flaking and missing paint on lower part of the panel.

CHIPS AND LOSS: Missing areas associated with the cracks; large missing chips in middle section of dexter edge, on lower part of drapery and on sinister foot of the figure.

Cracks

Ferrous items under plaster

Chips, abrasions, missing surfaces

Paint splashes

Flaking paint

- Areas of flaking paint were consolidated with 5% Primal B60A in de-ionised water.
- All areas of raw plaster were given an application of 10% Paraloid B72 in acetone to provide an isolating layer between the original plaster and the repairs.
- Exposed metal fixings were treated with 5% Tannic Acid so as to stabilise the corrosion, and covered with a protective layer of 20% Paraloid B72 in acetone.
- Areas of loss, open joints and cracks were filled with white micro-balloons mixed with 12% Paraloid B72 in acetone. Larger areas of loss around the screws were filled with an inert filler to provide extra strength.

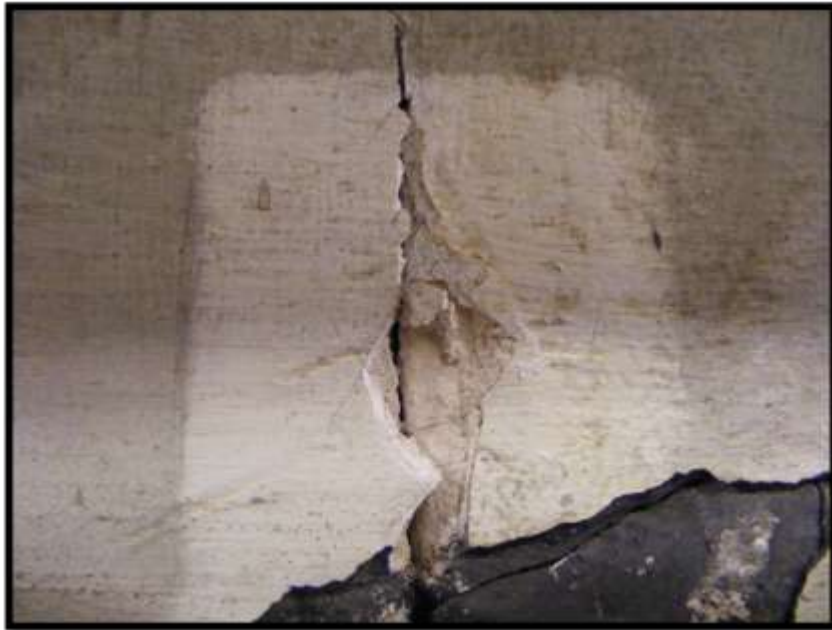
A mortar analysis was carried out by Mr Bill Revie of CMC on samples of the pointing material found between the Panel 10 and 11 on Ground Floor Galley North Wall. The mortar was found to be a thick layer of lime putty, gypsum plaster and fine sand and hair, followed by a thin layer of gypsum plaster and lime putty; and finally a layer of varnish. This final layer of varnish is found over the entire two floors of the North and South Walls and yet, interestingly, for some unknown reason, it was not applied to the slabs on the East Wall.

Samples of mortar were taken for analysis

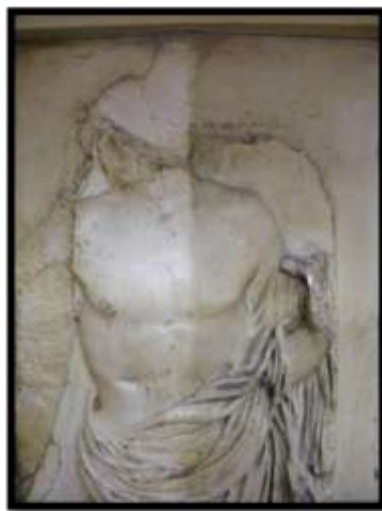
Cast during wet cleaning

- Prior to any conservation treatment, the cast was photographed. This photographic documentation was continued throughout all conservation processes.
- Initially, the cast was dry cleaned with soft brushes and Wishab Sponges with a rubber-nozzled vacuum to pick up the loose dust and dirt.
- Following wet cleaning spot tests on **Panel 1 on Upper Gallery South Wall**, the surface of the cast was cleaned with 2-5% Vulpex Liquid Soap in de-ionised water, using cotton wool swabs.

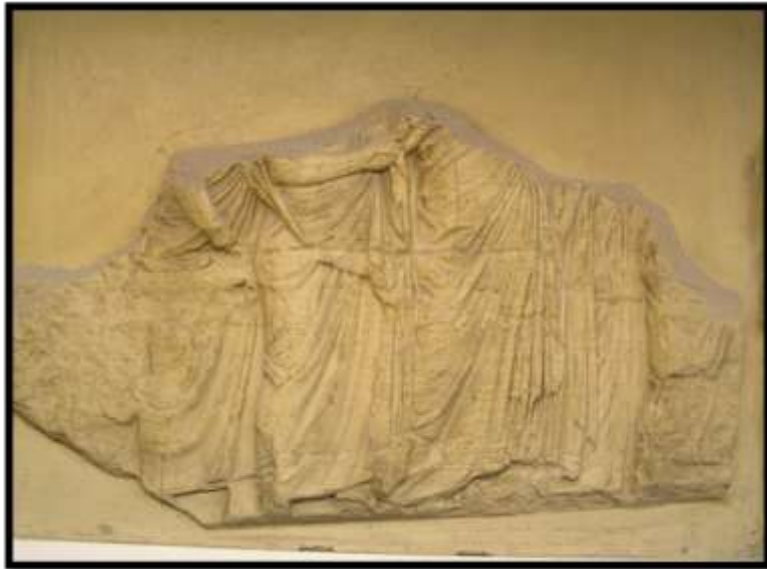
Panel before conservation

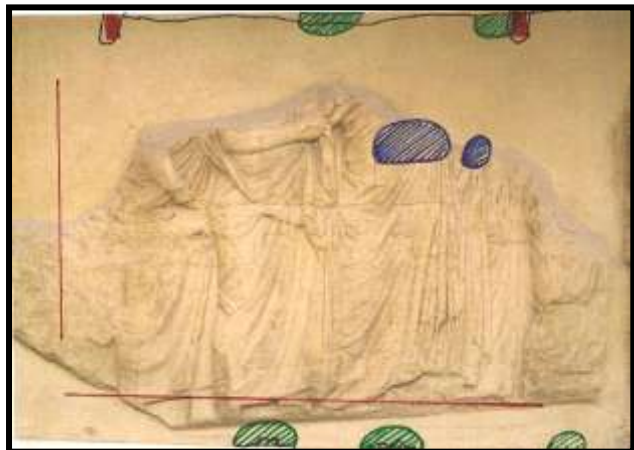
STRUCTURAL STABILITY: Fair. Open cracks running alongside top edge of the panel and around fixings.

VISIBLE PAINT LAYERS/UNSIGHTLY MARKINGS: Layer of cream-yellow paint/varnish on surface of the cast; the surface polychrome is discoloured and damaged on the lower part of the panel probably by the strip lights which used to run under the Frieze along the South and North walls of the Ground Floor Gallery; small spots of paint splash on middle section of the panel.

CHIPS AND LOSS: Missing areas associated with the crack; two chips at lower edge of the panel.

Cracks

Chips, abrasions and missing surfaces

Paint splashes

- Areas of flaking paint were consolidated with 5% Primal B60A in de-ionised water.
- All areas of raw plaster were given an application of 10% Paraloid B72 in acetone to provide an isolating layer between the original plaster and the repairs.

- Exposed metal fixings were treated with 5% Tannic Acid so as to stabilise the corrosion, and covered with a protective layer of 20% Paraloid B72 in acetone.

- Areas of loss, open joints and cracks were filled with white micro-balloons mixed with 12% Paraloid B72 in acetone. Larger areas of loss around the screws were filled with an inert filler to provide extra strength.

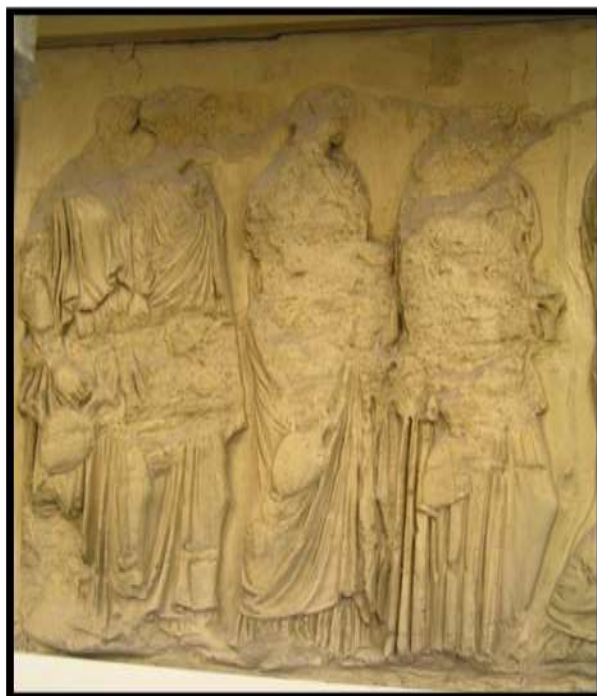
Panel before conservation

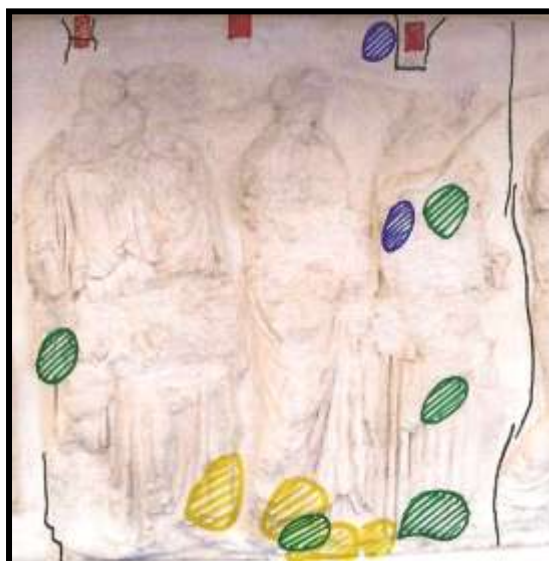
STRUCTURAL STABILITY: Stable. Open crack running alongside joint on sinister sides of the panel; cracks around fixings by top edge of the cast.

VISIBLE PAINT LAYERS/UNSIGHTLY MARKINGS: Layer of cream-yellow paint/varnish on surface of the cast; the surface polychrome is discoloured and damaged on the lower part of the panel probably by the strip lights which used to run under the Frieze along the South and North walls of the Ground Floor Gallery; areas of flaking and missing paint on lower part of the panel.

CHIPS AND LOSS: Missing areas associated with the cracks.

Cracks

Chips, abrasions and missing surfaces

Flaking paint

- Areas of flaking paint were consolidated with 5% Primal B60A in de-ionised water.
- All areas of raw plaster were given an application of 10% Paraloid B72 in acetone to provide an isolating layer between the original plaster and the repairs.

- Exposed metal fixings were treated with 5% Tannic Acid so as to stabilise the corrosion, and covered with a protective layer of 20% Paraloid B72 in acetone.

- Areas of loss, open joints and cracks were filled with white micro-balloons with 12% Paraloid B72 in acetone. Larger areas of loss around the screws were filled with an inert filler to provide extra strength.

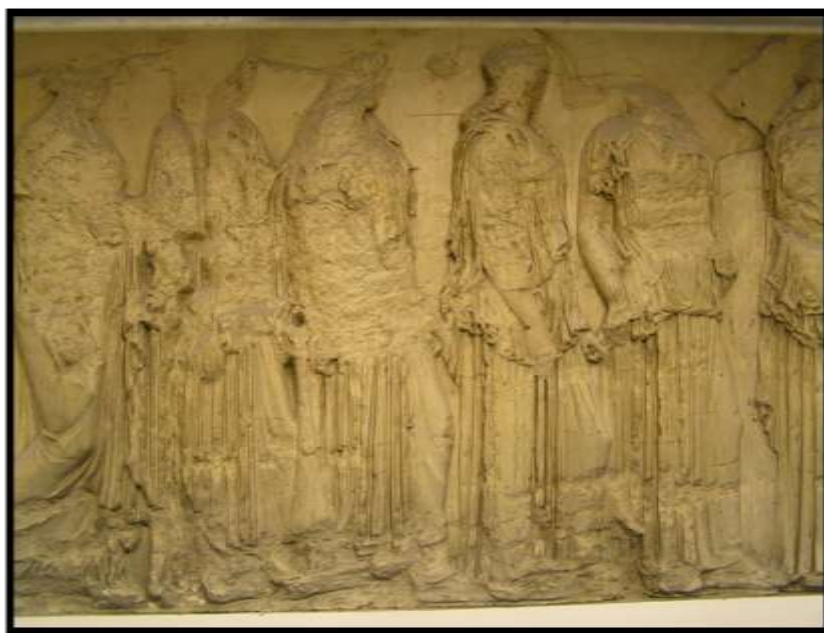
Panel before conservation

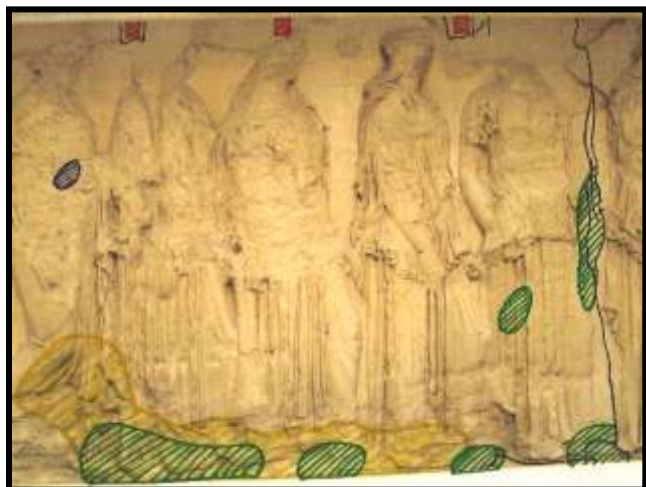
STRUCTURAL STABILITY: Fair. Open crack running alongside joint on sinister side of the panel; small cracks around fixings by the top edge of the cast.

VISIBLE PAINT LAYERS/UNSIGHTLY MARKINGS: layer of cream-yellow paint/varnish on surface of the cast; the surface polychrome is discoloured and damaged on the lower part of the panel probably by the strip lights which used to run under the Frieze along the South and North walls of the Ground Floor Gallery; area of flaking and missing paint on lower part of the panel.

CHIPS AND LOSS: Missing areas associated with the cracks.

Cracks

Chips, abrasions and missing surfaces

Flaking paint

- Areas of flaking paint were consolidated with 5% Primal B60A in de-ionised water.
- All areas of raw plaster were given an application of 10% Paraloid B72 in acetone to provide an isolating layer between the original plaster and the repairs.
- Exposed metal fixings were treated with 5% Tannic Acid so as to stabilise the corrosion, and covered with a protective layer of 20% Paraloid B72 in acetone.
- Areas of loss, open joints and cracks were filled with white micro-balloons with 12% Paraloid B72 in acetone. Larger areas of loss around the screws were filled with an inert filler to provide extra strength.
- All the fills and areas of discoloured paint were then toned out with acrylics, mixed with matting agent, to match the surrounding patina.
- Finally, the entire cast was given an application of micro-crystalline wax so as to protect the surface.

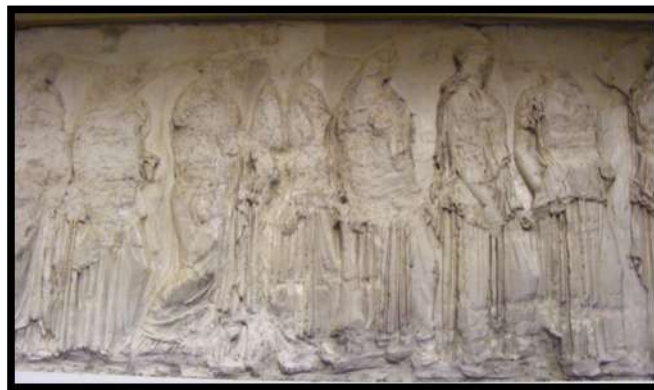
Panel during wet cleaning

- Prior to any conservation treatment the cast was photographed. This photographic documentation was continued throughout all conservation processes.
- Initially, the cast was dry cleaned with soft brushes and Wishab Sponges with a rubber-nozzled vacuum to pick up loose dust and dirt.
- Following wet cleaning spot tests on **Panel 1 on Upper Gallery South Wall**, the surface of the cast was cleaned with 2-5% Vulpex Liquid Soap in de-ionised water, using cotton wool swabs.

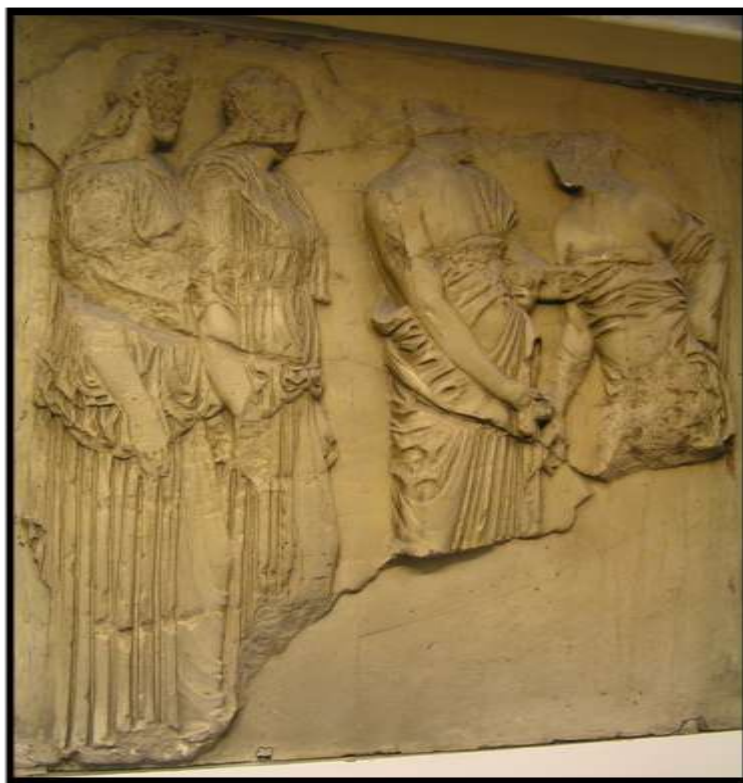
Panel before conservation

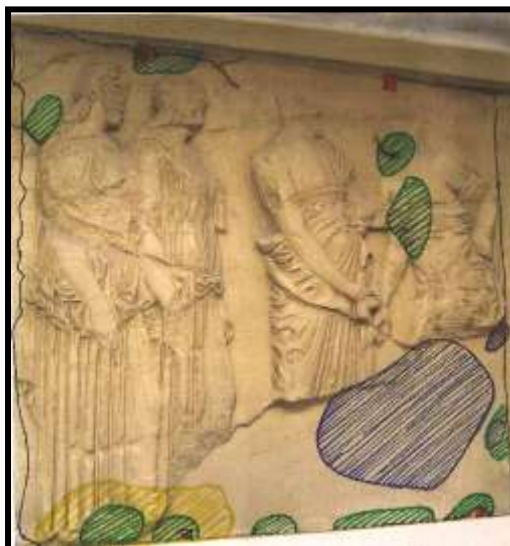
STRUCTURAL STABILITY: Fair. Open cracks running alongside joints on both sides of the panel; small cracks around fixings by top and bottom edges of the panel.

VISIBLE PAINT LAYERS/UNSIGHTLY MARKINGS: Layer of cream-yellow paint/varnish on surface of the cast; the surface polychrome is discoloured and damaged on the lower part of the panel probably by the strip lights which used to run under the Frieze along the South and North walls of the Ground Floor Gallery; small spots of paint splash and drip marks at the lower sinister corner of the cast; area of flaking and missing paint on lower part of the panel.

CHIPS AND LOSS: Missing areas associated with the cracks; two large chips on figure by sinister edge of the cast.

Cracks

Chips, abrasions and missing surfaces

Flaking paint

- Areas of flaking paint were consolidated with 5% Primal B60A in de-ionised water.
- All areas of raw plaster were given an application of 10% Paraloid B72 in acetone to provide an isolating layer between the original plaster and the repairs.
- Exposed metal fixings were treated with 5% Tannic Acid so as to stabilise the corrosion, and covered with a protective layer of 20% Paraloid B72 in acetone.
- Areas of loss, open joints and cracks were filled with white micro-balloons with 12% Paraloid B72 in acetone. Larger areas of loss around the screws were filled with an inert filler to provide extra strength.
- All the fills and areas of discoloured paint were then toned out with acrylics, mixed with matting agent, to match the surrounding patina.
- Finally, the entire cast was given an application of micro-crystalline wax so as to protect the surface.

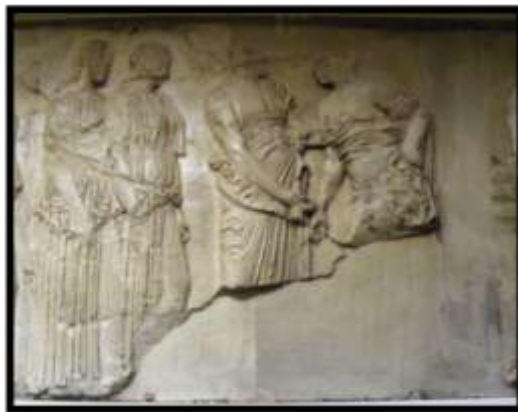
Panel during wet cleaning

- Prior to any conservation treatment the cast was photographed. This photographic documentation was continued throughout all conservation processes.
- Initially, the cast was dry cleaned with soft brushes and Wishab Sponges with a rubber-nozzled vacuum to pick up loose dust and dirt.
- Following wet cleaning spot tests on **Panel 1 on Upper Gallery South Wall**, the surface of the cast was cleaned with 2-5% Vulpex Liquid Soap in de-ionised water, using cotton wool swabs.

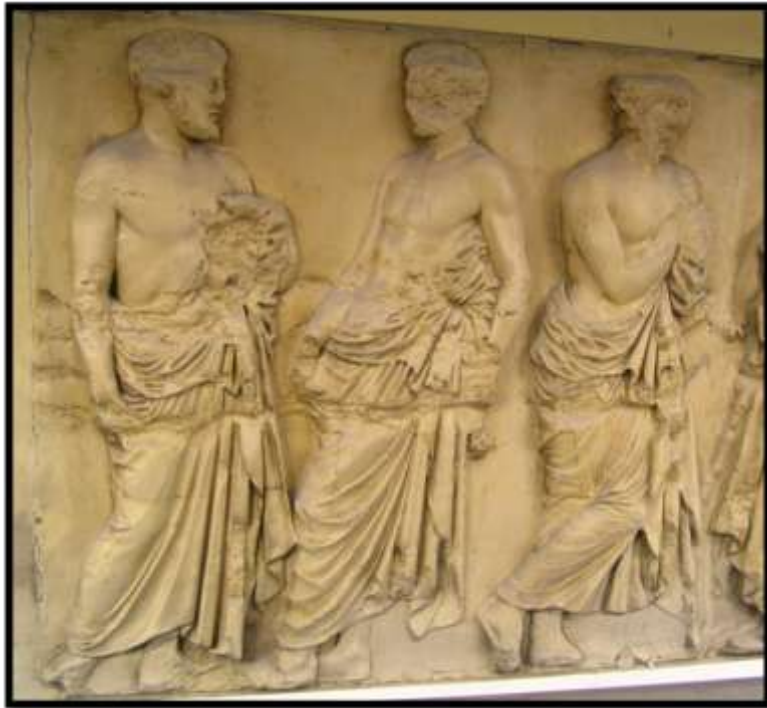
Panel before conservation

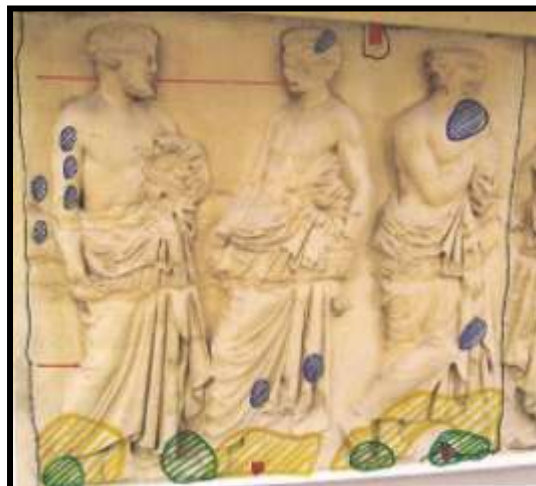
STRUCTURAL STABILITY: Fair. Open cracks running alongside joints on both sides of the panel and alongside top edge; small cracks around fixings by top and lower edges of the panel.

VISIBLE PAINT LAYERS/UNSIGHTLY MARKINGS: Layer of cream-yellow paint/varnish on the surface of the cast; the surface polychrome is discoloured and damaged on the lower part of the panel probably by the strip lights which used to run under Frieze along the South and North walls of the Ground Floor Gallery; small spots of paint splash scattered on the surface of the panel; area of flaking and missing paint on lower part of the panel.

CHIPS AND LOSS: Missing areas associated with the cracks.

Cracks

Chips, abrasions and missing surfaces

Flaking paint
