1. PARTHENON FRIEZE

1.5 SCULPTURE COURT LOWER EAST WALL

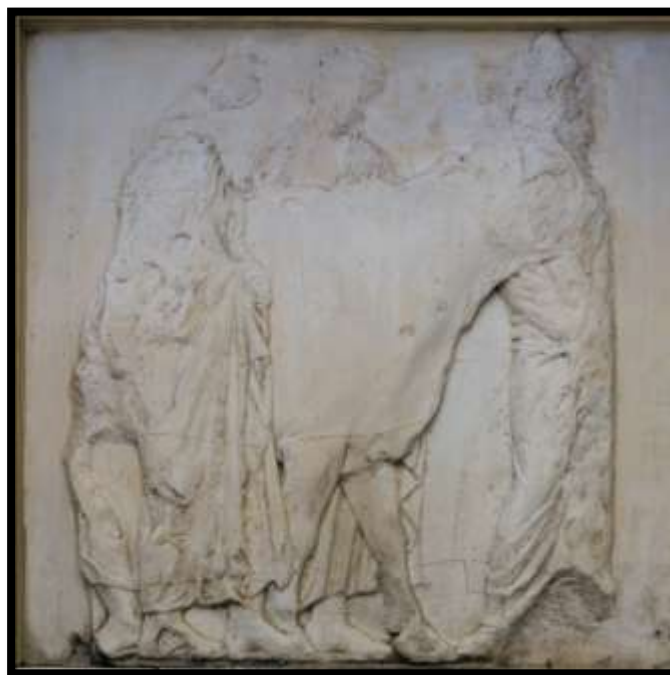
PANEL 1

Panel before conservation

STRUCTURAL STABILITY: Fair. Open crack running alongside joint on dexter side of the panel and small crack in middle section of sinister joint; small cracks around fixings by lower edge.

VISIBLE PAINT LAYERS/UNSIGHTLY MARKINGS: Layer of cream-white paint/varnish on surface of the cast; small spots of paint splash on surface of the panel; area of flaking and missing paint on lower part of the panel.

CHIPS AND LOSS: Missing areas associated with the cracks and around the screws at lower edge of the panel.

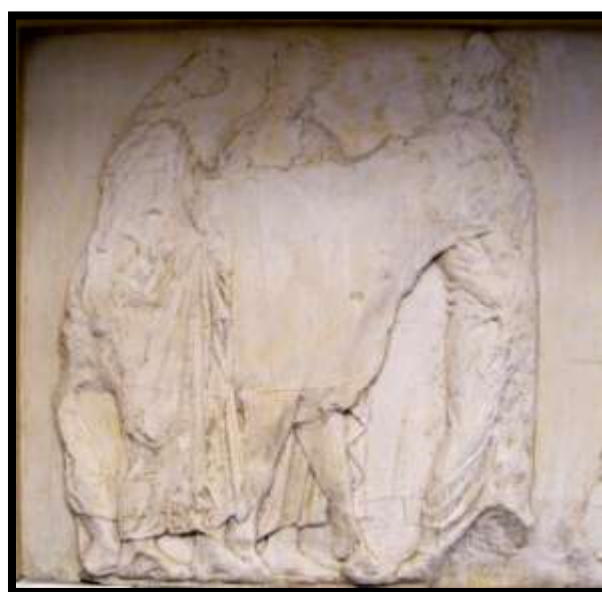
Panel after conservation

- Prior to any conservation treatment, the cast was photographed. This photographic documentation was continued throughout all conservation processes.
- Initially, the cast was dry cleaned with soft brushes and Wishab Sponges with a rubber-nozzled vacuum to pick up the loose dust and dirt.
- Areas of flaking paint were consolidated with application of 5% Primal B60A in de-ionised water.
- Following wet cleaning spot tests on **Panel 9 on Lower Gallery East Wall**, the surface of the cast was cleaned with Anjusil. The application of Anjusil was repeated in places if necessary.

- All areas of raw plaster were given an application of 10% Paraloid B72 in acetone to provide an isolating layer between the original plaster and the repairs.
- Exposed metal fixings were treated with 5% Tannic Acid so as to stabilise the corrosion, and covered with a protective layer of 20% Paraloid B72 in acetone.
- Areas of loss, open joints and cracks were filled with white micro-balloons mixed with 12% Paraloid B72 in acetone. Larger areas of loss around the screws were filled with an inert filler to provide extra strength.
- All the fills were then toned out with acrylics, mixed with matting agent, to match the surrounding patina.

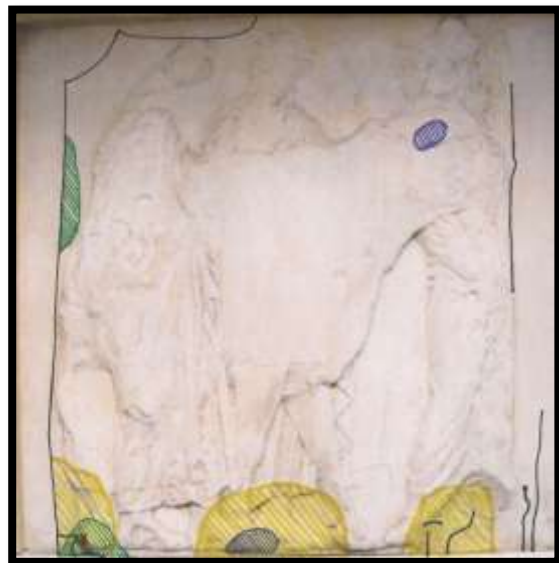
Cracks

Chips, abrasions, missing surfaces

Paint splashes

Flaking paint

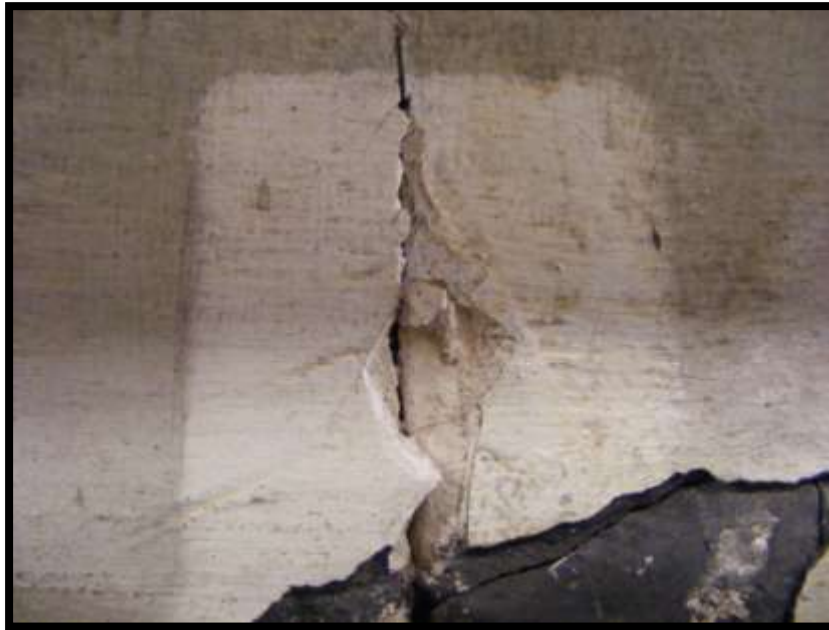
At the time of re-siting the cast collection from the Royal Scottish Academy building on Princes Street to the Edinburgh College of Art in 1913, the Parthenon Frieze panels were installed with metal fixings set into the wall. The open joints between the panels were filled with a mortar that was smeared over the adjacent edges of the panels.

A mortar analysis was carried out by Mr Bill Revie of CMC on samples of the pointing material found between the Panel 10 and 11 on Ground Floor Galley North Wall. The mortar was found to be a thick layer of lime putty, gypsum plaster and fine sand and hair, followed by a thin layer of gypsum plaster and lime putty; and finally a layer of varnish. This final layer of varnish is found over the entire two floors of the North and South Walls and yet, interestingly, for some unknown reason, it was not applied to the slabs on the East Wall.

Samples of mortar were taken for analysis

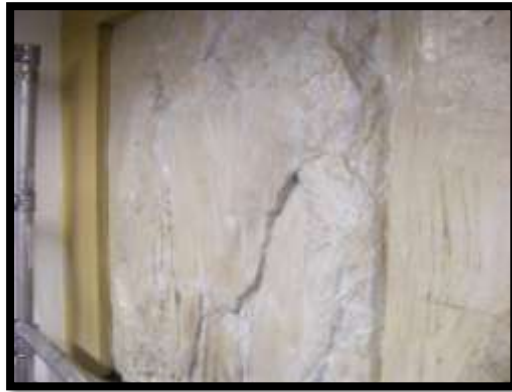
Cast during wet cleaning

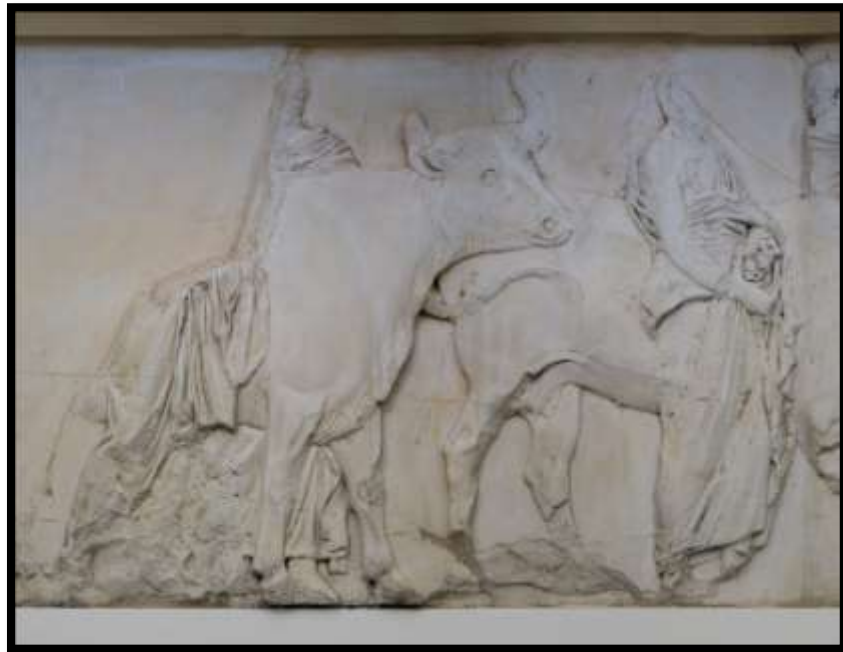
PANEL 2

Panel before conservation

STRUCTURAL STABILITY: Fair. Open cracks running alongside joint on sinister sides of the panel; small cracks in top dexter corner of the cast.

CHIPS AND LOSS: Missing areas associated with the crack on sinister joint.

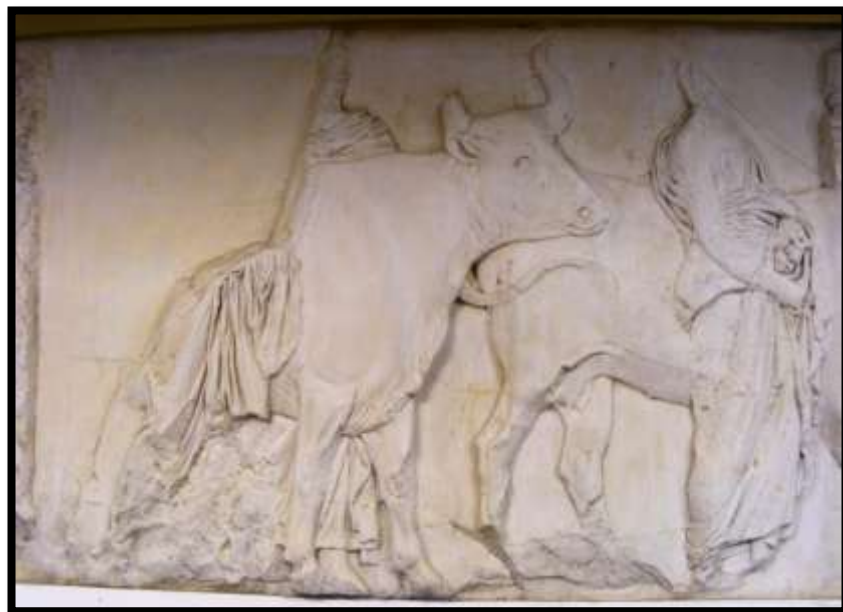
Panel after conservation

- Prior to any conservation treatment the cast was photographed. This photographic documentation was continued throughout all conservation processes.
- Initially, the cast was dry cleaned with soft brushes and Wishab Sponges with a rubber-nozzled vacuum to pick up loose dust and dirt.
- Following wet cleaning spot tests on **Panel 9 on Lower Gallery East Wall**, the surface of the cast was cleaned with Anjusil. The application of Anjusil was repeated in places if necessary.

- All areas of raw plaster were given an application of 10% Paraloid B72 in acetone to provide an isolating layer between the original plaster and the repairs.
- Exposed metal fixings were treated with 5% Tannic Acid so as to stabilise the corrosion, and covered with a protective layer of 20% Paraloid B72 in acetone.
- Areas of loss, open joints and cracks were filled with white micro-balloons mixed with 12% Paraloid B72 in acetone. Larger areas of loss around the screws were filled with an inert filler to provide extra strength.
- All the fills were then toned out with acrylics, mixed with matting agent, to match the surrounding patina.

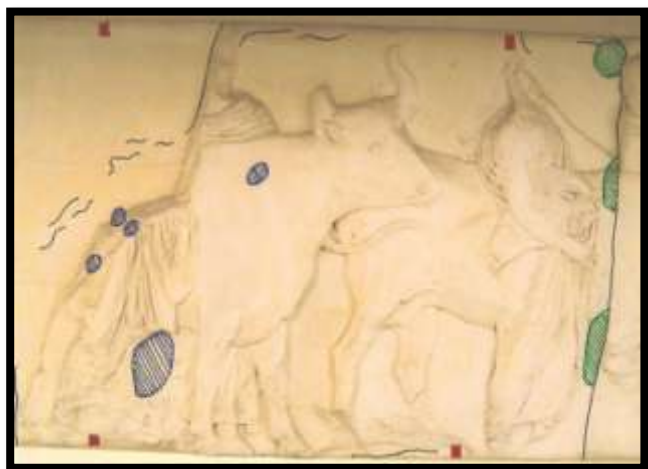
Cracks

Chips, abrasions and missing surfaces

Paint splashes

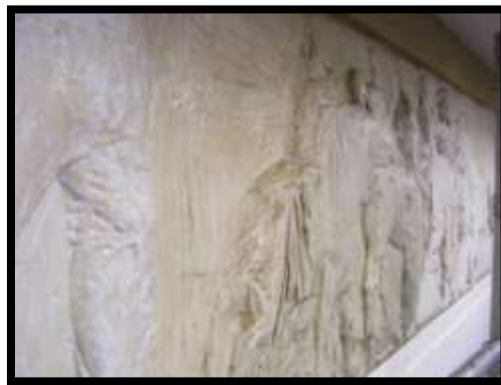
Panel during wet cleaning

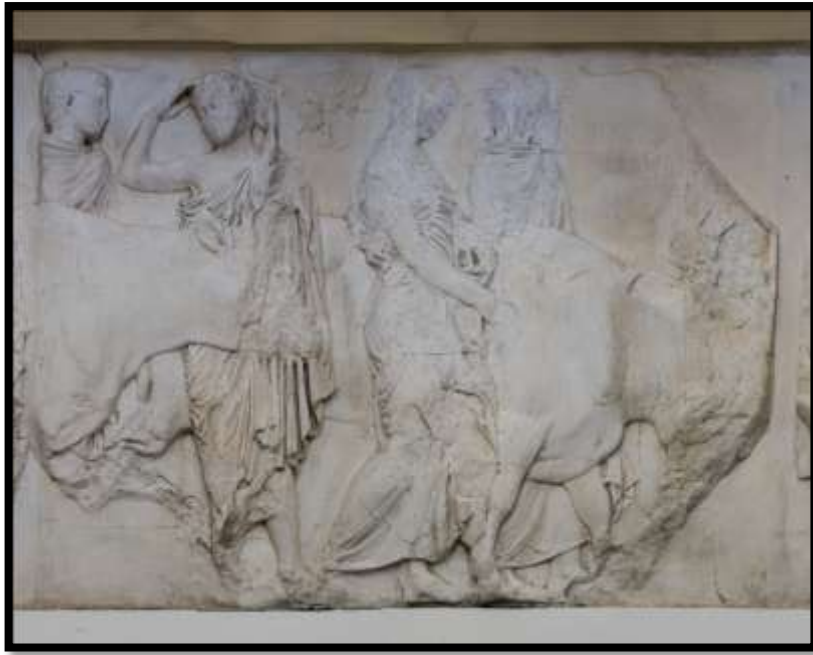
PANEL 3

Panel before conservation

STRUCTURAL STABILITY: Fair. Open cracks running alongside joints on both sides of the panel.

VISIBLE PAINT LAYERS/UNSIGHTLY MARKINGS: Layer of cream-white paint on surface of the cast; small spots of paint splash on surface of the panel; area of flaking and missing paint on lower part of the panel.

CHIPS AND LOSS: Missing areas associated with the cracks.

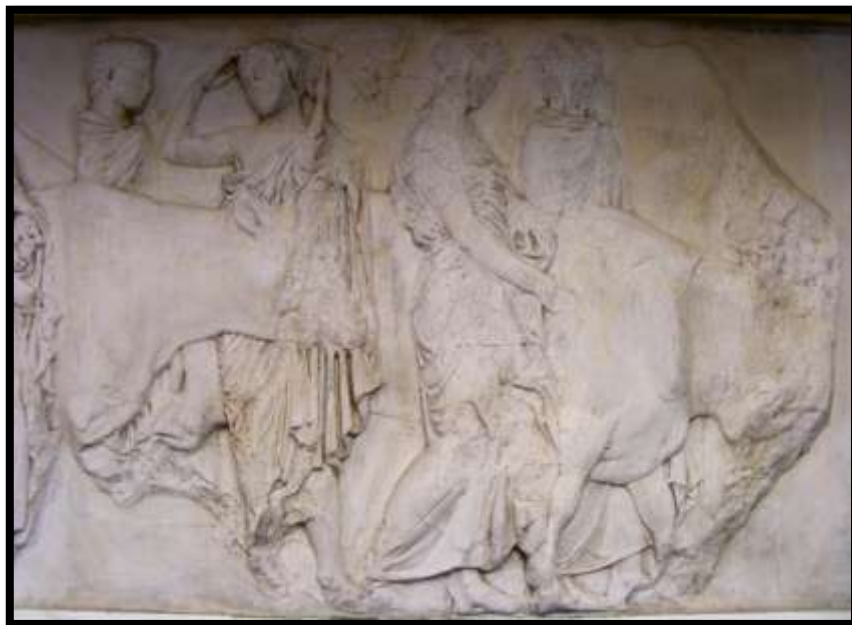
Panel after conservation

- Prior to any conservation treatment the cast was photographed. This photographic documentation was continued throughout all conservation processes.
- Initially, the cast was dry cleaned with soft brushes and Wishab Sponges with a rubber-nozzled vacuum to pick up loose dust and dirt.

- All areas of raw plaster were given an application of 10% Paraloid B72 in acetone to provide an isolating layer between the original plaster and the repairs.

- Exposed metal fixings were treated with 5% Tannic Acid so as to stabilise the corrosion, and covered with a protective layer of 20% Paraloid B72 in acetone.

- Areas of loss, open joints and cracks were filled with white micro-balloons with 12% Paraloid B72 in acetone. Larger areas of loss around the screws were filled with an inert filler to provide extra strength.

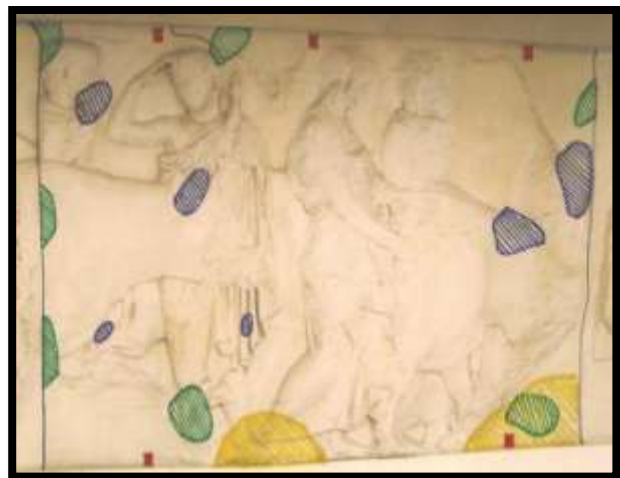
Cracks

Chips, abrasions and missing surfaces

Paint splashes

Flaking paint

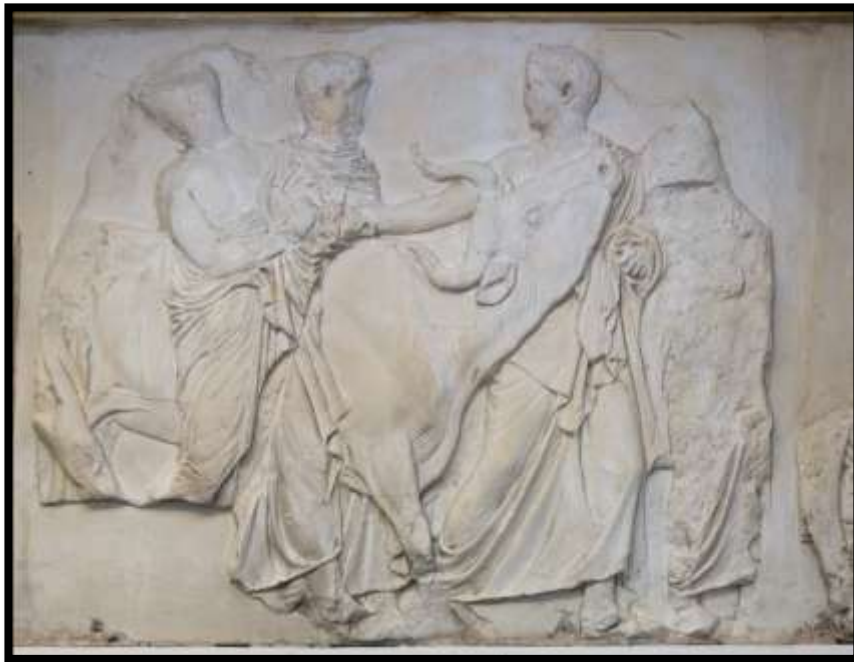
PANEL 4

Panel before conservation

STRUCTURAL STABILITY: Fair. Open cracks running alongside joints on both sides of the panel and by the top edge of the cast.

VISIBLE PAINT LAYERS/UNSIGHTLY MARKINGS: Layer of cream-white paint on surface of the cast; small spots of paint splash on surface of the panel; area of flaking and missing paint on lower part of the panel.

CHIPS AND LOSS: Missing areas associated with the cracks.

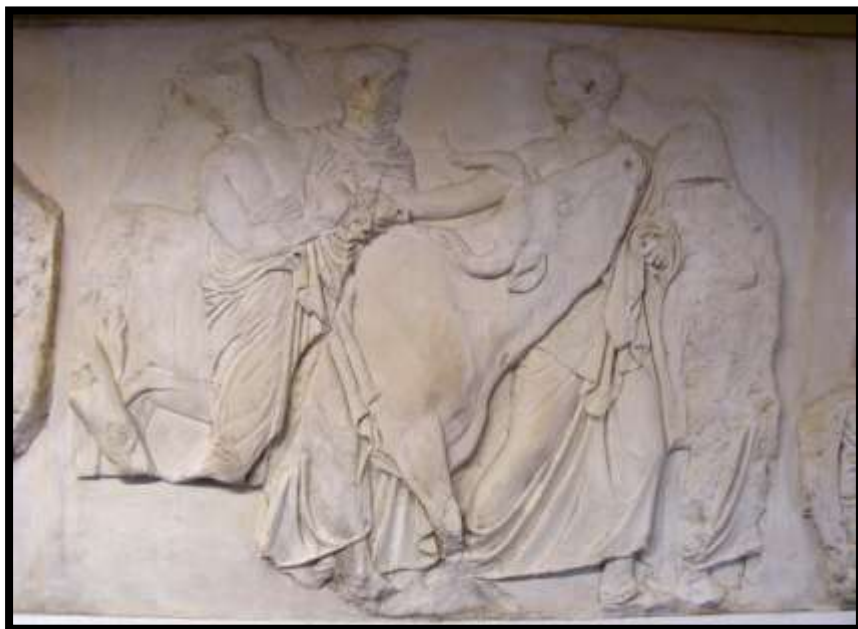
Panel after conservation

- Prior to any conservation treatment the cast was photographed. This photographic documentation was continued throughout all conservation processes.
- Initially, the cast was dry cleaned with soft brushes and Wishab Sponges with a rubber-nozzled vacuum to pick up loose dust and dirt.
- Areas of flaking paint were consolidated with application of 5% Primal B60A in de-ionised water
- Following wet cleaning spot tests on **Panel 9 on Lower Gallery East Wall**, the surface of the cast was cleaned with Anjusil. The application of Anjusil was repeated in places if necessary.

- All areas of raw plaster were given an application of 10% Paraloid B72 in acetone to provide an isolating layer between the original plaster and the repairs.
- Exposed metal fixings were treated with 5% Tannic Acid so as to stabilise the corrosion, and covered with a protective layer of 20% Paraloid B72 in acetone.
- Areas of loss, open joints and cracks were filled with white micro-balloons with 12% Paraloid B72 in acetone. Larger areas of loss around the screws were filled with an inert filler to provide extra strength.
- All the fills were then toned out with acrylics, mixed with matting agent, to match the surrounding patina.

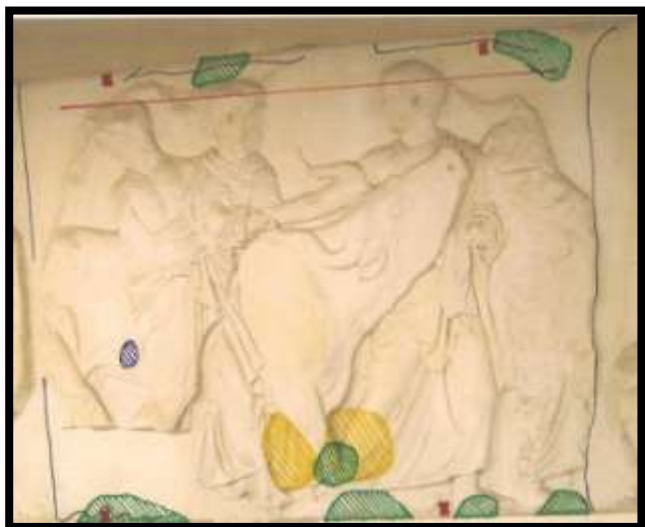
Cracks

Chips, abrasions and missing surfaces

Paint splashes

Flaking paint

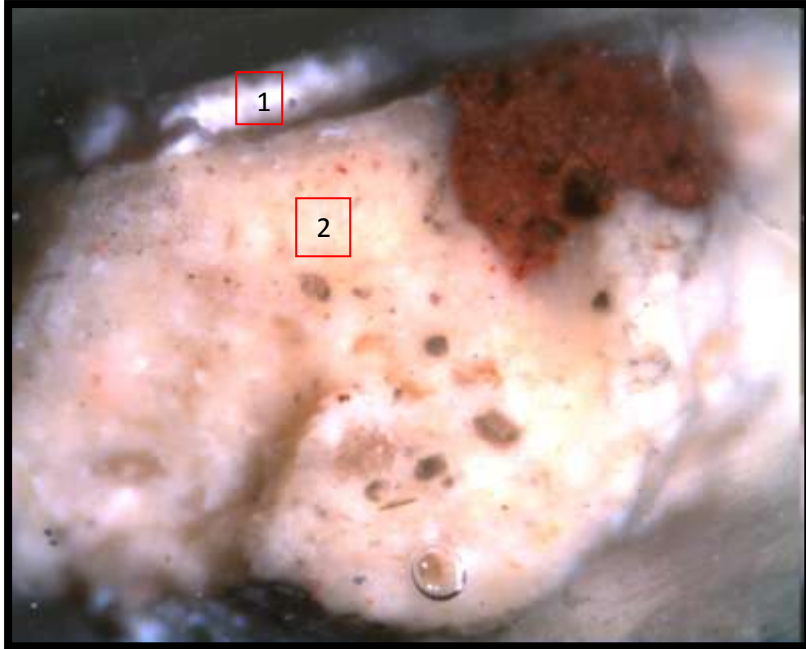
Parthenon Frieze, Lower Gallery East Wall, Panel 4 – Cross-section

Sample seems to consist largely of one layer containing white and pale orange / brown particles. There is what appears to be a bright white paint layer at the top of the section, as photographed, and also towards the top is a large brown inclusion. The brown inclusion appeared completely black under UV, showing no fluorescence, whereas the bright white paint layer fluoresced white indicating that it may contain lead white.

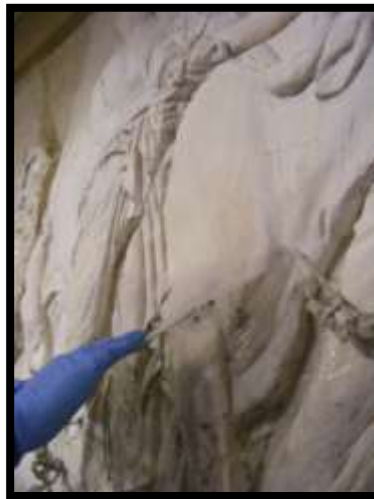
Panel during wet cleaning

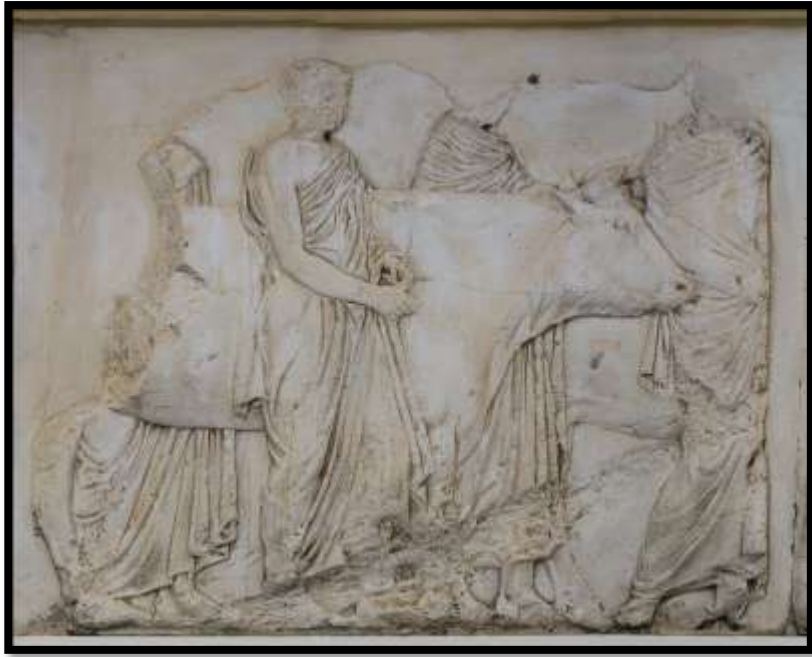
PANEL 5

Panel before conservation

STRUCTURAL STABILITY: Fair. Open cracks running alongside joints on both sides of the panel; small cracks at the lower corners of the panel.

VISIBLE PAINT LAYERS/UNSIGHTLY MARKINGS: Layer of cream-white paint on surface of the cast; small spots of paint splashes on dexter part of the panel; area of flaking and missing paint on lower part of the cast.

CHIPS AND LOSS: Missing areas associated with the cracks and on top section of dexter part of the panel.

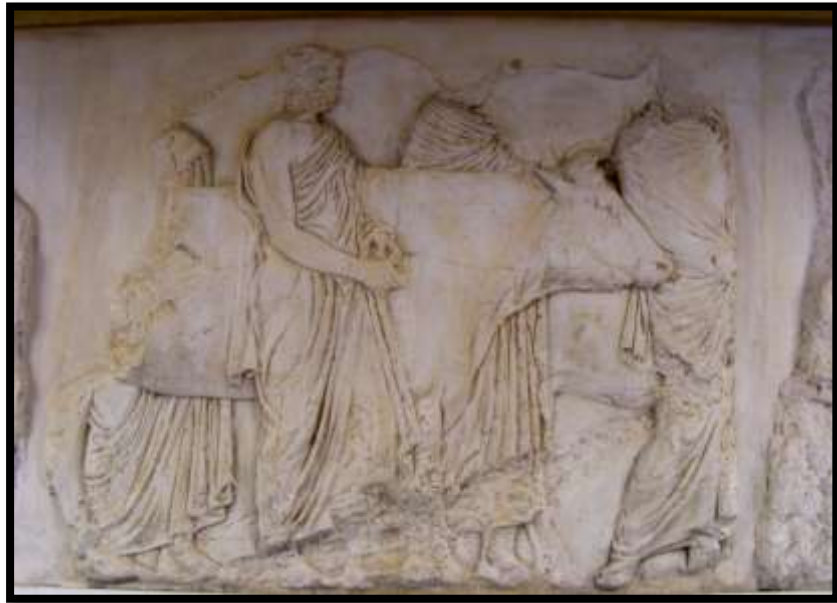
Panel after conservation

- Prior to any conservation treatment the cast was photographed. This photographic documentation was continued throughout all conservation processes.
- Initially, the cast was dry cleaned with soft brushes and Wishab Sponges with a rubber-nozzled vacuum to pick up loose dust and dirt.
- Areas of flaking paint were consolidated with application of 5% Primal B60A in de-ionised water.
- Following wet cleaning spot tests on **Panel 9 on Lower Gallery East Wall**, the surface of the cast was cleaned with Anjusil. The application of Anjusil was repeated in places if necessary.

- All areas of raw plaster were given an application of 10% Paraloid B72 in acetone to provide an isolating layer between the original plaster and the repairs.
- Exposed metal fixings were treated with 5% Tannic Acid so as to stabilise the corrosion, and covered with a protective layer of 20% Paraloid B72 in acetone.
- Areas of loss, open joints and cracks were filled with white micro-balloons with 12% Paraloid B72 in acetone. Larger areas of loss around the screws were filled with an inert filler to provide extra strength.
- All the fills were then toned out with acrylics, mixed with matting agent, to match the surrounding patina.

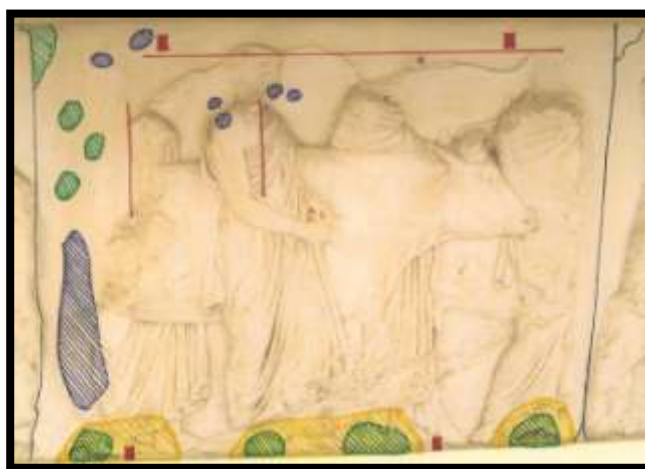
Cracks

Chips, abrasions and missing surfaces

Paint splashes

Flaking paint

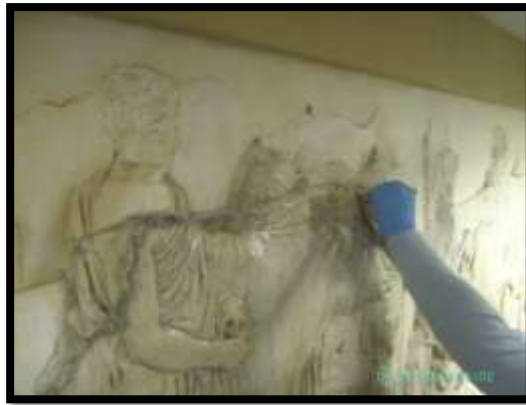
Panel during wet cleaning

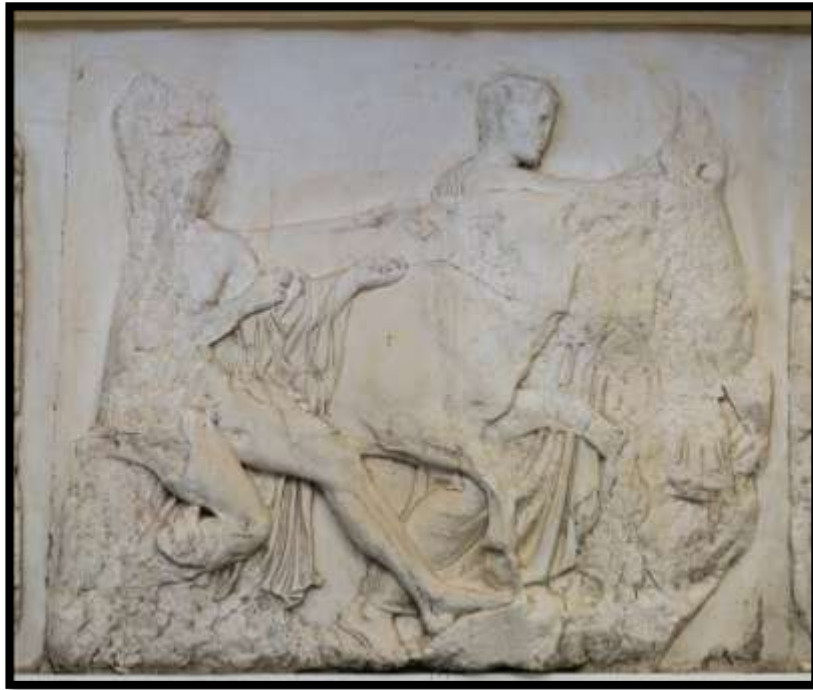
PANEL 6

Panel before conservation

STRUCTURAL STABILITY: Fair. Open cracks running alongside joint on dexter side of the panel and in the corners.

CHIPS AND LOSS: Missing areas associated with the cracks.

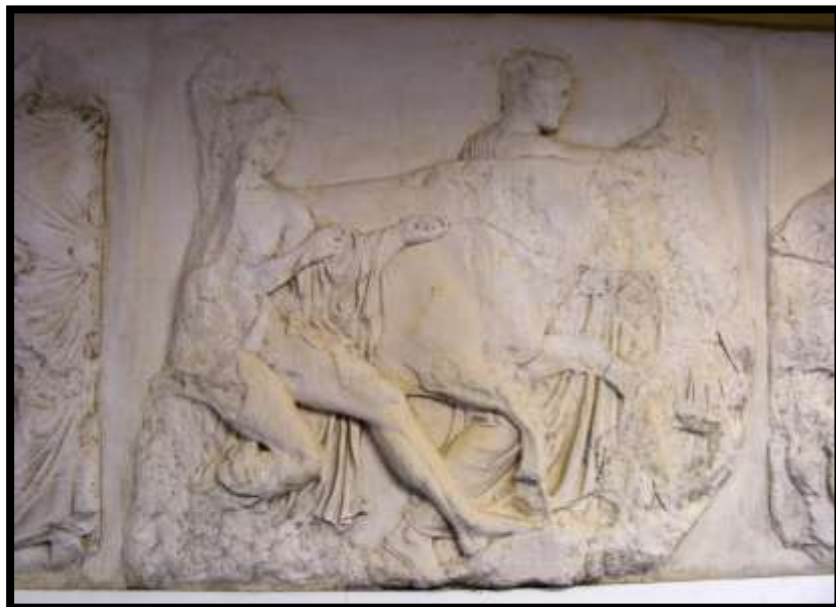
Panel after conservation

- Prior to any conservation treatment the cast was photographed. This photographic documentation was continued throughout all conservation processes.
- Initially, the cast was dry cleaned with soft brushes and Wishab Sponges with a rubber-nozzled vacuum to pick up loose dust and dirt.

- All areas of raw plaster were given an application of 10% Paraloid B72 in acetone to provide an isolating layer between the original plaster and the repairs.

- Exposed metal fixings were treated with 5% Tannic Acid so as to stabilise the corrosion, and covered with a protective layer of 20% Paraloid B72 in acetone.

- Areas of loss, open joints and cracks were filled with white micro-balloons with 12% Paraloid B72 in acetone. Larger areas of loss around the screws were filled with an inert filler to provide extra strength.

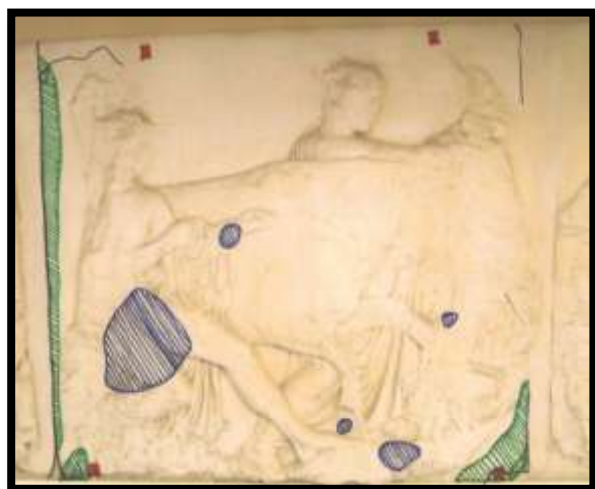
Cracks

Chips, abrasions and missing surfaces

Paint splashes

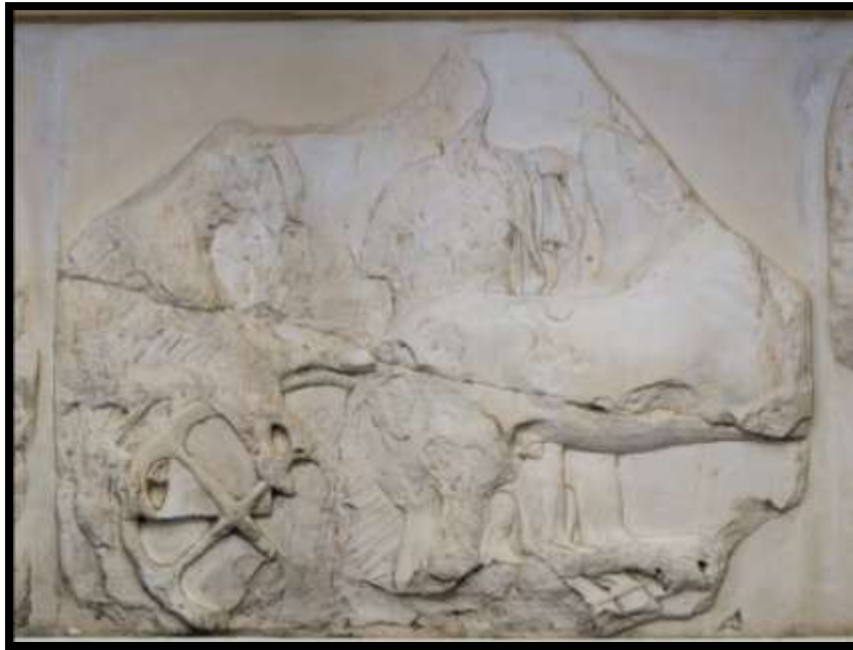
PANEL 7

Panel before conservation

STRUCTURAL STABILITY: Fair. Open crack running alongside joint on dexter side of the panel; small cracks in corners of the panel.

VISIBLE PAINT LAYERS/UNSIGHTLY MARKINGS: Layer of cream-white paint on the surface of the cast; small spots of paint splash scattered on surface of the pane; area of flaking and missing paint on lower part of the panel.

CHIPS AND LOSS: Missing areas associated with the cracks.

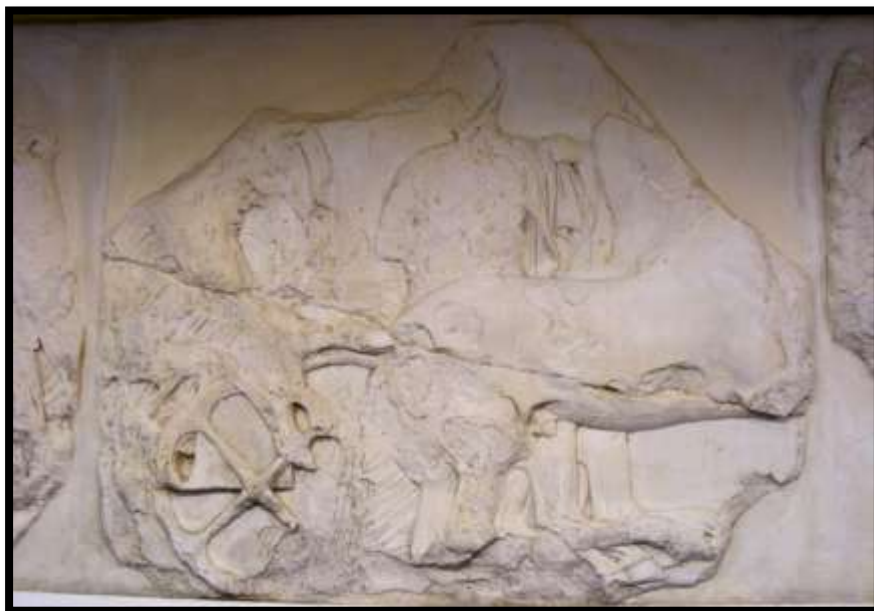
Panel after conservation

- Prior to any conservation treatment the cast was photographed. This photographic documentation was continued throughout all conservation processes.
- Initially, the cast was dry cleaned with soft brushes and Wishab Sponges with a rubber-nozzled vacuum to pick up loose dust and dirt.
- Areas of flaking paint were consolidated with application of 5% Primal B60A in de-ionised water.
- Following wet cleaning spot tests on **Panel 9 on Lower Gallery East Wall**, the surface of the cast was cleaned with Anjusil. The application of Anjusil was repeated in places if necessary.

- All areas of raw plaster were given an application of 10% Paraloid B72 in acetone to provide an isolating layer between the original plaster and the repairs.
- Exposed metal fixings were treated with 5% Tannic Acid so as to stabilise the corrosion, and covered with a protective layer of 20% Paraloid B72 in acetone.
- Areas of loss, open joints and cracks were filled with white micro-balloons with 12% Paraloid B72 in acetone. Larger areas of loss around the screws were filled with an inert filler to provide extra strength.
- All the fills were then toned out with acrylics, mixed with matting agent, to match the surrounding patina.

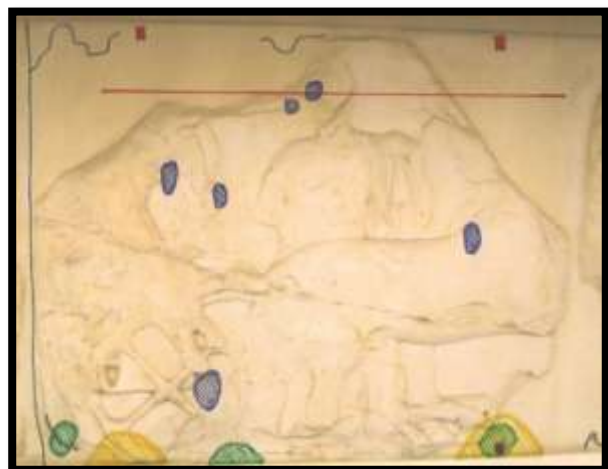
Cracks

Chips, abrasions and missing surfaces

Flaking paint

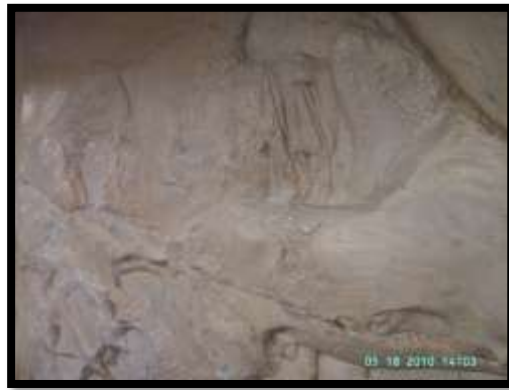
Panel during wet cleaning

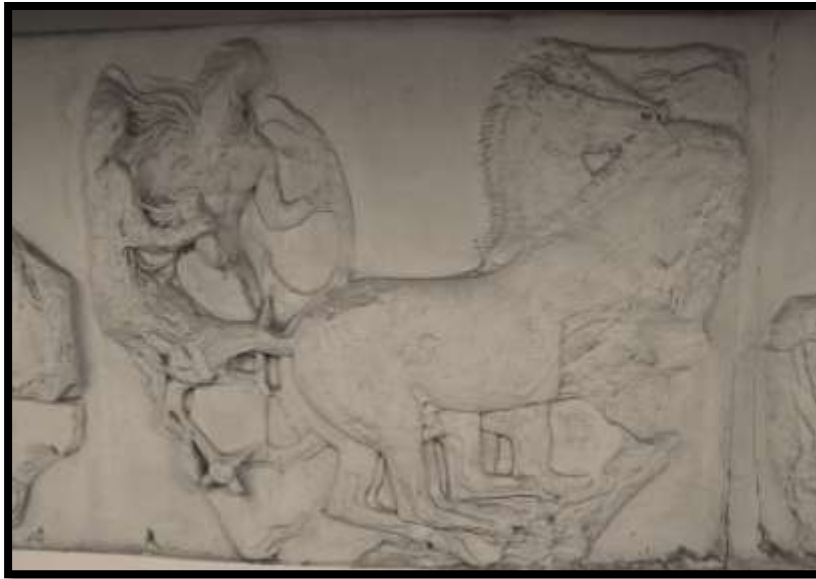
PANEL 8

Panel before conservation

STRUCTURAL STABILITY: Fair. Open cracks running alongside joints on both sides of the panel and alongside middle section of the top edge; small cracks around fixings by top and bottom edge of the panel.

VISIBLE PAINT LAYERS/UNSIGHTLY MARKINGS: Layer of cream-white paint on surface of the cast; small spots of paint splash scattered on surface of the panel and alongside the lower edge; area of flaking and missing paint on lower part of the panel.

CHIPS AND LOSS: Missing areas associated with the cracks.

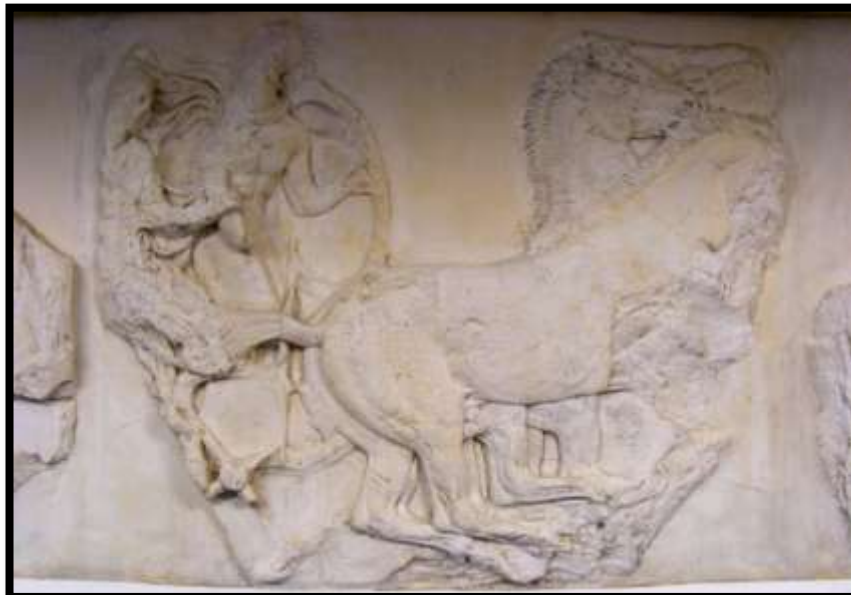
Panel after conservation

- Prior to any conservation treatment the cast was photographed. This photographic documentation was continued throughout all conservation processes.
- Initially, the cast was dry cleaned with soft brushes and Wishab Sponges with a rubber-nozzled vacuum to pick up loose dust and dirt.
- Areas of flaking paint were consolidated with application of 5% Primal B60A in de-ionised water.
- Following wet cleaning spot tests on **Panel 9 on Lower Gallery East Wall**, the surface of the cast was cleaned with Anjusil. The application of Anjusil was repeated in places if necessary.

- All areas of raw plaster were given an application of 10% Paraloid B72 in acetone to provide an isolating layer between the original plaster and the repairs.
- Exposed metal fixings were treated with 5% Tannic Acid so as to stabilise the corrosion, and covered with a protective layer of 20% Paraloid B72 in acetone.
- Areas of loss, open joints and cracks were filled with white micro-balloons with 12% Paraloid B72 in acetone. Larger areas of loss around the screws were filled with an inert filler to provide an extra strength.

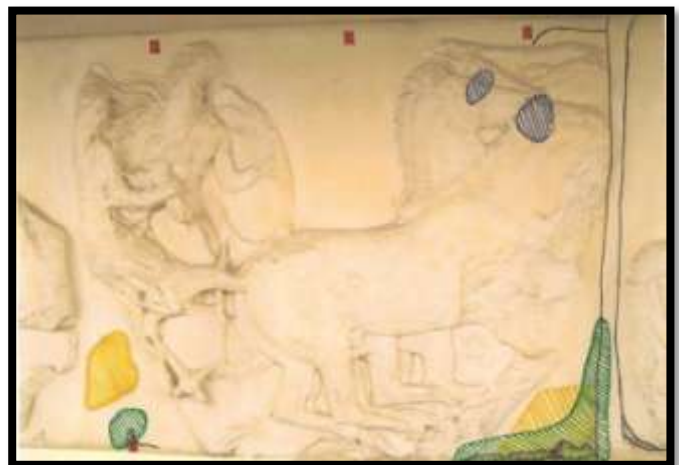
Cracks

Chips, abrasions and missing surfaces

Flaking paint

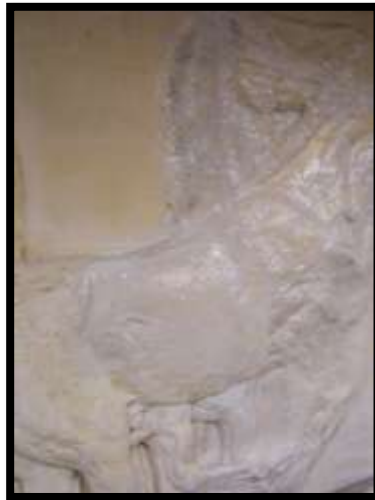
Panel during wet cleaning

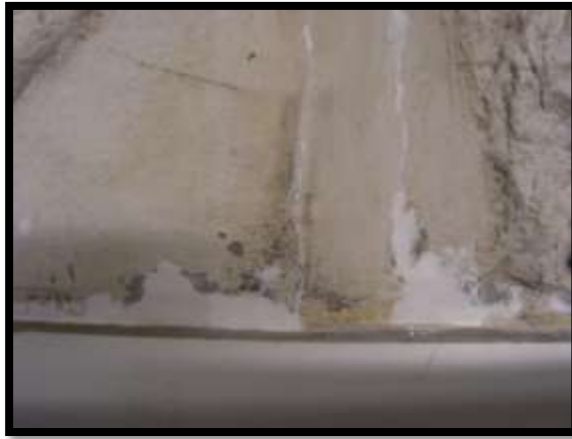
Details of fill repairs

- All the fills were then toned out with acrylics mixed, with matting agent, to match the surrounding patina.

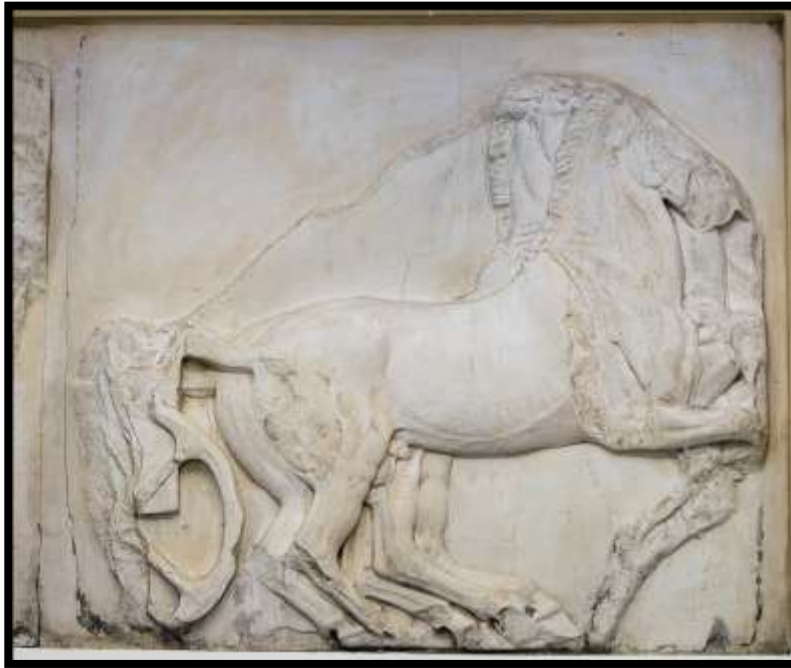
PANEL 9

Panel before conservation

STRUCTURAL STABILITY: Fair. Open cracks running alongside joint on dexter side of the panel; small cracks around fixing at top and lower edges of the panel.

VISIBLE PAINT LAYERS/UNSIGHTLY MARKINGS: Layer of cream-white paint on the surface of the cast; area of flaking and missing paint on lower part of the panel.

CHIPS AND LOSS: Missing areas associated with the cracks.

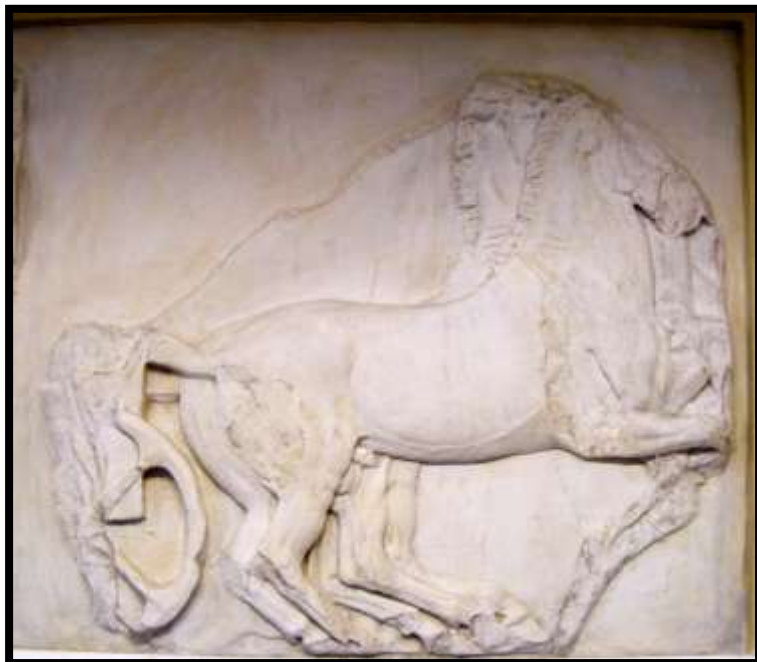
Panel after conservation

- Prior to any conservation treatment the cast was photographed. This photographic documentation was continued throughout all conservation processes.
- Initially, the cast was dry cleaned with soft brushes and Wishab Sponges with a rubber-nozzled vacuum to pick up loose dust and dirt.
- Areas of flaking paint were consolidated with application of 5% Primal B60A in de-ionised water.
- Following wet cleaning spot tests on **Panel 9 on Lower Gallery East Wall**, the surface of the cast was cleaned with Anjusil. The application of Anjusil was repeated in places if necessary.

- All areas of raw plaster were given an application of 10% Paraloid B72 in acetone to provide an isolating layer between the original plaster and the repairs.
- Exposed metal fixings were treated with 5% Tannic Acid so as to stabilise the corrosion, and covered with a protective layer of 20% Paraloid B72 in acetone.
- Areas of loss, open joints and cracks were filled with white micro-balloons with 12% Paraloid B72 in acetone. Larger areas of loss around the screws were filled with an inert filler to provide extra strength.

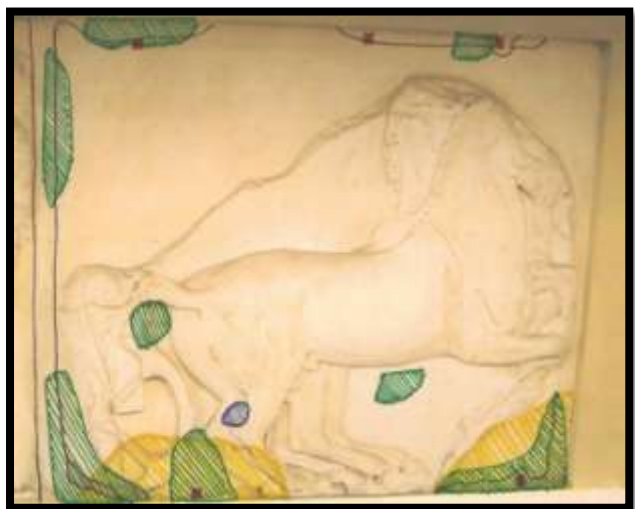
Cracks

Chips, abrasions and missing surfaces

Flaking paint

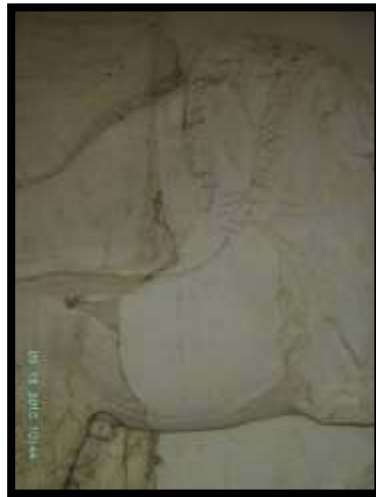
Panel during wet cleaning

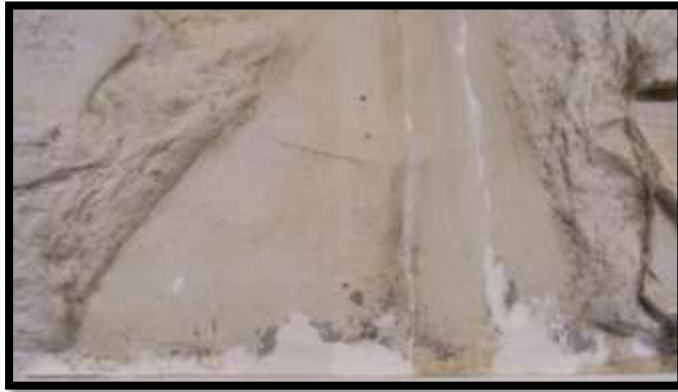
Details of fill repair

- All the fills were then toned out with acrylics, mixed with matting agent, to match the surrounding patina.
