1.6 PARTHENONE FRIEZE SLAB IN STUDIO C3

1.6.1 DESCRIPTION OF THE OBJECT

TITLE: Parthenon Frieze, copy of the panel from Parthenon Frieze from Temple of Athena – Parthenon in Acropolis in Athens, Greece, between 443 and 438 B.C.

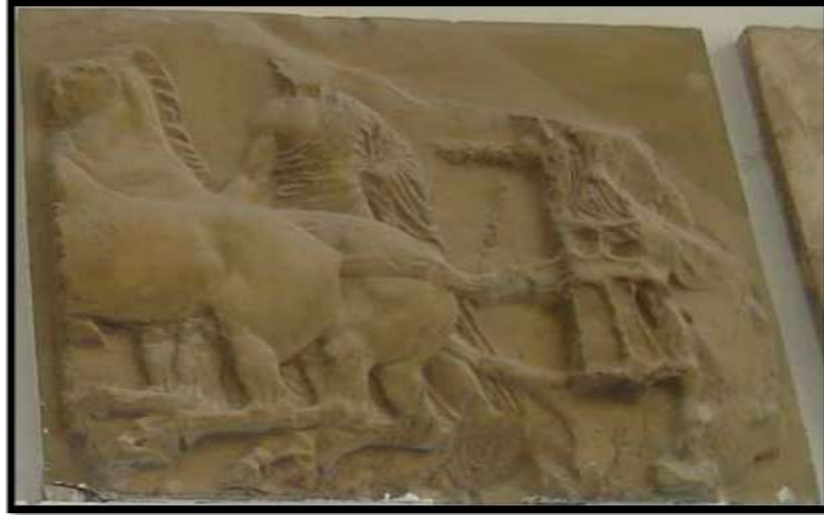
Panel before conservation

STRUCTURAL STABILITY: Fair, but open crack at top sinister corner.

SURFACE DUST AND DIRT: Severe, 100% coverage.

VISIBLE PAINT LAYERS/UNSIGHTLY MARKINGS: Layer of cream-yellow paint on surface of the cast; small spots of paint splash on all surface of the panel; white paint smears by the lower edge of the cast and on all side edges.

CHIPS AND LOSS: Large missing area at the middle of its top edge and two smaller chips to the sinister side; damaged and loose lower dexter corner; three small chips on lower edge of the cast.

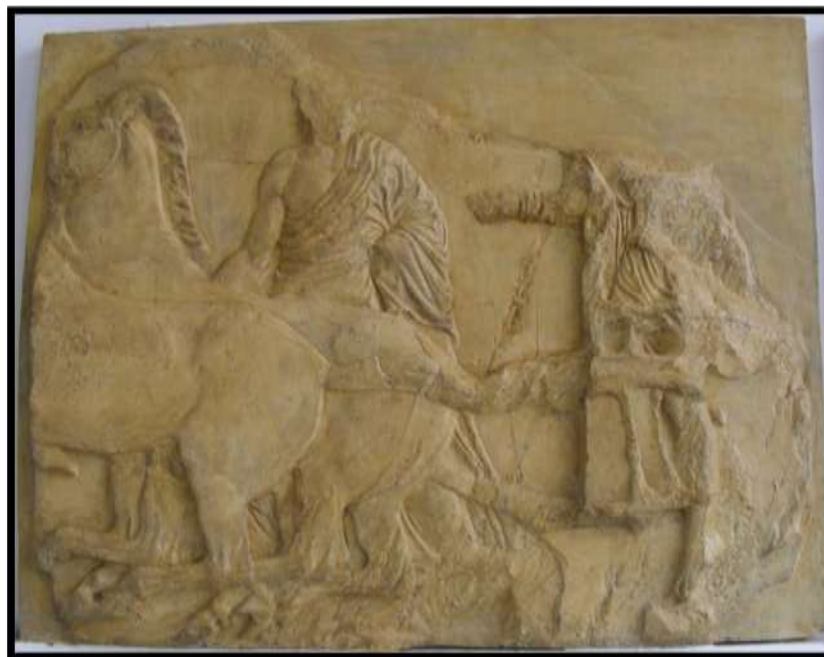
Panel after conservation

- All the fills were then toned out with acrylics, mixed with matting agent, to match the surrounding patina.
- Finally, the entire cast was given an application of micro-crystalline wax so as to protect the surface.

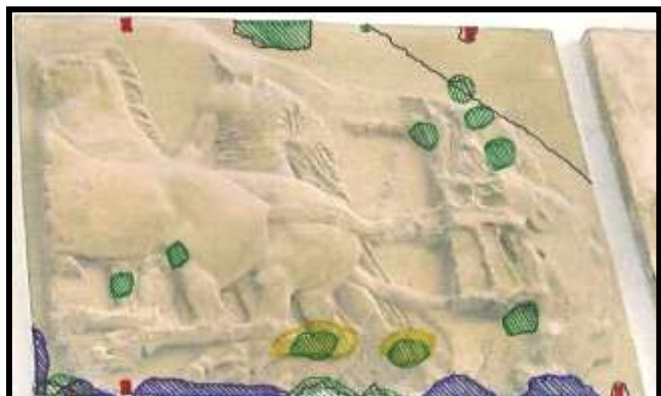
Cracks

Chips, abrasions, missing surfaces

Flaking paint

Paint splashes

Ferrous items under plaster

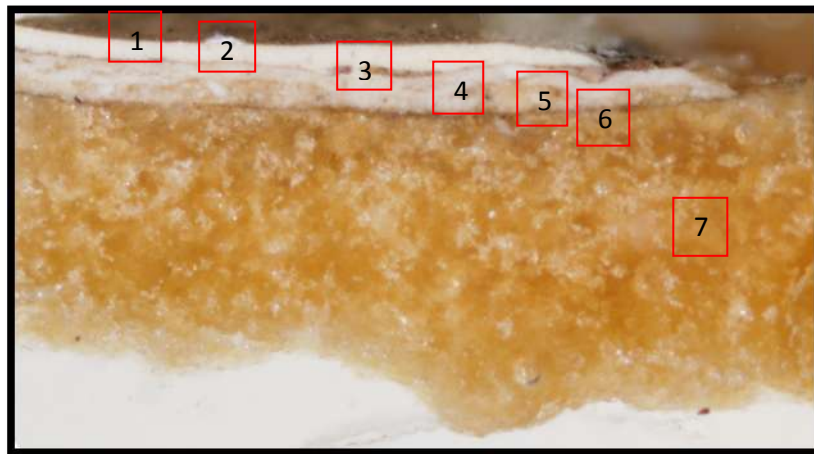
Photograph of the cross-section sample from Panel 030

ECA 030 Sample has at the top, as photographed, a very thin black dirt layer followed by a white layer. At one point on the white layer is a small white highlight. Beneath the top white layer is another dirt or varnish layer and then a greyish white layer. Below this is a mixed white and orange layer and then a brownish dirt or varnish layer on top of the thick orange coloured plaster layer. The top layer, and the highlight, showed a dull grey fluorescence under UV light whereas the two layers below showed a bright blue-white fluorescence indicating lead white. The plaster layer had a slightly yellowish fluorescence.

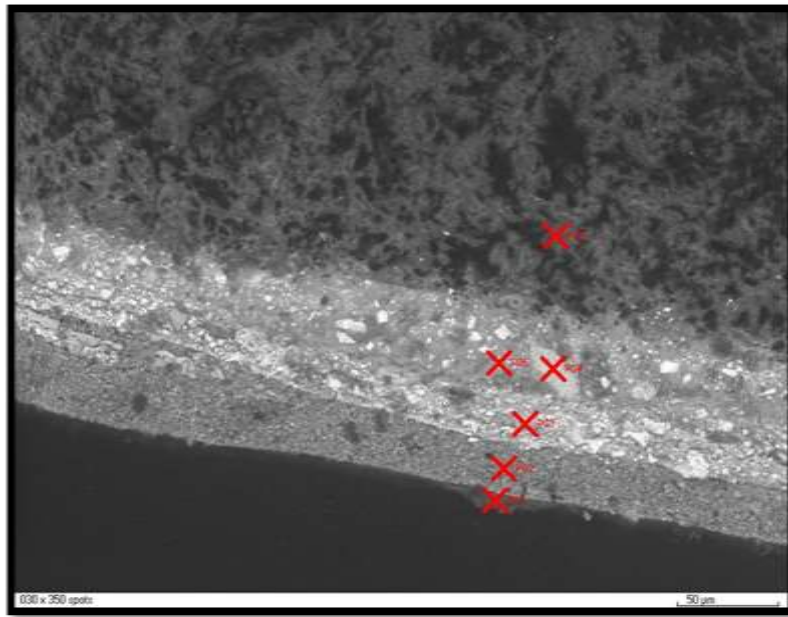
Electron micrograph of cross-section of sample from Panel 030

The electron micrograph showed the three paint layers and the highlight and part of the plaster. The photograph shows this upside down. Analysis of the highlight at spot 1 showed the presence of mainly titanium (spectrum 6) indicating titanium white as the pigment. There are also small amounts of zinc, calcium and sulphur, perhaps from the other layers though it might be that some zinc white and some gypsum are included. Aluminium and silicon are present so the titanium white may be extended with kaolin. Titanium white was not introduced until 1916 so this highlight could not have been applied till then.

The main white top layer was investigated at spot 2 and showed the presence of zinc, barium, sulphur, silicon, a small amount of iron and traces of calcium and lead (spectrum 7). This paint may be either a mixture of zinc oxide and barium sulphate or lithopone which is a mixture of zinc sulphide and barium sulphate. There may be small amounts of silica, ochre, chalk and lead white present, though the lead may have carried across from the layer below. Zinc oxide was introduced in about 1830 and lithopone was not used until the 1870's.

The layer below was analysed at spot 3 and was found to contain mainly lead (spectrum 8), indicating that the main pigment in this layer is lead white. There are small amounts of silicon and calcium, indicating silica and chalk extenders and trace amounts of zinc and barium which may be from the layer above.

The lowest paint layer was analysed at spot 4 and was found to contain mainly lead (spectrum 9), indicating that the main pigment in this layer is lead white. There are small amounts of silicon and calcium, indicating silica and chalk extenders. It differs from spectrum 8 in that there is virtually no zinc and barium is absent.

The plaster was analysed at spot 5 and showed the presence of calcium and sulphur, confirming that the plaster is gypsum.

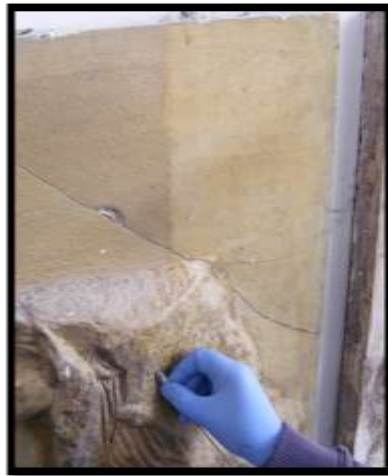
Cast during wet cleaning

- Prior to any conservation treatment, the cast was photographed. This photographic documentation was continued throughout all conservation processes.
- Initially, the cast was dry cleaned with soft brushes and Wishab Sponges with a rubber-nozzled vacuum to pick up the loose dust and dirt.
- Following a variety of wet cleaning spot tests, the surface of the panel was cleaned with 2-5% Vulpex Liquid Soap in de-ionised water, using cotton wool swabs.

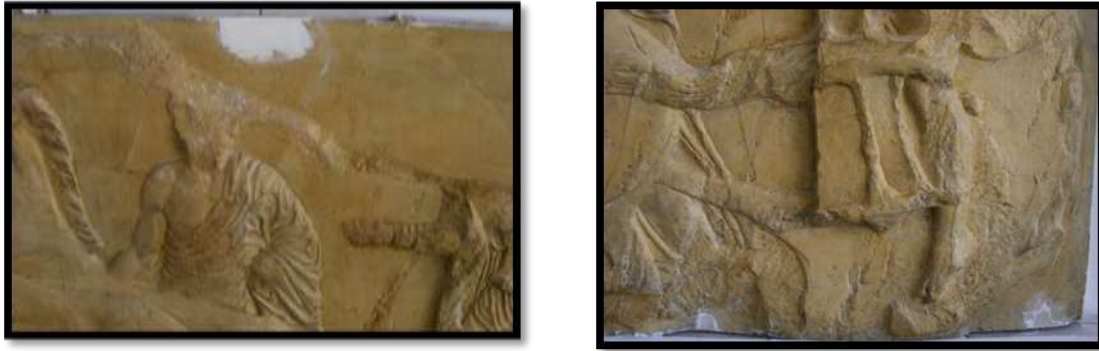
Details of fill repairs

- Areas of flaking paint were consolidated with 5% Primal B60A in de-ionised water.
- All areas of raw plaster were given an application of 10% Paraloid B72 in acetone to provide an isolating layer between the original plaster and the repairs.
- Exposed metal fixings were treated with 5% Tannic Acid so as to stabilise the corrosion, and covered with a protective layer of 20% Paraloid B72 in acetone.
- Areas of loss, open joints and cracks were filled with white micro-balloons mixed with 12% Paraloid B72 in acetone. Larger areas of loss and around the screws were filled with an inert filler to provide extra strength.
