**2. PART OF THE FRIEZE FROM THE TEMPLE OF ATHENA**  
**NIKE**

**2.1 SLAB 1**

**TITLE:** Part of the frieze from the Temple of Athena Nike, Slab 1, copy of Frieze from Athena Nike Temple in Acropolis in Athens in Greece, 5<sup>th</sup> century B.C.

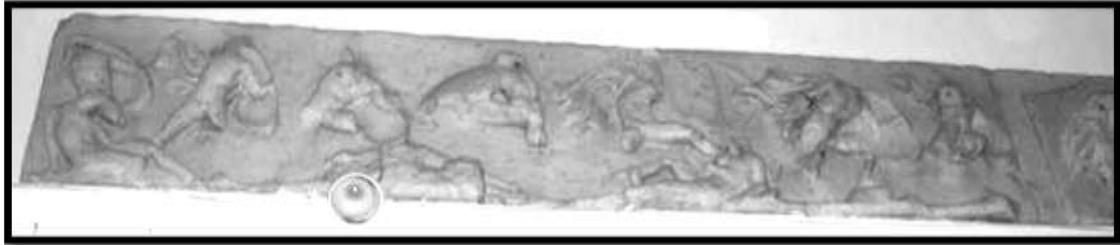
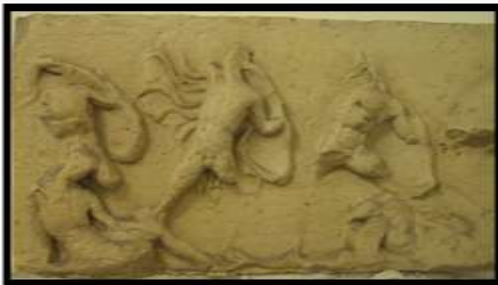
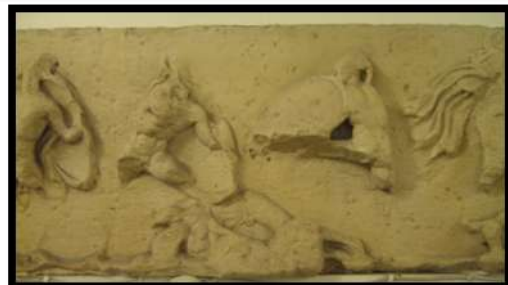
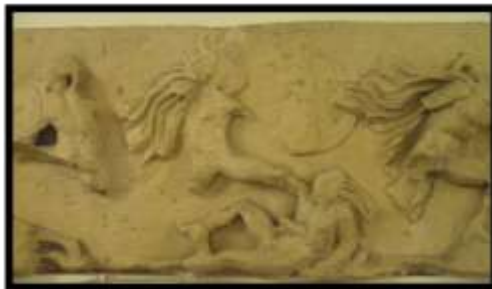
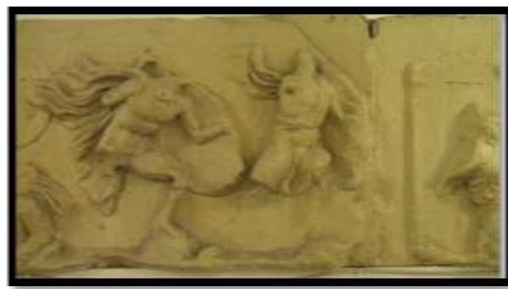
*Panel before conservation*

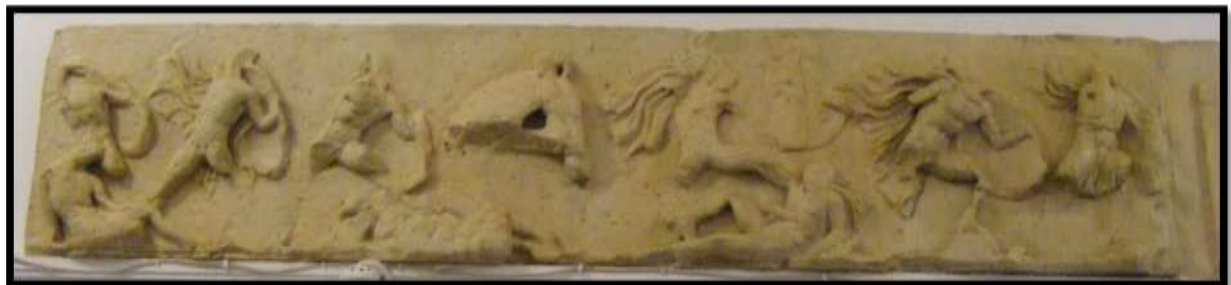
*Panel after conservation*

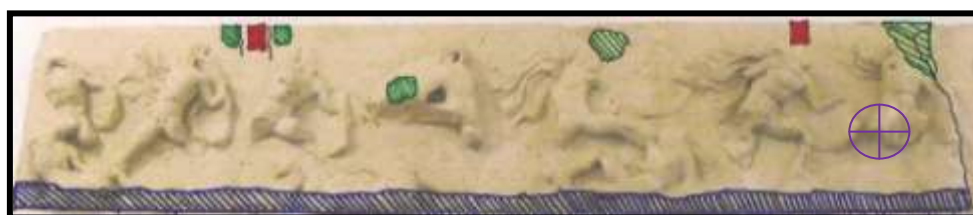
**STRUCTURAL STABILITY:** Good, but crack in between panels by dexter edge.

**SURFACE DUST AND DIRT:** Severe, 100% coverage.

**VISIBLE PAINT LAYERS/UNSIGHTLY MARKINGS:** Layer of cream-yellow paint on surface of the cast; small spots of paint splash on surface of the panel; white paint smears by the lower edge of the cast and on sinister edge.

**CHIPS AND LOSS:** Areas of loss associated with cracks; chip in middle part of the panel by top edge.

#### **Cracks**

**Chips, abrasions, missing surfaces**

**Paint splashes**

**Ferrous items under plaster**

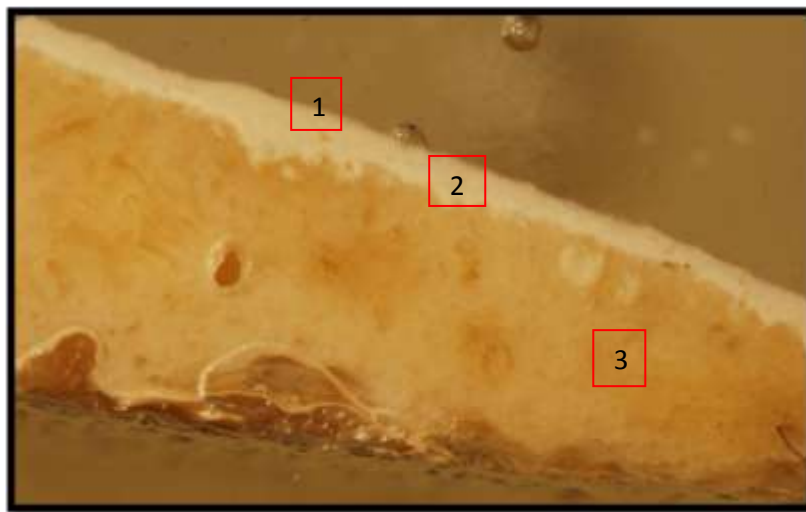
*Photograph of the cross-section sample from Frieze from Temple of Athena Nike – panel 1*

A cross-section of the paint revealed, from the top layer downwards, as photographed, the presence of several layers; a top pale orange-grey-white layer containing white and orange and yellow particles above a white layer. Beneath this is the thick plaster layer with some orange-brown material in it.

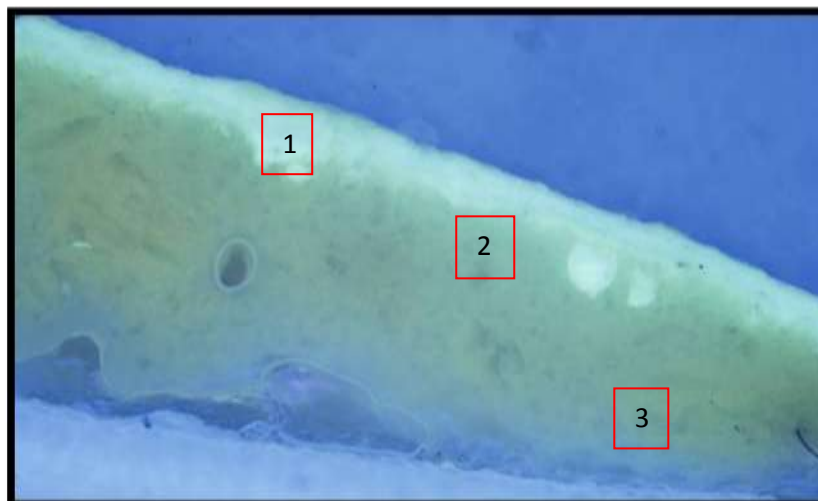
*Photograph of the cross-section sample from Frieze from Temple of Athena Nike – in UV*

Observation under UV light showed that the pale orange-white layer showed some greenish white fluorescence, which may indicate that it may contain zinc oxide (zinc white). The next white layer fluoresced blue-white indicating that it may contain lead white. The thick plaster layer showed a yellowish orange fluorescence indicating that it may contain shellac; hence this sample was selected for GC-MS investigation.

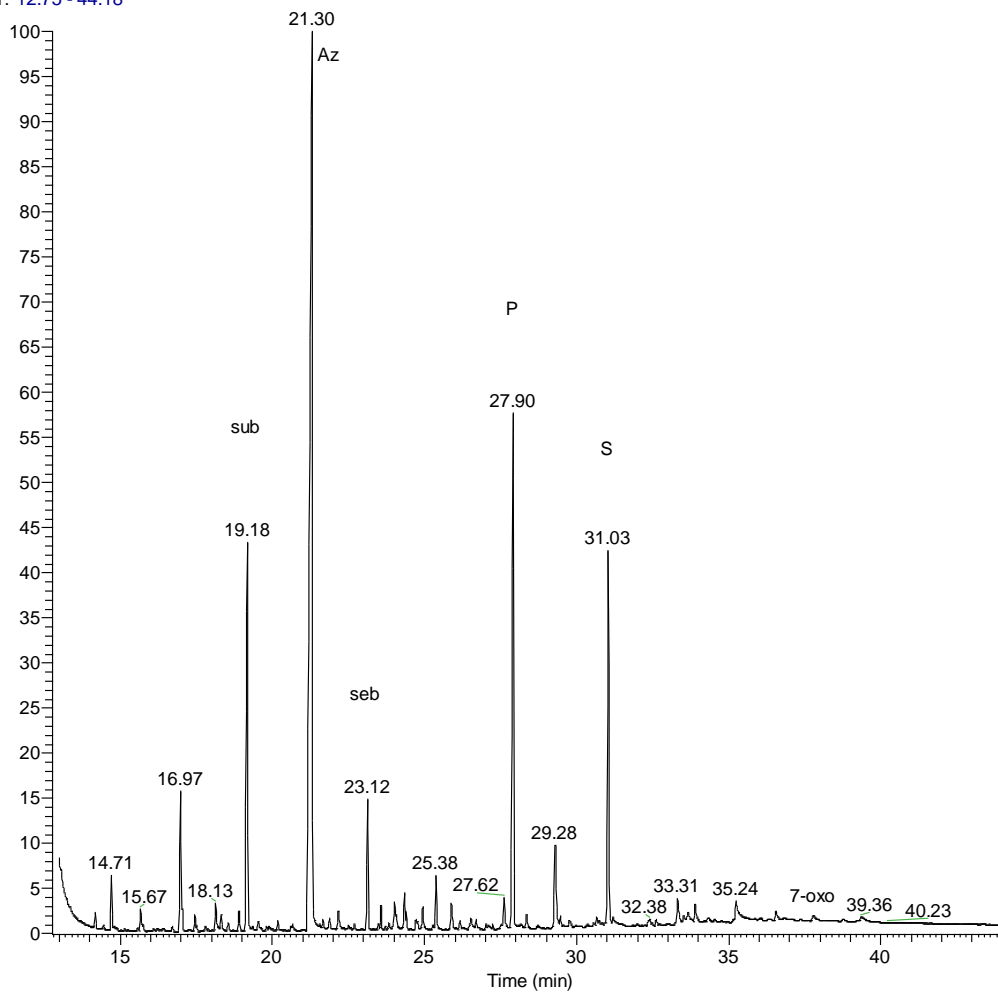
A Sample containing both the plaster layer and the paint layers was cut from sample *ECA 079-082* and was treated with trifluoromethylphenyl trimethyl ammonium hydroxide (5% in methanol) and the mixture separated by GC-MS the chromatogram (Figure 2) which showed a strong peak for the methyl ester of nonandioic acid (azelic acid) with an azelate to palmitate ratio of 2.6 indicating a drying oil<sup>1</sup>. The ratio of palmitic acid (hexadecanoic acid) to stearic acid (octadecanoic acid) (as their methyl esters) is 1.5, which is in the range for linseed oil<sup>1</sup>. The azelate to suberate ratio is 3.9 and the azelate to sebacate ratio is 14.2, which together indicate that the oil has been heat bodied<sup>2</sup>.

*Oil / resin analysis of ECA 079-08; Seb= dimethyl sebacate, Az = dimethyl azelate, Sub = dimethyl suberate, P = methyl palmitate, S = methyl stearate, 7-oxo = methyl 7-oxodehydroabietate*

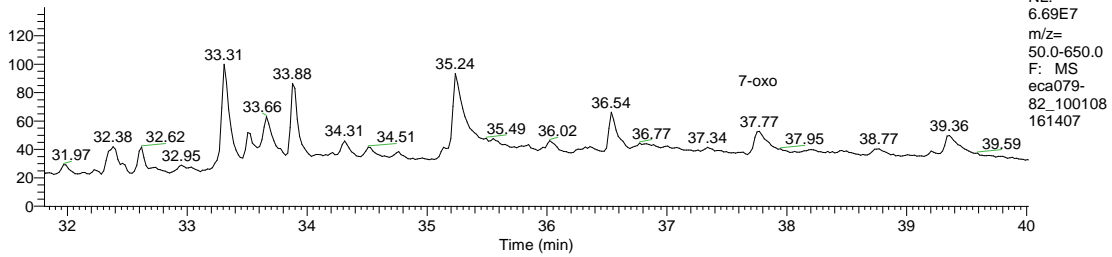
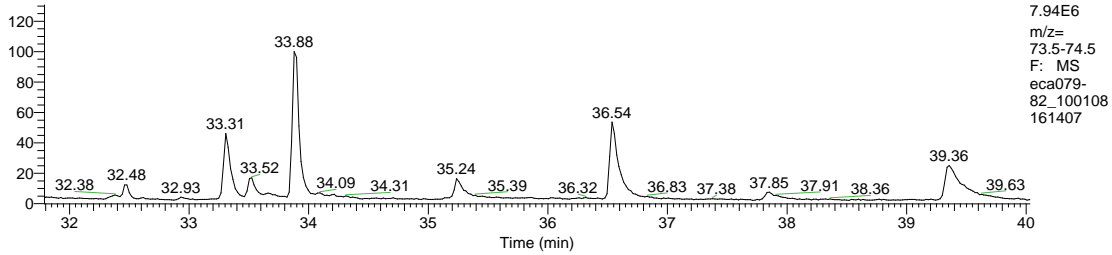
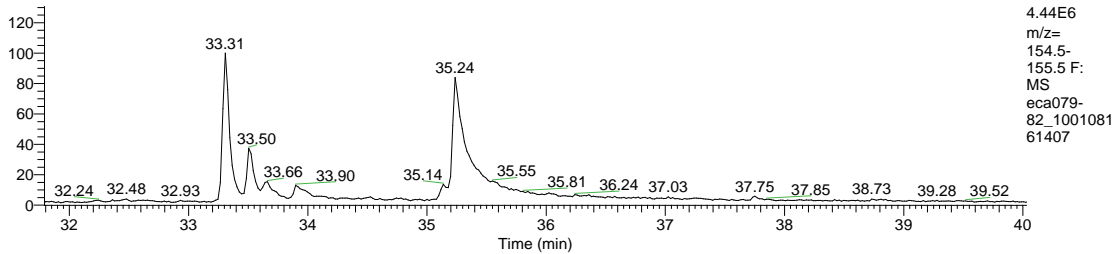
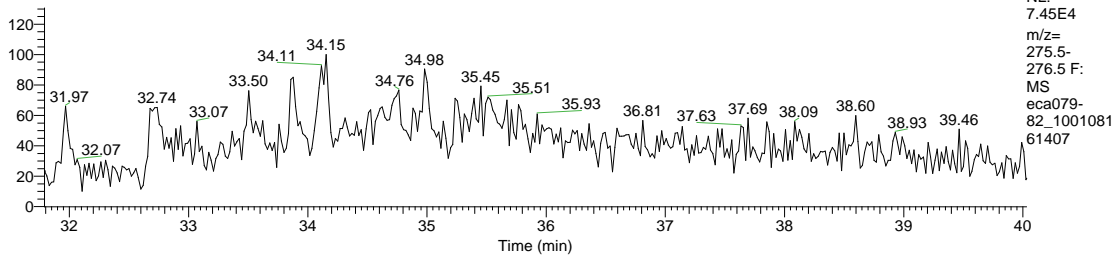
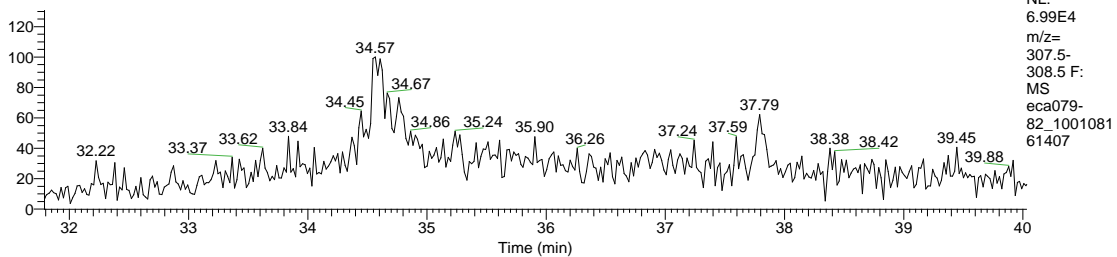
An attempt was made to find indicative components for shellac by displaying single ion chromatographs (Figure 3). Mills and White report<sup>3</sup> that shellac can be identified by characteristic, but unidentified compounds, showing a 276 ion and a 308 ion. Compounds containing a 155 ion are also abundant in shellac. However this sample did not yield compounds peaks at similar retention times with a mass 276 ion (Figure 3) and also with a mass 308 ion (Figure 3). There are abundant peaks with a 155 ion count (Figure 3) but these were found to be due to epoxy-carboxylic acids, these, being oxidation products of the oil. Also present is a small peak for methyl 7-oxodehydroabietate which indicates the presence of coniferous resin, most probably pine resin.

Thus there is no evidence to indicate that sample *ECA079-82* contains shellac, though it does contain some coniferous resin such as pine resin and it also contains, mainly, heat bodied linseed oil, probably in the paint layers and possibly also in the organic material within the plaster.

Single ion chromatographs from sample ECA 079-082.

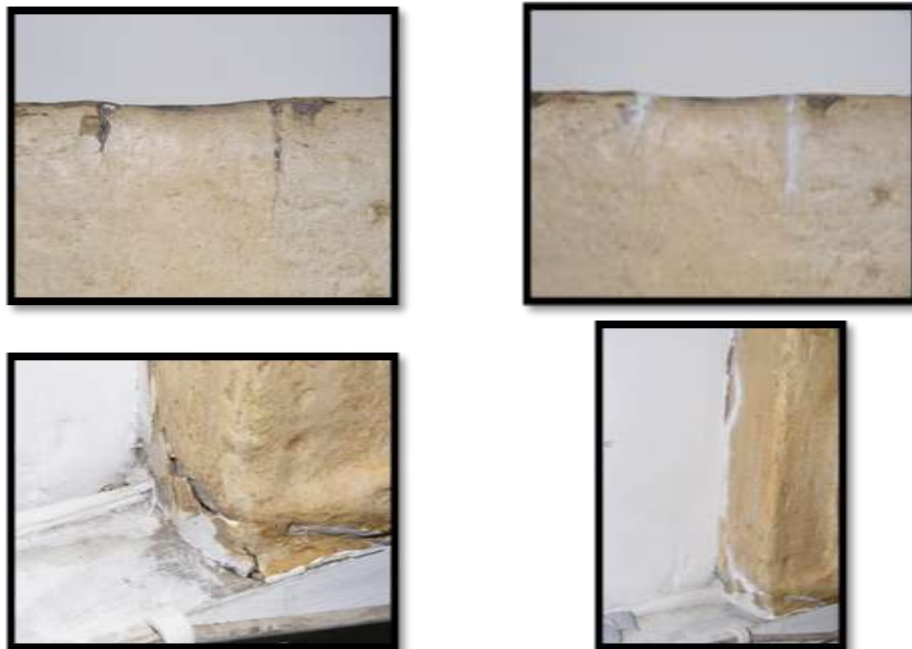
*Details of fill repairs*

- The areas of flaking paint were consolidated with an application of 5% Primal B60A in de-ionised water.
- Areas of loss, open joints and cracks were filled with white micro-balloons mixed with 12% Paraloid B72 in acetone. Larger areas of loss and around the screws were filled with an inert filler to provide extra strength.

- All the fills were then toned out with acrylics, mixed with matting agent, to match the surrounding patina.
- Finally, the entire cast was given an application of micro-crystalline wax so as to protect the surface.

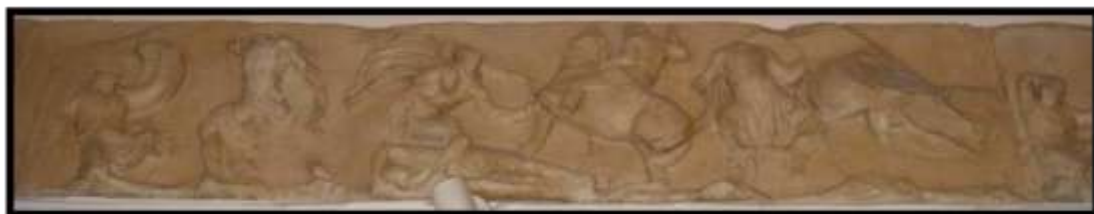
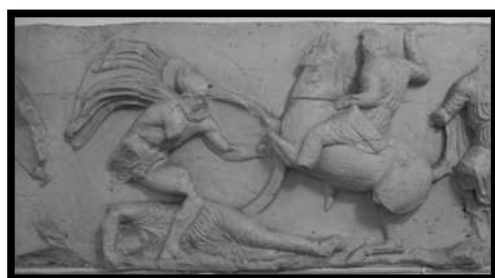
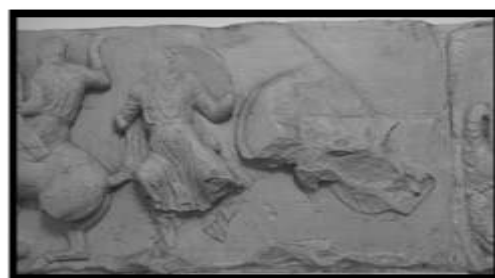
*Panel before conservation*

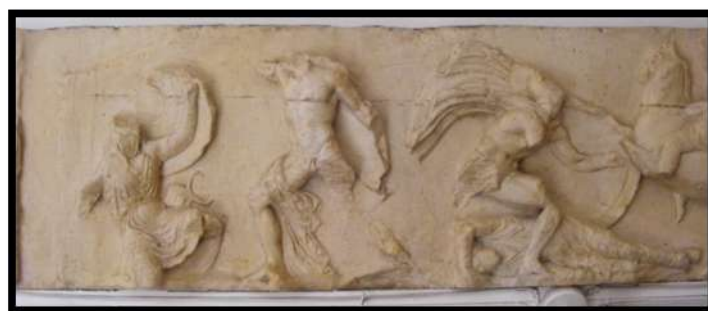
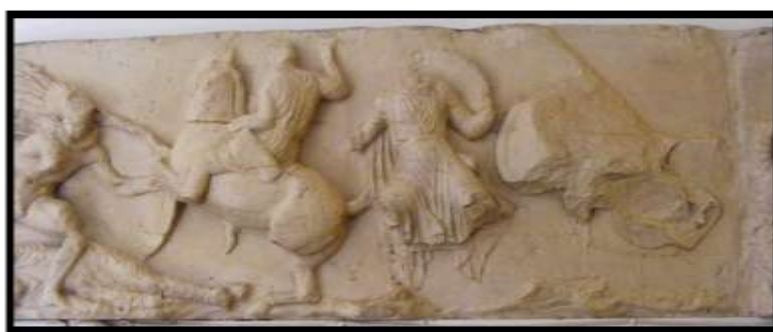
*Panel after conservation*

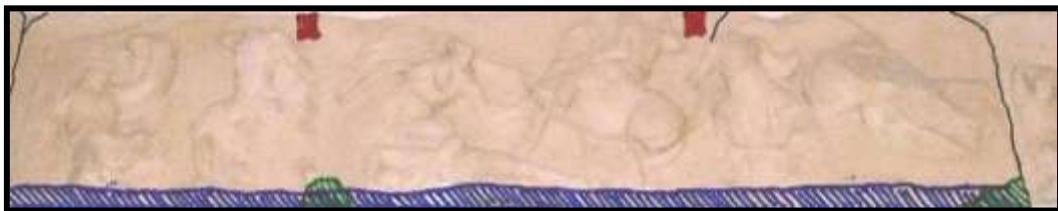
**STRUCTURAL STABILITY:** Good, but crack in between panels by dexter edge.

**SURFACE DUST AND DIRT:** Severe, 100% coverage.

**VISIBLE PAINT LAYERS/UNSIGHTLY MARKINGS:** Layer of cream-yellow paint on surface of the cast; small spots of paint splash on surface of the panel; white paint smears by the lower edge of the cast and on sinister edge.

**CHIPS AND LOSS:** Areas of loss associated with cracks; chip in middle part of the panel by top edge.

#### **Cracks**

**Chips, abrasions, missing surfaces**

**Paint splashes**

**Ferrous items under plaster**

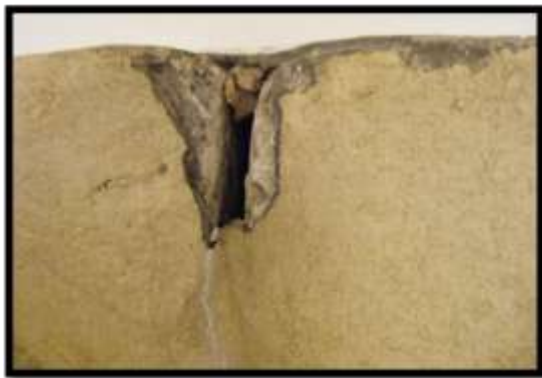
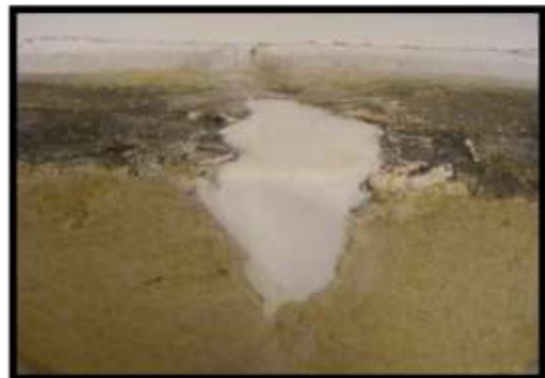
*Details of fill repair*

- The areas of flaking paint were consolidated with an application of 5% Primal B60A in de-ionised water.
- Areas of loss, open joints and cracks were filled with white micro-balloons mixed with 12% Paraloid B72 in acetone. Larger areas of loss and around the screws were filled with an inert filler to provide extra strength.

- All the fills were then toned out with acrylics, mixed with matting agent, to match the surrounding patina.
- Finally, the entire cast was given an application of micro-crystalline wax so as to protect the surface.

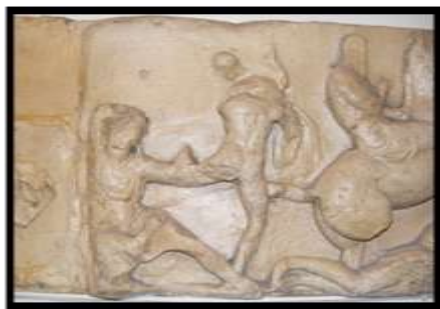
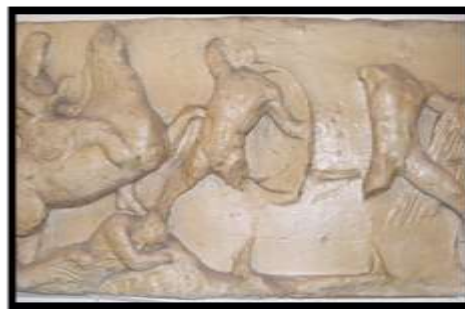
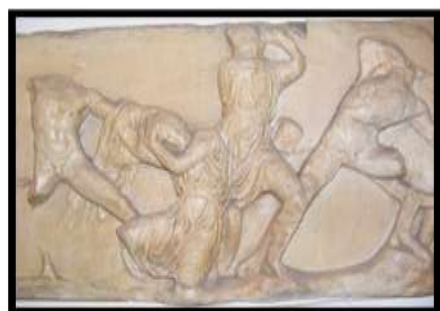
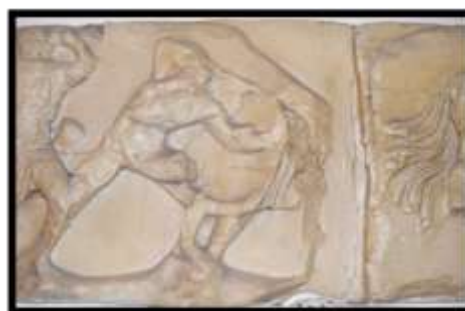
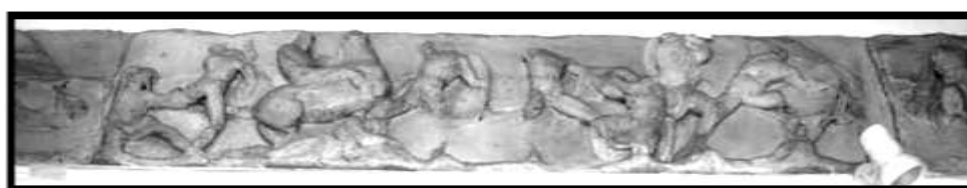
*Panel before conservation*

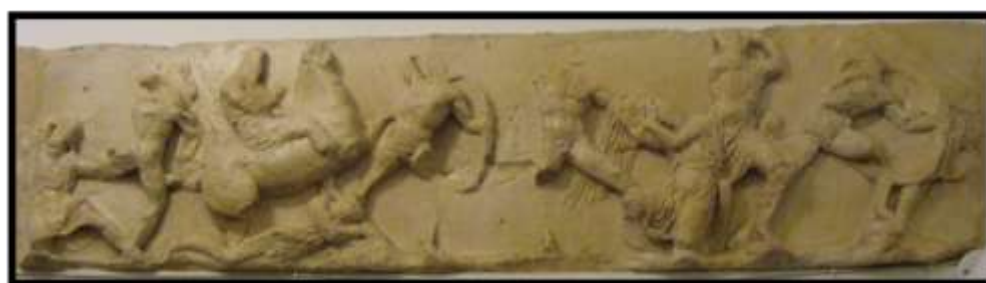
*Panel after conservation*

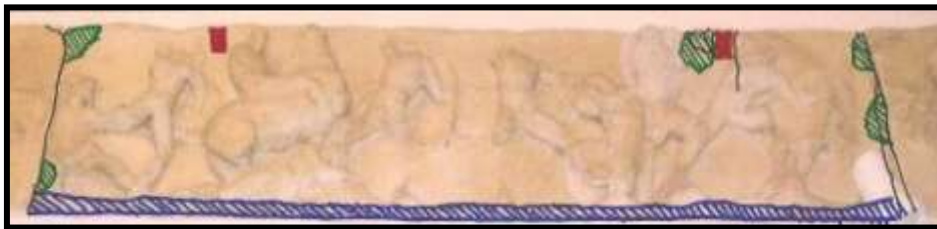
**STRUCTURAL STABILITY:** Good, but cracks in between panels on both sides of the panel.

**SURFACE DUST AND DIRT:** Severe, 100% coverage.

**VISIBLE PAINT LAYERS/UNSIGHTLY MARKINGS:** Layer of cream-yellow paint on surface of the cast; small spots of paint splash on surface of the panel; white paint smears by the lower edge of the cast and on sinister edge.

**CHIPS AND LOSS:** Areas of loss associated with cracks; chip in sinister part of the panel by top edge.

**Cracks**

**Chips, abrasions, missing surfaces**

**Paint splashes**

**Ferrous items under plaster**

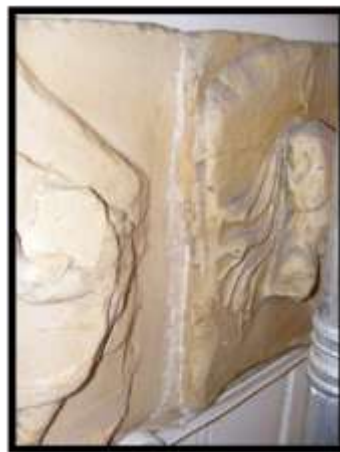
*Details of fill repair*

- The areas of flaking paint were consolidated with an application of 5% Primal B60A in de-ionised water.
- Areas of loss, open joints and cracks were filled with white micro-balloons mixed with 12% Paraloid B72 in acetone. Larger areas of loss and around the screws were filled with an inert filler to provide extra strength.

- All the fills were then toned out with acrylics, mixed with matting agent, to match the surrounding patina.
- Finally, the entire cast was given an application of micro-crystalline wax so as to protect the surface.

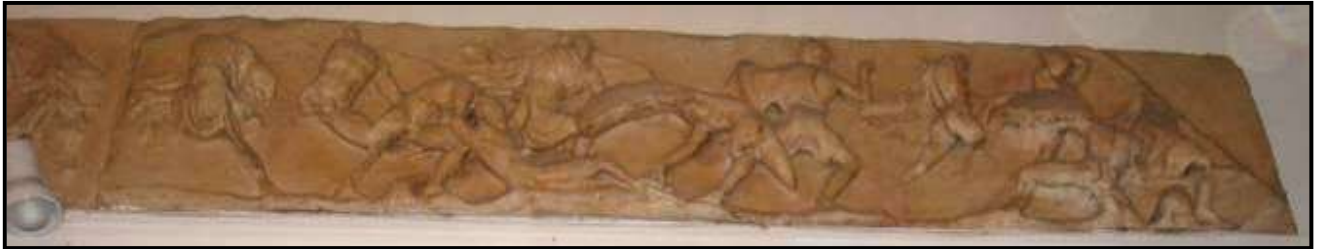
*Panel before conservation*

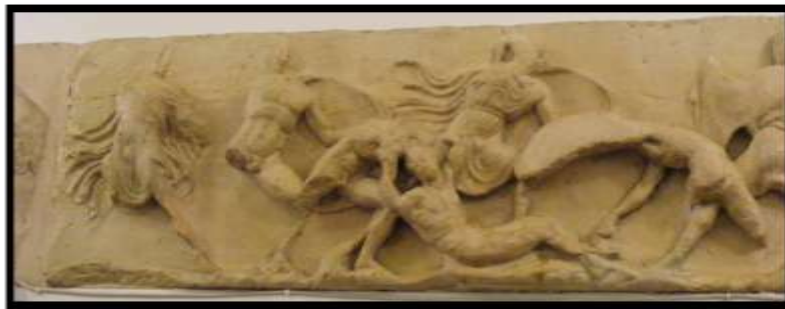
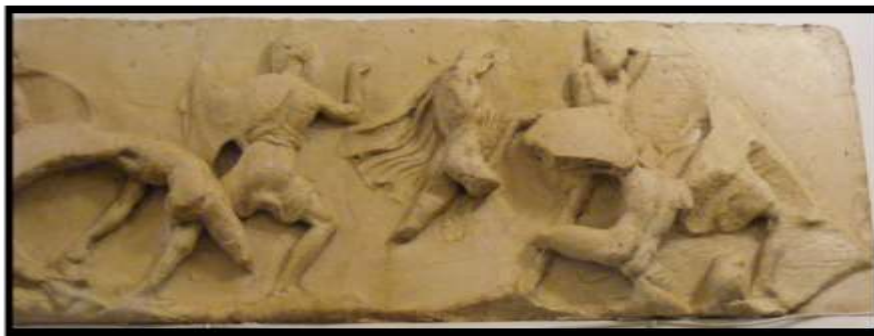
*Panel after conservation*

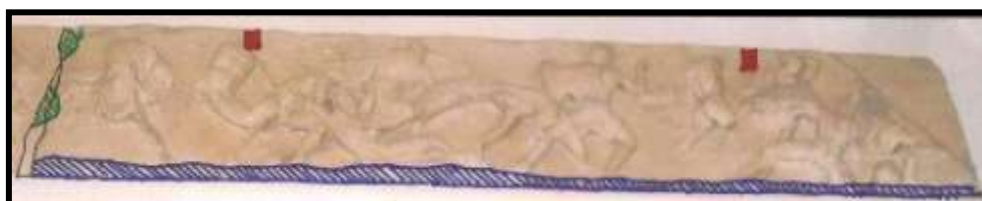
**STRUCTURAL STABILITY:** Good, but crack in between panels on dexter side of the cast.

**SURFACE DUST AND DIRT:** Severe, 100% coverage.

**VISIBLE PAINT LAYERS/UNSIGHTLY MARKINGS:** Layer of cream-yellow paint on surface of the cast; small spots of paint splash on surface of the panel; white paint smears by the lower edge of the cast and on sinister edge.

**CHIPS AND LOSS:** Areas of loss associated with cracks.

**Cracks**

**Chips, abrasions, missing surfaces**

**Paint splashes**

**Ferrous items under plaster**
