### 3. METOPES

#### 3.1 METOPE P010 in Studio C4

**TITLE:** Metope of Parthenon, copy of metope from Temple of Athena – Parthenon in Acropolis in Athens, Greece(443-438 BC)

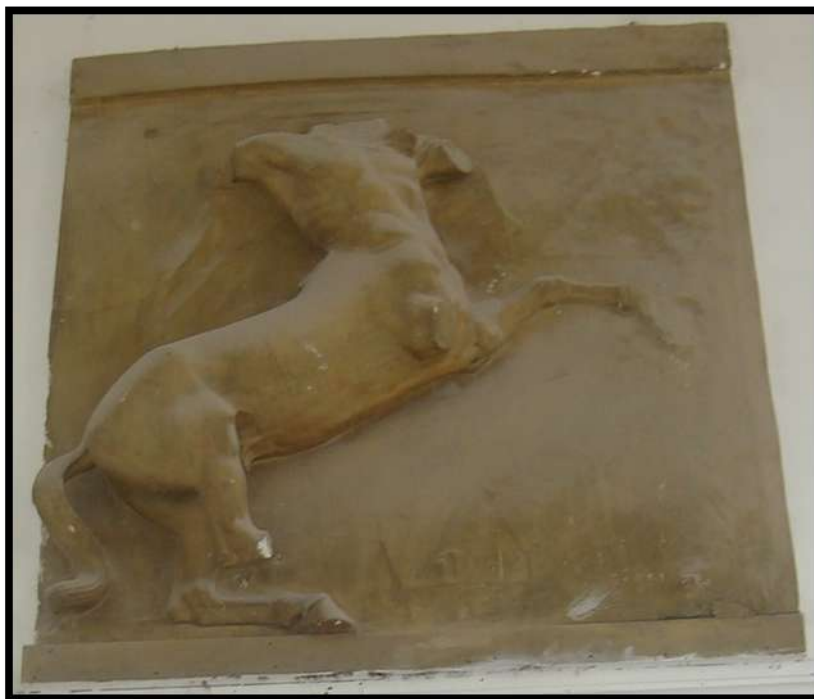
*Panel before conservation*

**STRUCTURAL STABILITY:** Good, but crack at dexter side of the cast.

**SURFACE DUST AND DIRT:** Severe, 100% coverage.

**VISIBLE PAINT LAYERS/UNSIGHTLY MARKINGS:** Layer of cream-yellow paint on surface of the cast; small spots of paint splash on all surface of the panel; white paint smears by the lower edge of the cast.

**CHIPS AND LOSS:** Areas of loss associated with cracks; small crack and loose fragment around fixing in lower sinister corner of the cast.

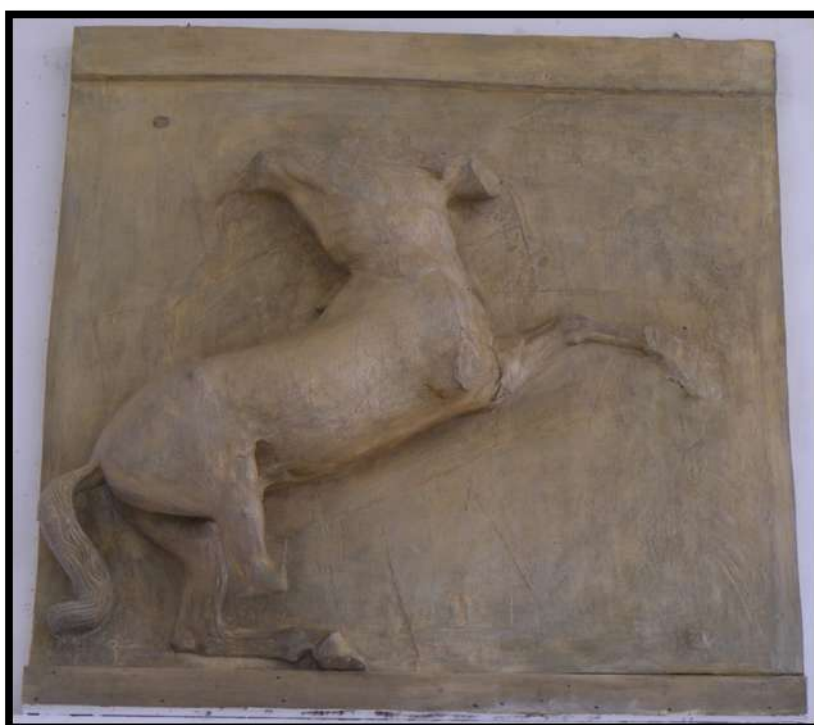
*Panel after conservation*

- Areas of loss, open joints and cracks were filled with white micro-balloons mixed with 12% Paraloid B72 in acetone. Larger areas of loss and around the screws were filled with an inert filler to provide extra strength.

- All the fills were then toned out with acrylics, mixed with matting agent, to match the surrounding patina.
- Finally, the entire cast was given an application of micro-crystalline wax so as to protect the surface.

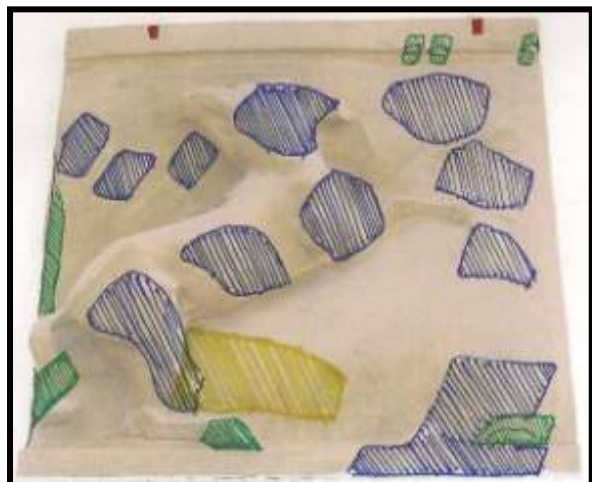
**Cracks**

**Chips, abrasions, missing surfaces**

**Paint splashes**

**Flaking paint**

**Ferrous items inside plaster**

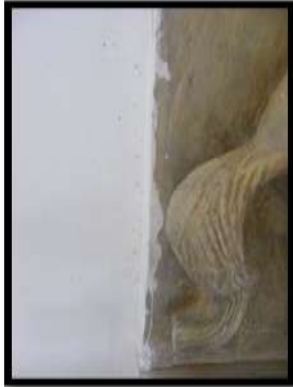
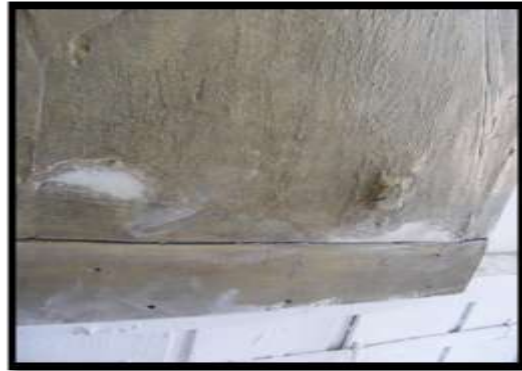
*Details of fill repair*

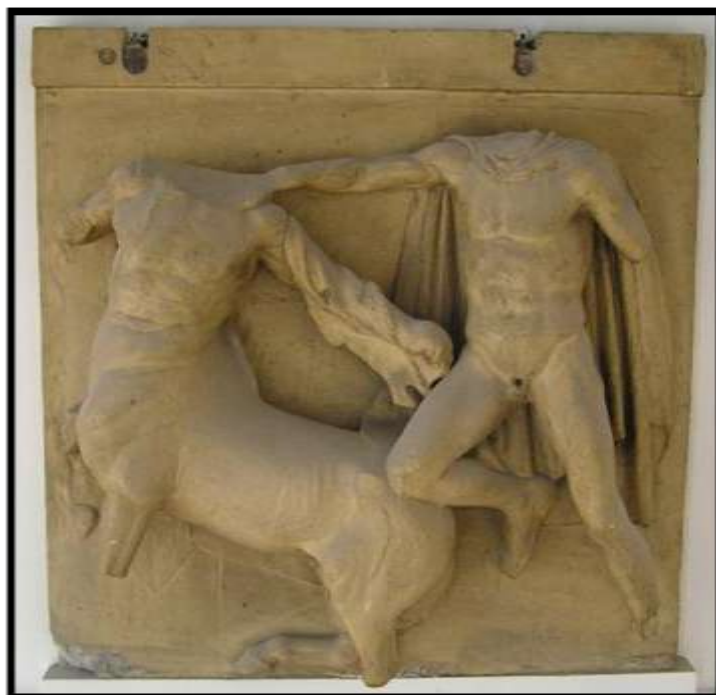
*Panel before conservation*

**STRUCTURAL STABILITY:** Good, but crack at dexter side of the cast.

**CHIPS AND LOSSES:** Areas of loss associated with cracks; small crack and loose fragment around fixing in lower sinister corner of the cast.

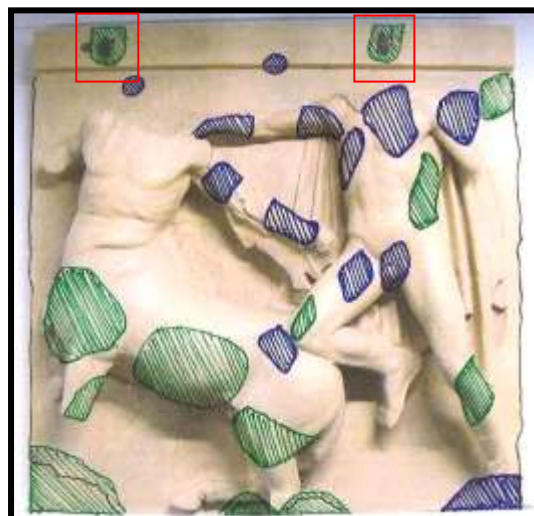
#### **Cracks**

**Chips, abrasions, missing surfaces**

**Ferrous fixings**

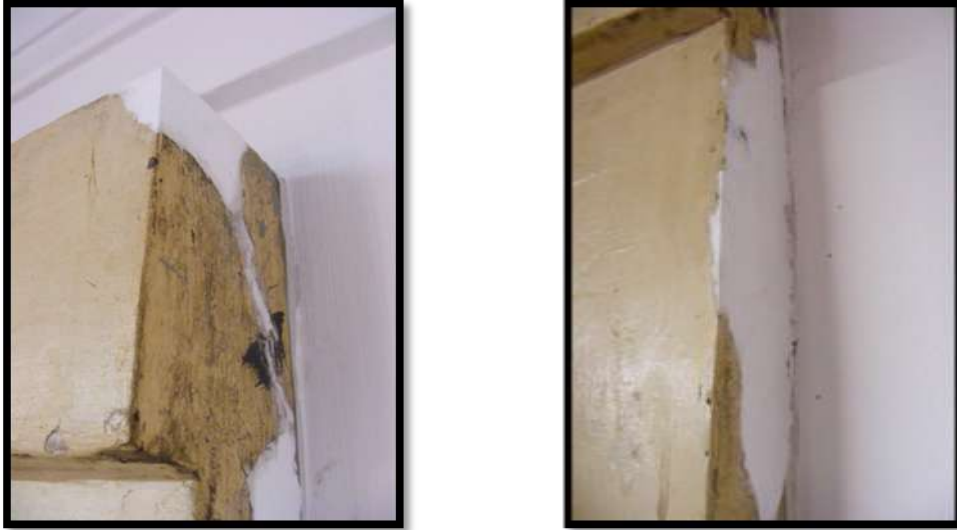
*Details of fill repair*

- Areas of loss, open joints and cracks were filled with white micro-balloons mixed with 12% Paraloid B72 in acetone. Larger areas of loss and around the screws were filled with an inert filler to provide extra strength.

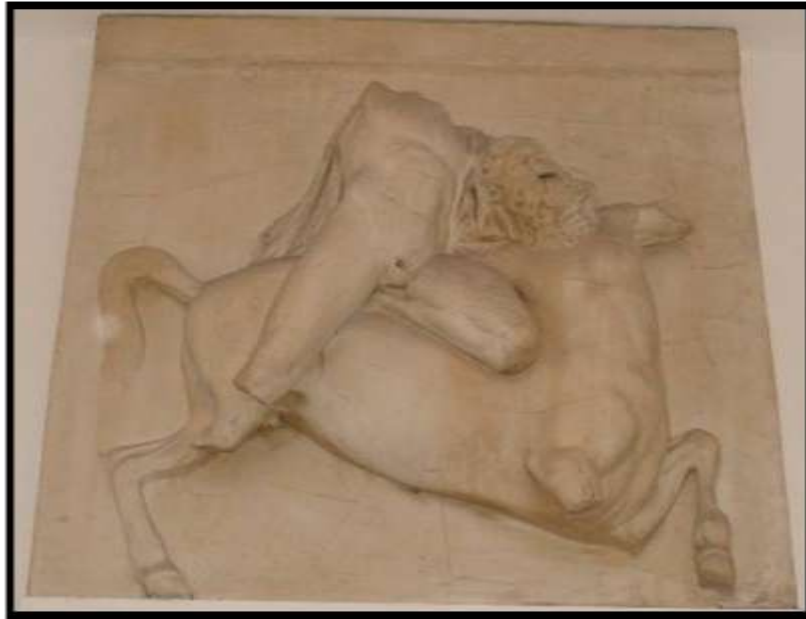
*Panel before conservation*

**STRUCTURAL STABILITY:** Good, but crack at sinister top corner of the cast.

**CHIPS AND LOSS:** Areas of loss associated with crack in corner of the cast; small crack and loose fragment around fixing in lower sinister corner of the cast.

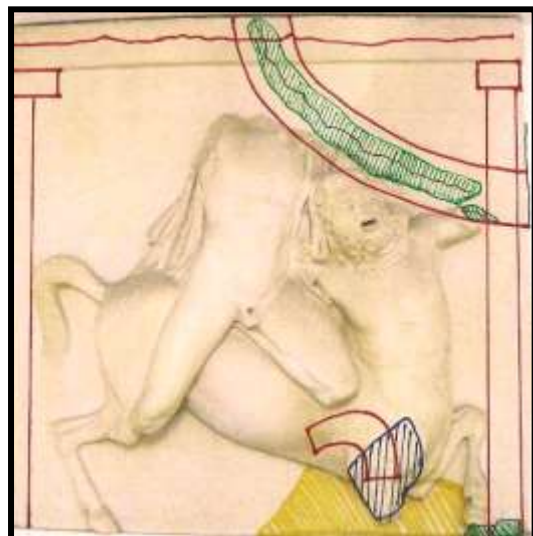
#### Cracks

Chips, abrasions, missing surfaces

Ferrous items under the plaster

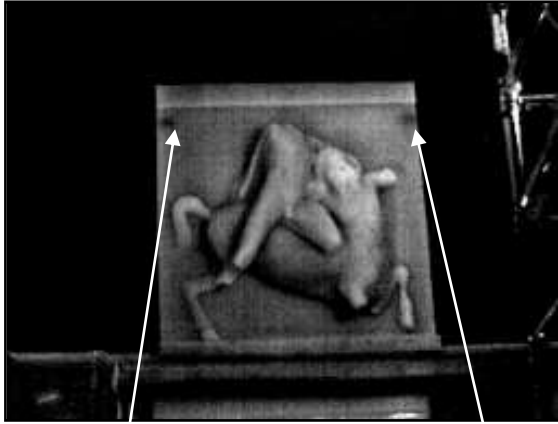
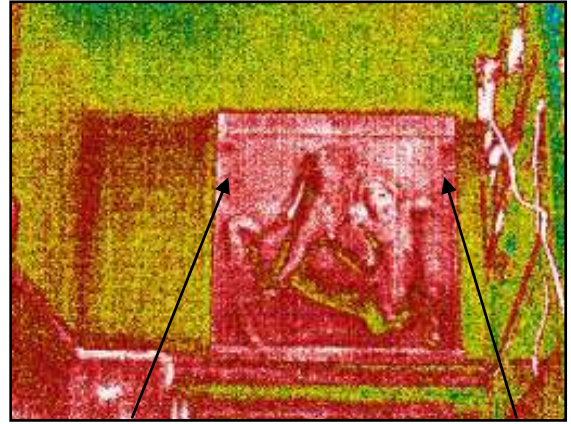
**Thermogram No. 14:** Recorded at 1030, note greater detail in thermogram. The two dark areas, arrowed either side of the cast, at the top of the cast is the location of fixings.

Following the Infrared Thermographic examination of the cast, both the cast and adjacent wall were examined visually and a metal detector used to scan the areas indicated to contain fixings and, possibly, past repairs. The later was carried out to establish if the fixings or straps were metallic or non-metallic in composition. No open cracks were observed on the basis of the visual examination, however, light levels were low and very fine cracks would not be seen. However, indications of past repairs were apparent and it may be that the crack paths indicated in the Infrared were also the sites of past repairs.

The fixings were indicated from the scan with the detector to be metallic, possibly ferrous, and be connected to a wire or small diameter bar, on the left side of the cast but a flat bar on the right side of the cast. This would require further investigation to clarify the actual dimensions and the actual composition of the fixings.

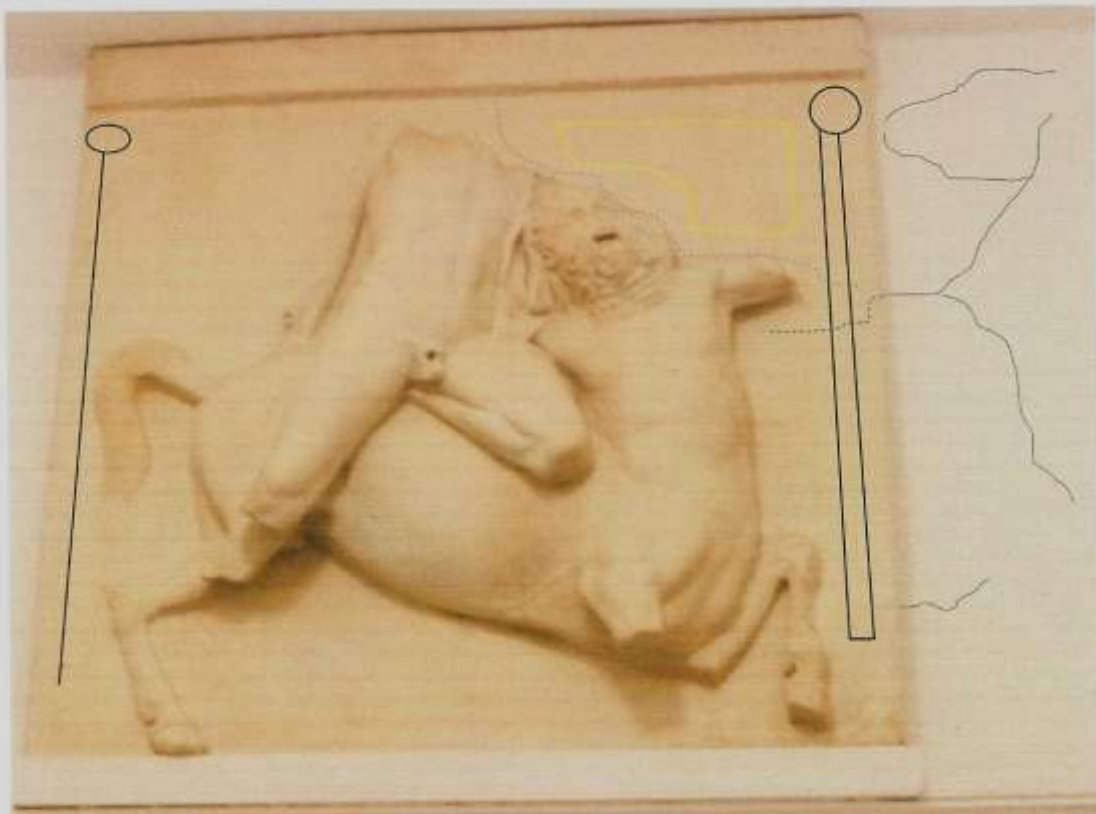
**Plate No. 1:** Metope, Cast No. 56, South Corridor, above doorway.

The position of fixings is highlighted on the following image. In addition the position of a possible past repair is also indicated along with the indicated position of crack paths, or past repaired crack paths, which were observed in the infrared. The indicated positions of cracks in the plaster, to the right of the cast, are also shown, for reference.

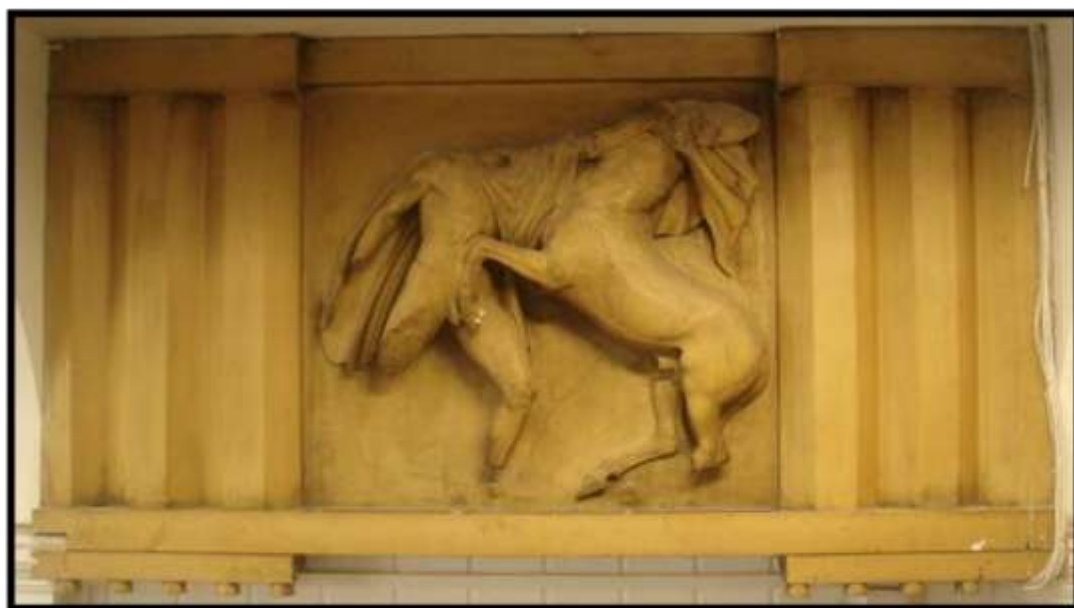
*Panel before conservation*

**STRUCTURAL STABILITY:** Good, but crack at dexter side of the cast by joint with wooden triglyphs; cracks at lower corners of the triglyphs.

**CHIPS AND LOSS:** Areas of loss associated with cracks; small chips on male figure.

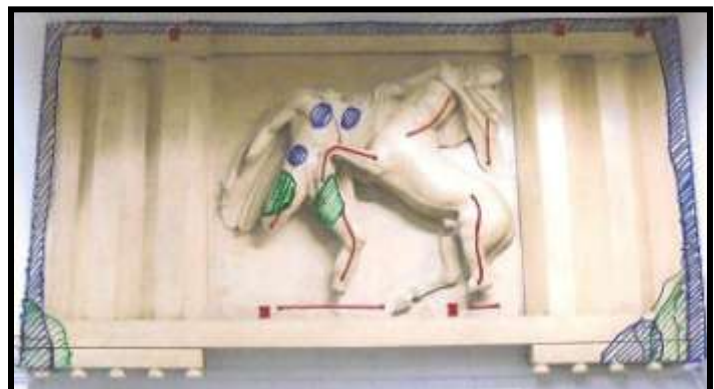
**Cracks**

**Chips, abrasions, missing surfaces**

**Ferrous items under plaster**

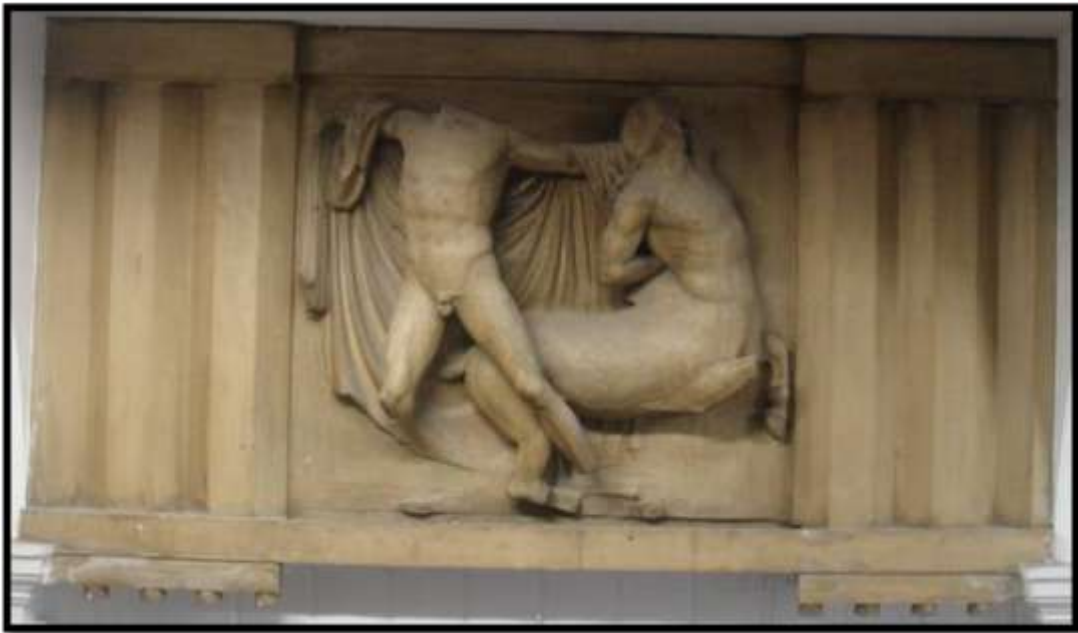
*Panel before conservation*

**STRUCTURAL STABILITY:** Good, but crack at sinister side of the cast by joint with wooden triglyphs; cracks in bottom corners of the triglyphs and on lower and upper parts on both sides.

**CHIPS AND LOSS:** Areas of loss associated with cracks.

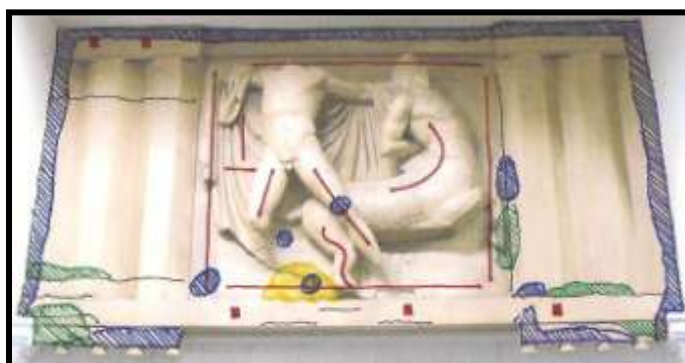
**Cracks**

**Chips, abrasions, missing surfaces**

**Ferrous items under plaster**

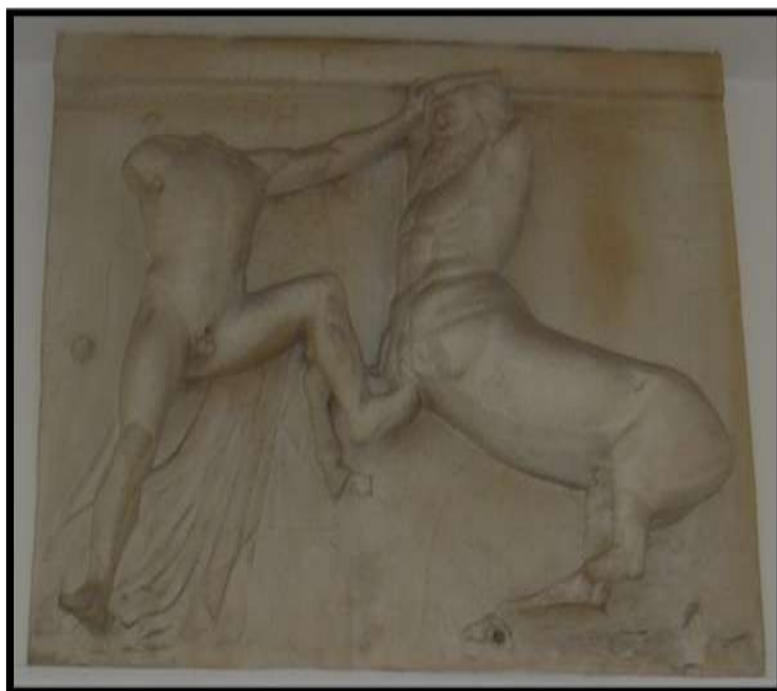
*Panel before conservation*

**STRUCTURAL STABILITY:** Good, but crack at corners and edges of the cast.

**CHIPS AND LOSS:** Areas of loss and loose fragments associated with cracks.

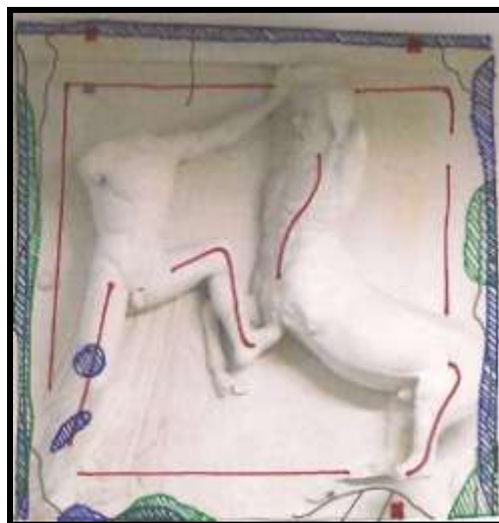
#### Cracks

Chips, abrasions, missing surfaces

Ferrous item under plaster

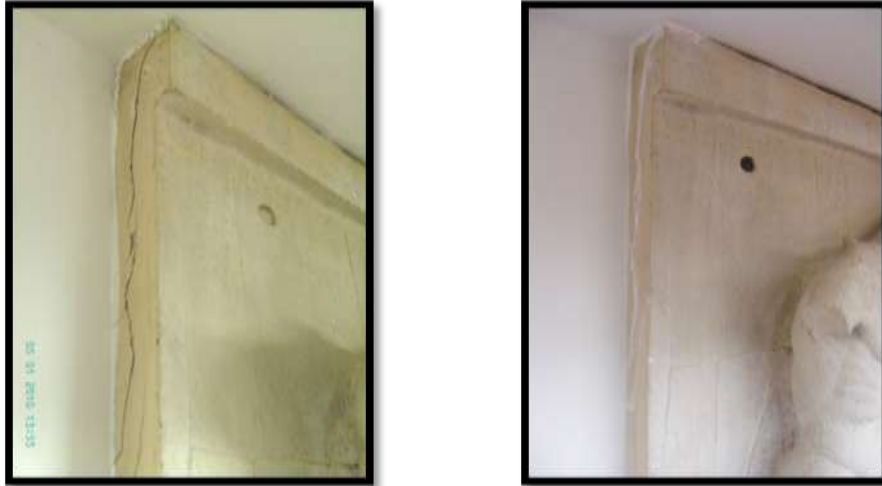
*Details of fills repairs*

- All areas of raw plaster were given an application of 10% Paraloid B72 in acetone to provide an isolating layer between the original plaster and the repairs.
- All loose fragments were reattached with HMG adhesive.
- Areas of loss, open joints and cracks were filled with white micro-balloons mixed with 12% Paraloid B72 in acetone. Larger areas of loss and around the screws were filled with an inert filler to provide extra strength.

- All the fills were then toned out with acrylics, mixed with matting agent, to match the surrounding patina.

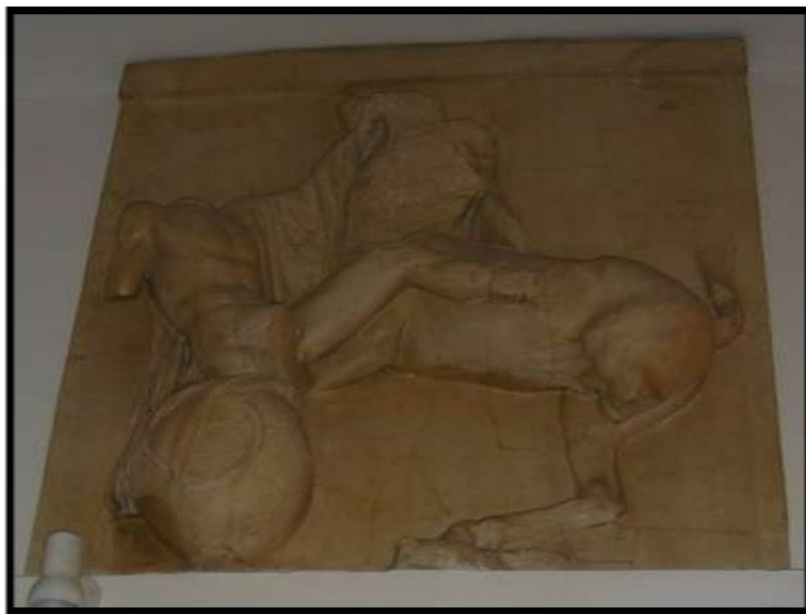
*Panel before conservation*

**STRUCTURAL STABILITY:** Good, some small cracks by fixings and on edges.

**CHIPS AND LOSS:** Areas of loss associated with cracks and at arm of centaur.

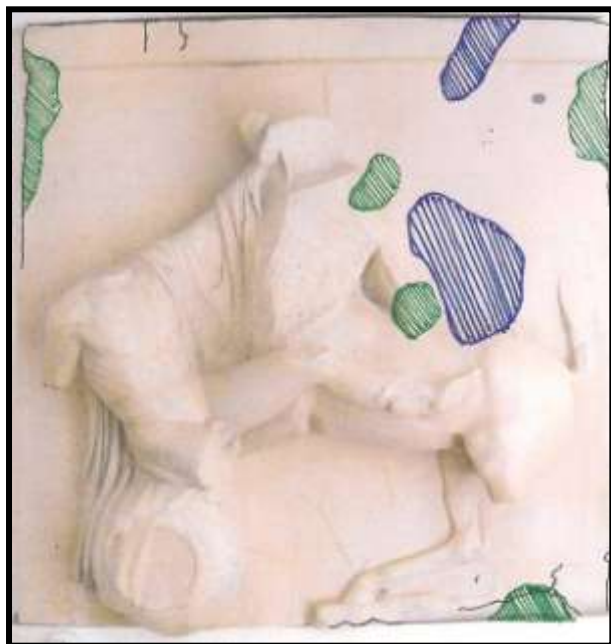
**Cracks**

**Chips, abrasions, missing surfaces**

**Paint splashes**

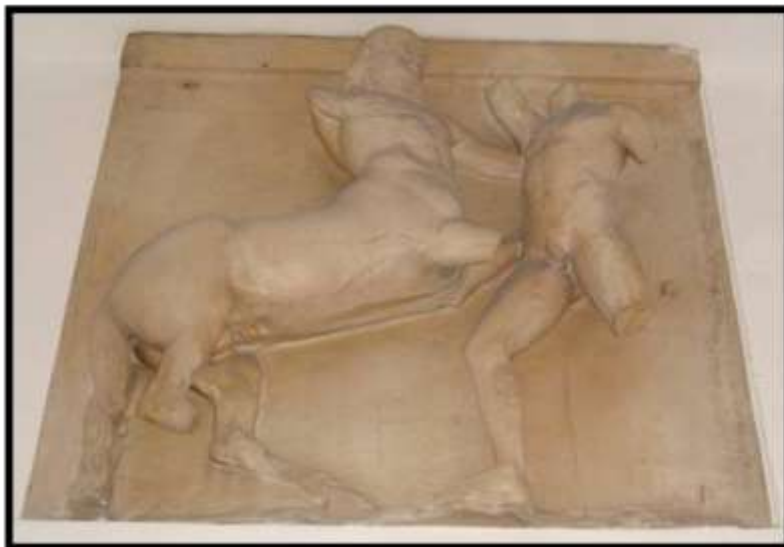
*Panel before conservation*

**STRUCTURAL STABILITY:** Good; several small cracks by the fixings at the lower dexter corner of the cast.

**CHIPS AND LOSS:** Areas of loss associated with cracks; small chip in top dexter section of the cast.

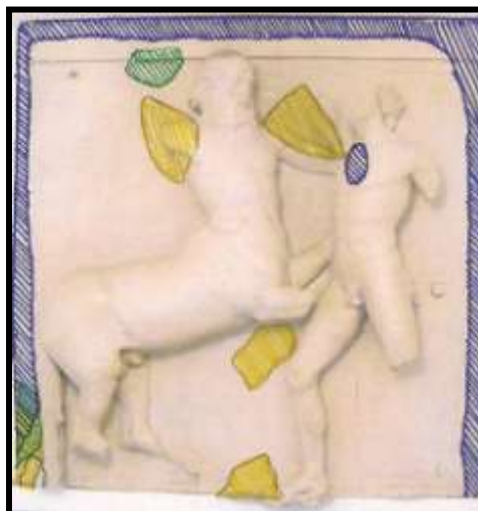
**Cracks**

**Chips, abrasions, missing surfaces**

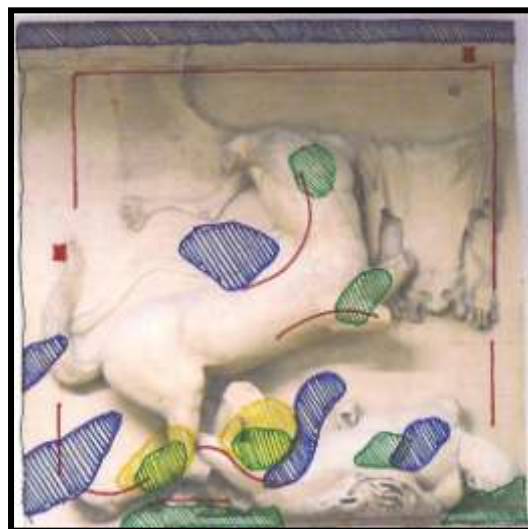
**Cracks**

**Ferrous items under plaster**

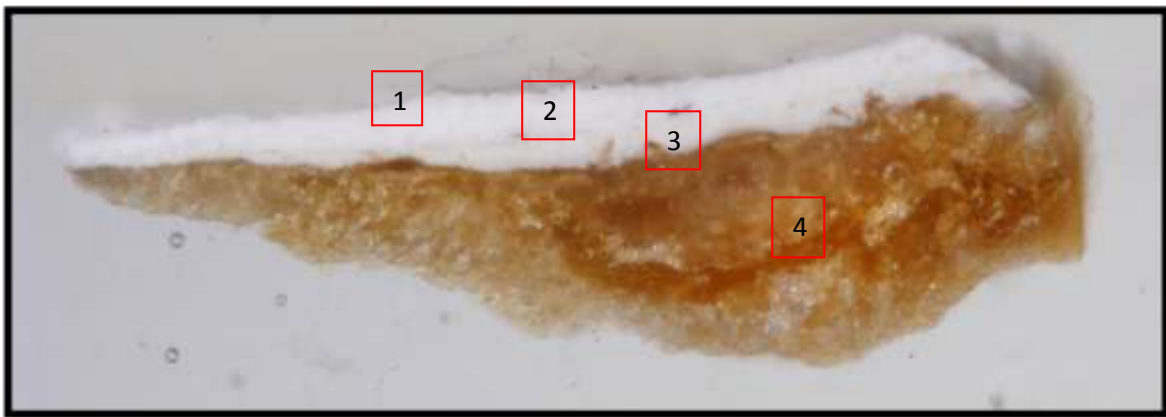
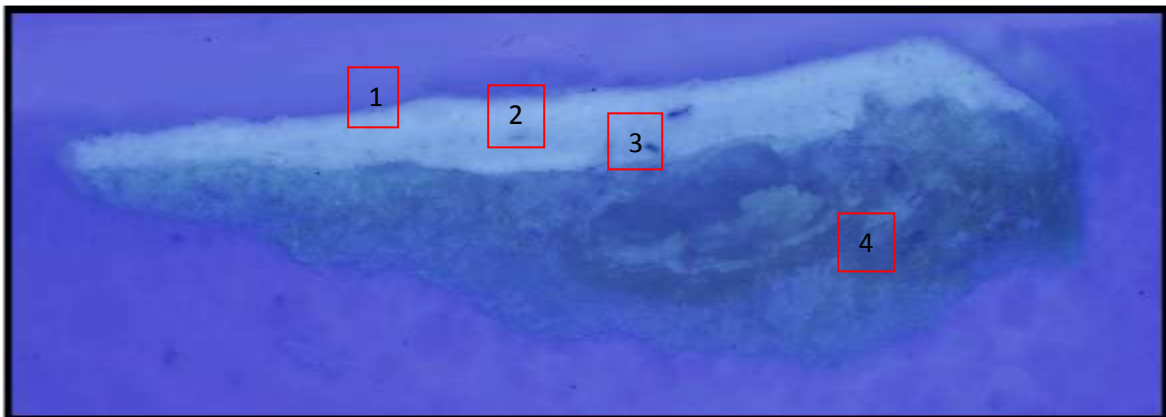
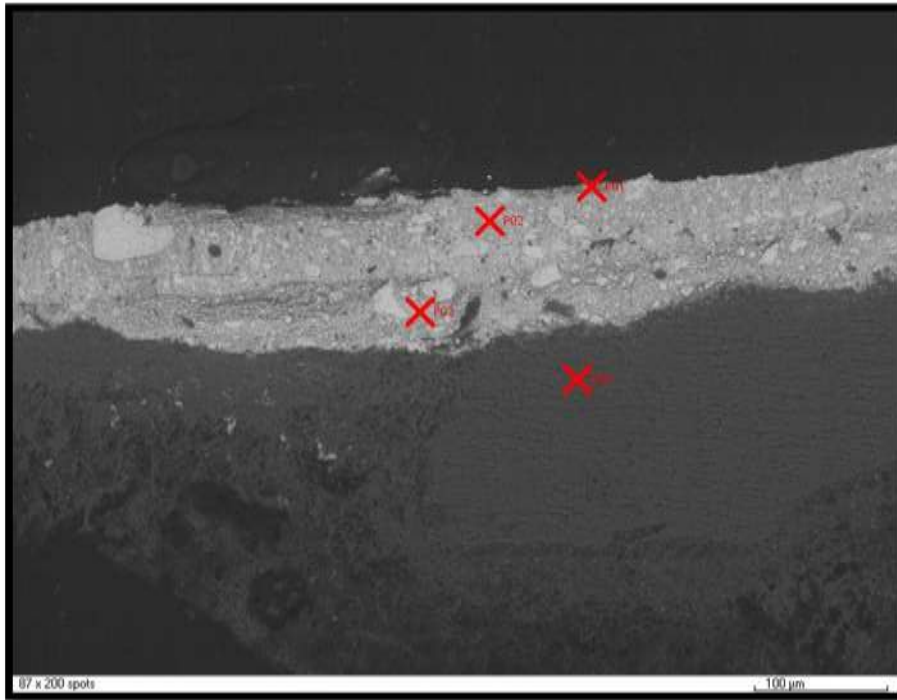
#### Sample from Metope P019 – Cross-section

The sample from Metope P019 seems to contain a thick plaster layer containing white particles and an orange / brown substance which may be discoloured glue size or oil or resin. There are what appear to be two bright white paint layers at the top of the section, as photographed, and also towards the bottom is a large brown inclusion. The brown inclusion appeared black under UV, showing no fluorescence, unusual for old glue, or old oil or resin and may be due to an iron oxide pigment. Both the bright white paint layers fluoresced blue-white indicating that they may contain lead white. The electron micrograph indicated a thin incomplete layer on top of the two thicker white layers EDX analysis at spot 1 in this thin, uppermost upper paint layer gave a spectrum containing mainly lead (spectrum 4), indicating the presence of mostly lead white, with a trace of silicon and calcium indicating the presence of some silica, eg. quartz and chalk. Analysis of the two main layers at spots 2 and 3 gave similar spectra, indicating that these paint layers consist mainly of lead white with some chalk and silica extenders. The plaster was analysed at spot 4 (Figure 9) and gave a spectrum similar to that of spectrum 3 above, containing mainly calcium and sulphur indicating that the plaster is gypsum.

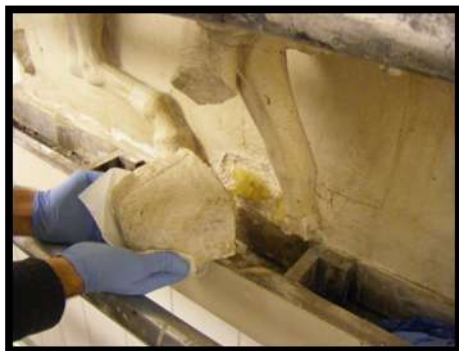
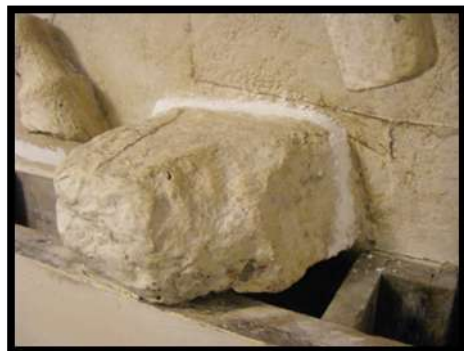
*Details of the repair works*

- The areas of flaking paint were consolidated with an application of 5% Primal B60A in de-ionised water.
- All areas of raw plaster were given an application of 10% Paraloid B72 in acetone to provide an isolating layer between the original plaster and the repairs.
- The loose fragment by the bottom edge of the cast was reattached using Perspex dowels and polyester resin.

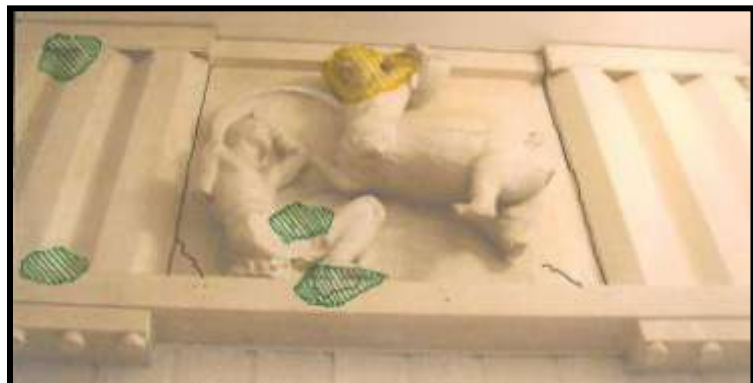
**Cracks**

**Chips, abrasions, missing surfaces**
