Urbanism + Landscape E-proceedings 8 • July 2017

**CHINA'S VANISHING SOCIALIST HOUSING HERITAGE:
The Public Housing Complex of the Transport Fleet for
Materials Outside Hunan Province, Changsha: Historical
Context and Contemporary Conservation issues**

Workshop Report June 25 - July 1, 2017
DOCOMOMO International / Hunan University
in collaboration with the
Scottish Centre for Conservation Studies
University of Edinburgh

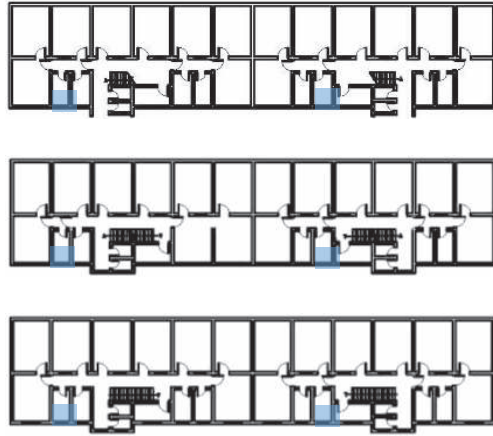
外运宿舍厕所布置
Arrangement of toilets in the apartment of foreign trade transportation fleet
(draw by author)
来源：小组自绘

- 分析
由于时代特性，建筑内每层设置多处厕所，但由于厕所布置于建筑物的入口处，建筑内有一定异味。同时，由于该公共厕所缺少淋浴部分，并不适应于现代生活。
- 结论
厕所需要重新安排布置。
- Analysis
The building smells as the toilets are arranged at the entrance to this building. It is not very convenient for modern life for people can't take a shower inside.
- Conclusion
Bathrooms needed to be rearranged.

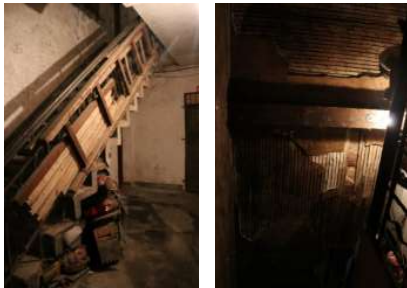
走廊局部照片
Photos of some parts of corridor in the house
(photo by author)
来源：小组自摄

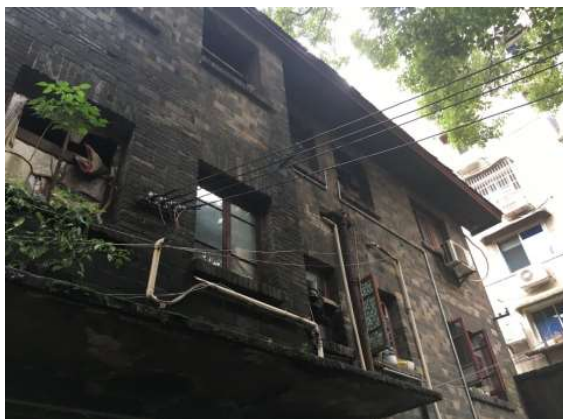
外运宿舍外立面
Façade of the apartment of foreign trade transportation fleet
(photo by author)
来源：小组自摄

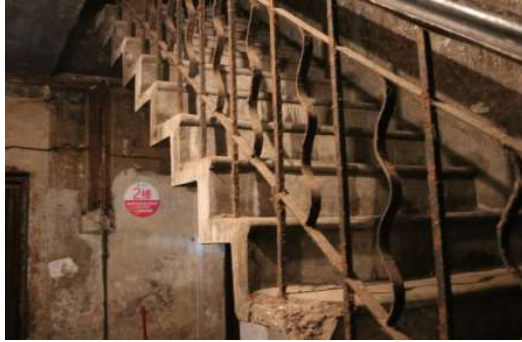
外运宿舍楼梯
Stair in the apartment of foreign trade transportation fleet
(photo by author)
来源：小组自摄

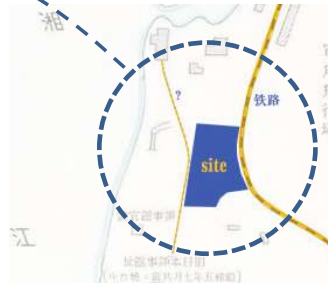
场地周围只有两条道路，东侧是铁路，西侧道路记录不明，估计是人车共用的小马路
Initially there are only two roads around the site--the east is the railway, the west is a path.

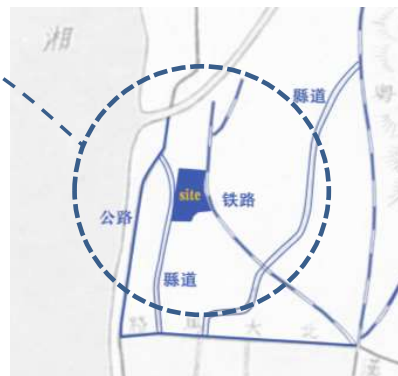
交通发达，道路增多，出现县道、公路、铁路三个等级的道路系统
Traffic has developed, new road appeared.

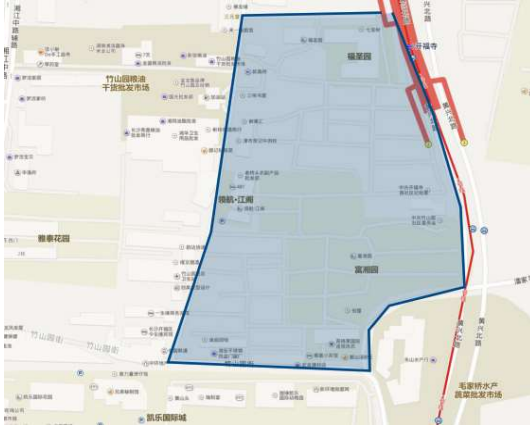
2016.沿黄兴北路建地铁1号线
in 2016, Metro Line 1 was built

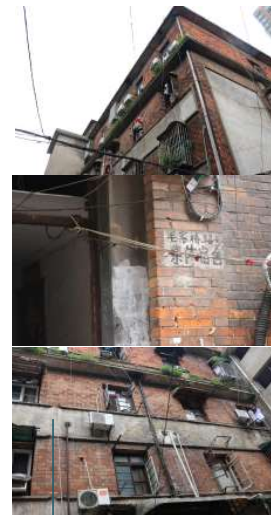
70s加建一层的痕迹
70s to build a layer of traces

变成集体宿舍后的门牌
List of collective dorms

文革遗迹, 毛泽东语录
Cultural Revolution relics, Mao Zedong's quotations
“战无不胜的毛泽东思想万岁”
“毛泽东的无产阶级革命路线胜利万岁”

70s流行的外廊式住宅, 现因居住需求改变, 廊道变成每家每户的阳台
70s popular corridor-style residential, is due to changes in living need, corridors into each household balcony

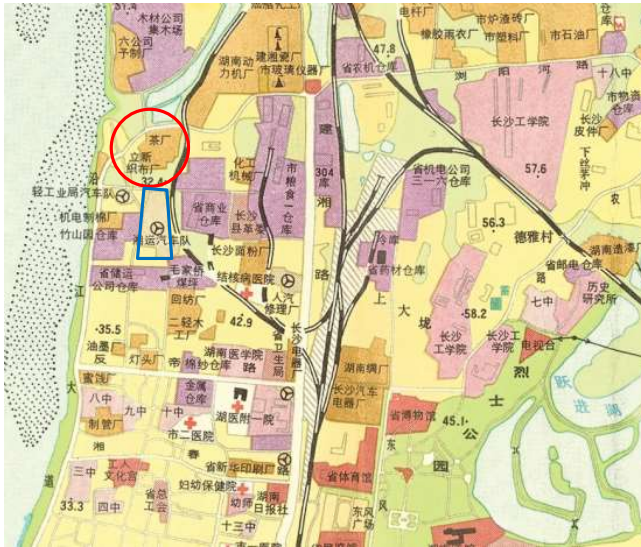
年代: 1979
 出处: 长沙市现况图
 出品方: 未知

因为工业、运输业依靠铁路而生，因此这一块出现大量厂区 and 运输企业。当时有湘运，储运等运输队，还有茶厂、机电制棉厂、回纺厂、面粉厂等工厂。这张地图反应了基地周边的产业分布情况。

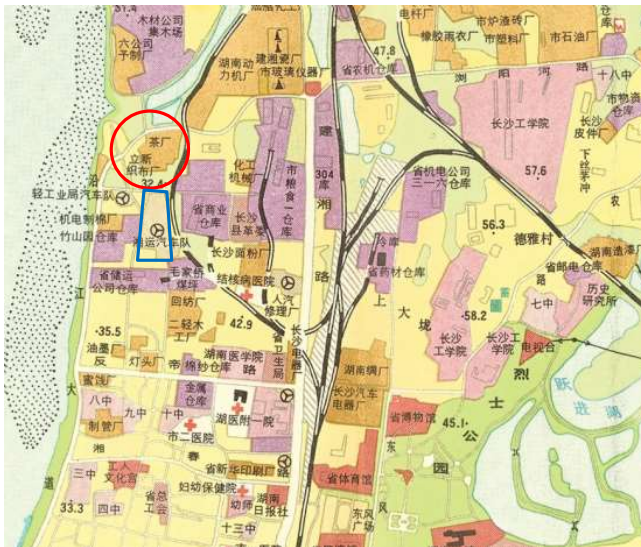
年代: 1979
 出处: 长沙市现况图
 出品方: 未知

Because industry and transportation depend on railroads, this one has a large number of factories and transportation enterprises. At that time, there were xiangyun, storage and transportation teams, tea factory, electromechanical cotton factory, back spinning plant, flour mill and other factories. This map reflects the distribution of the industry around the base.

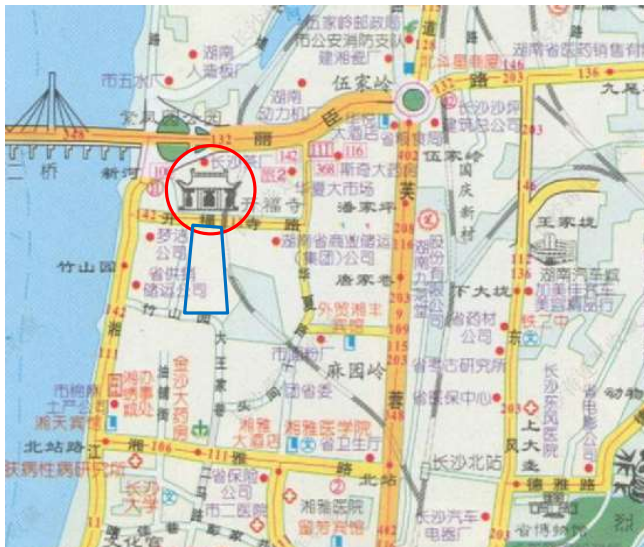
年代：2002
 出处：长沙交通旅游地图
 出品方：未知

随着经济关系的解体，国营企业倒闭，基地地区只剩下省供销储运公司、省商业储运公司、市面粉厂三个厂区。同时出现许多市场和宾馆，新型的商业体开始逐渐代替原有的工业体系。

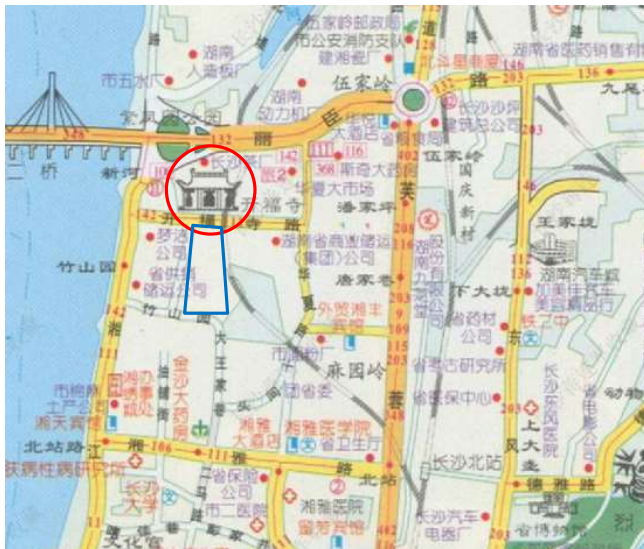
年代：2002
出处：长沙交通旅游地图
出品方：未知

With the disintegration of economic relations, the state-owned enterprises have failed, and the base area is only left to the three factories of the provincial supply and marketing company, the provincial commercial storage and transportation company, and the city flour mill. At the same time, there are many markets and guesthouses, and the new commercial body gradually replaced the original industrial system.

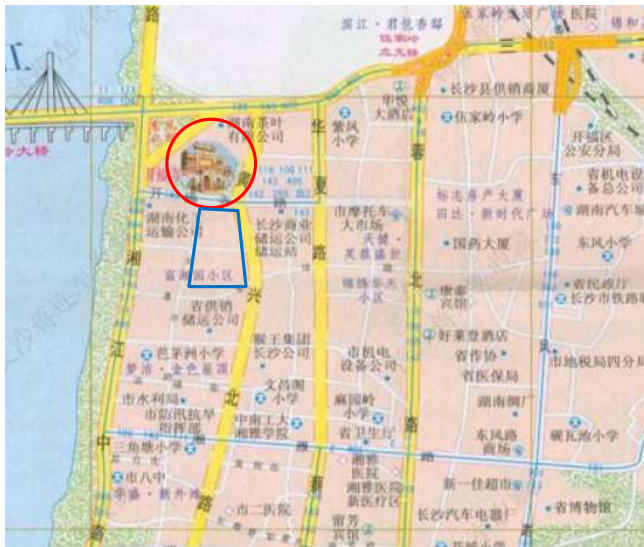
年代：2008
出处：长沙交通旅游图
出品方：未知

原有铁路被完全拆除，开福寺路、潘家坪路被拉通，逐渐完善的交通体系开始肢解原生完整的厂区路网。The original railway was completely demolished, and the kaifu temple road and panjiaping road were pulled through, and the gradual and perfect transportation system began to dismember the original intact plant network.

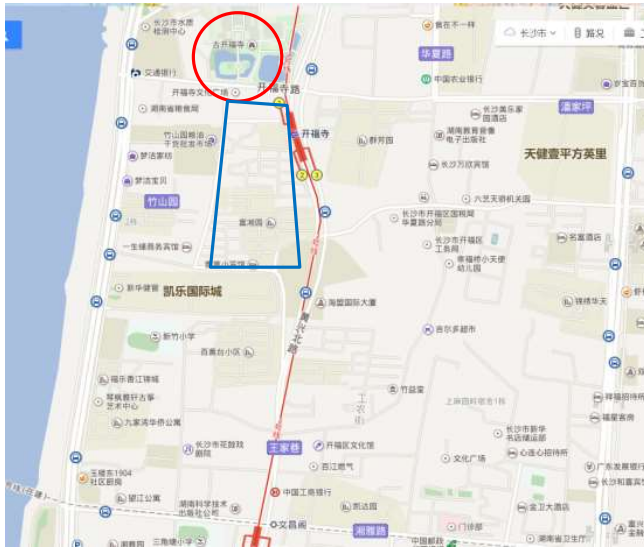
年代：2017
出处：百度地图
出品方：百度

基地大多数厂区消失或仅留局部遗存，高档的商住楼和新型的商业关系完全取代原有工业环境。

Most of the plant's factories disappear or remain only partially, and high-end commercial buildings and new commercial relationships have completely replaced the original industrial environment.

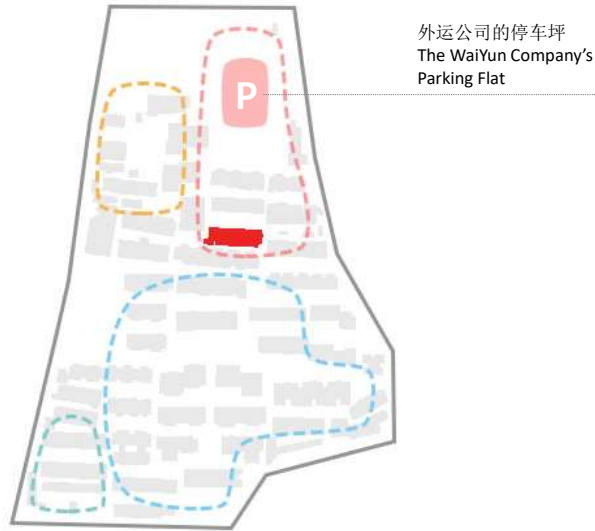
原始厂址的大体分布
The General Distribution Of The Original Plants

- - - 外运公司
WaiYun Company
- - - 储运公司
ChuYun Company
- - - 湘运公司
XiangYun Company
- - - 茶厂
ChaChang Company

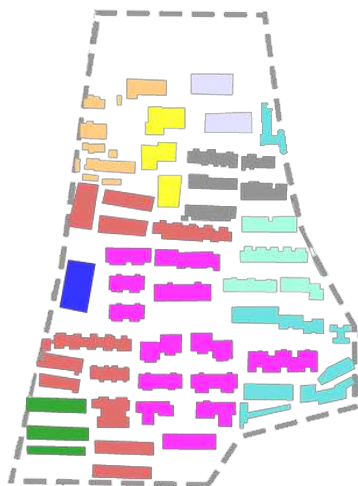
产权分区
Property Partition(now)

- 福圣园 Fu Sheng Commercial housing
- 外运公司Wai Yun Company
- 拆迁安置房Relocate households
- 富湘园Fuxiang Commercial housing
- 湘运公司Xiang Yun Company
- 茶厂 Tea factory
- 领航江阁Ling Hang Commercial housing
- 石油公司Oil company
- 泓福园Hong Fu Commercial housing
- 其他others

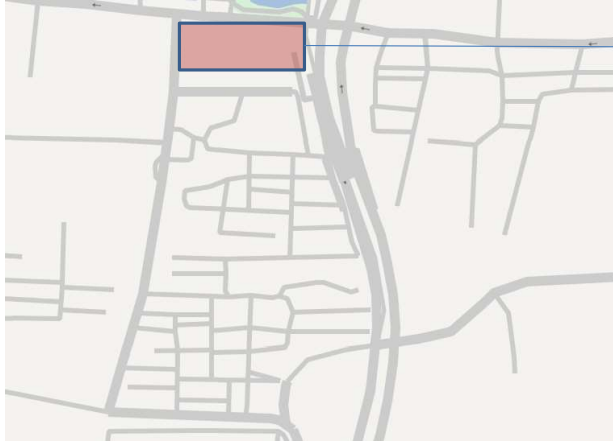
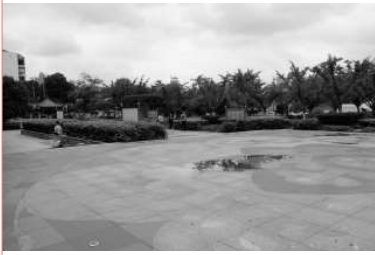
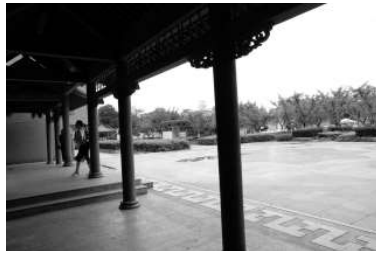
公共活动场所
Public places of activity

面向开福寺的
公共活动广场
public square
facing the Kaifu
Temple

缺少公共活动的地方
There is a lack of public
area for activity.

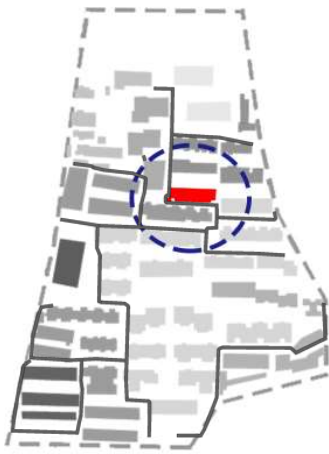
Peripheral public space analysis

- 1. 建筑周围的空间被加建的小房子和围墙阻隔变得狭小。
- 2. 周围的公共活动空间少。

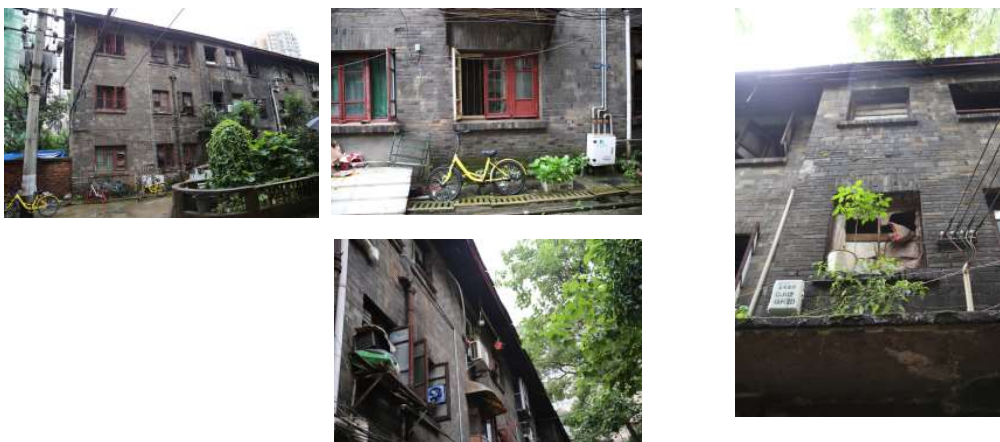
4. Characteristic building facade 特色建筑立面

Building facade through the windows and outdoor interaction, life through the windows show, very life and sense of the scene.

建筑立面通过窗户与户外进行互动，生活通过窗户展示出来，很有生活气息和场景感。

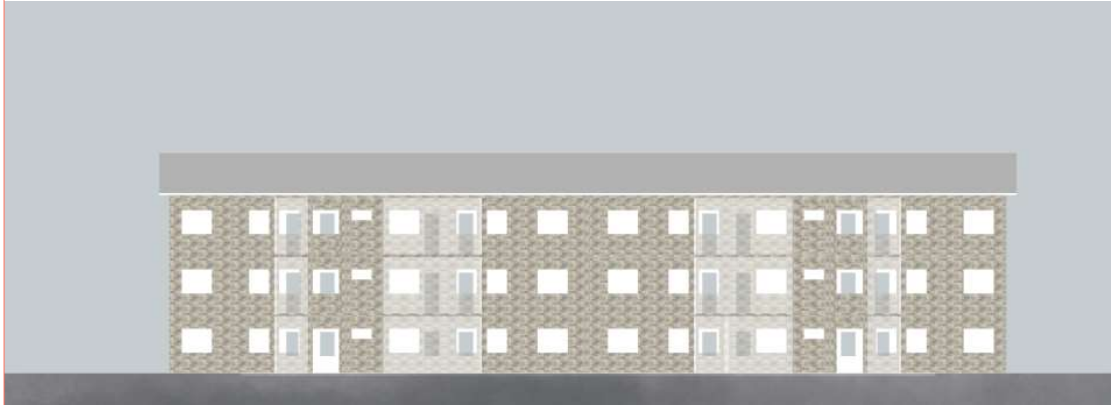
The picture of transformation

为了保留窗户的元素和立面的纹理，我们采用玻璃砖让光通过的同时，与周围取得统一。

In order to preserve the elements of the window and the facade of the texture, we use the glass tiles to let the light pass through at the same time, with the surrounding to achieve unity.

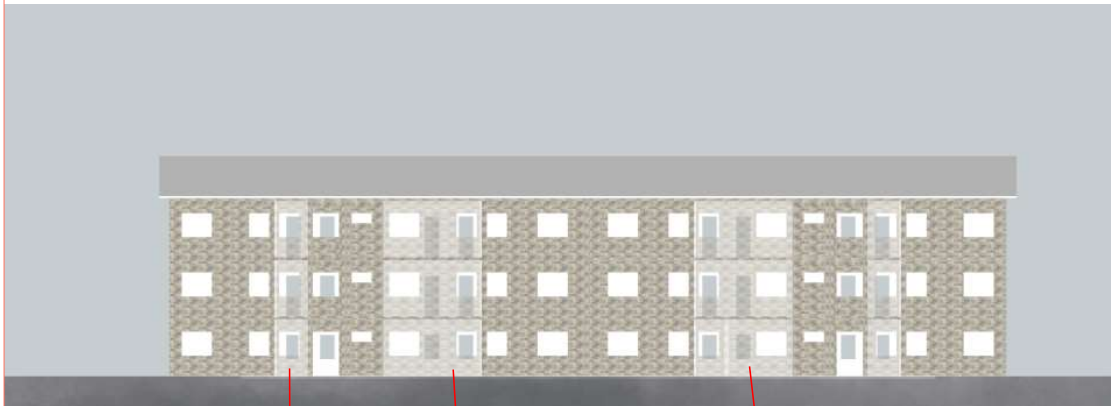
The picture of transformation

透明的表面使得建筑内部扩大的公共空间得以展示出来，也作为一种集体生活的展示。

The transparent surface allows the expansion of the public space within the building to be displayed, but also as a collective life show.

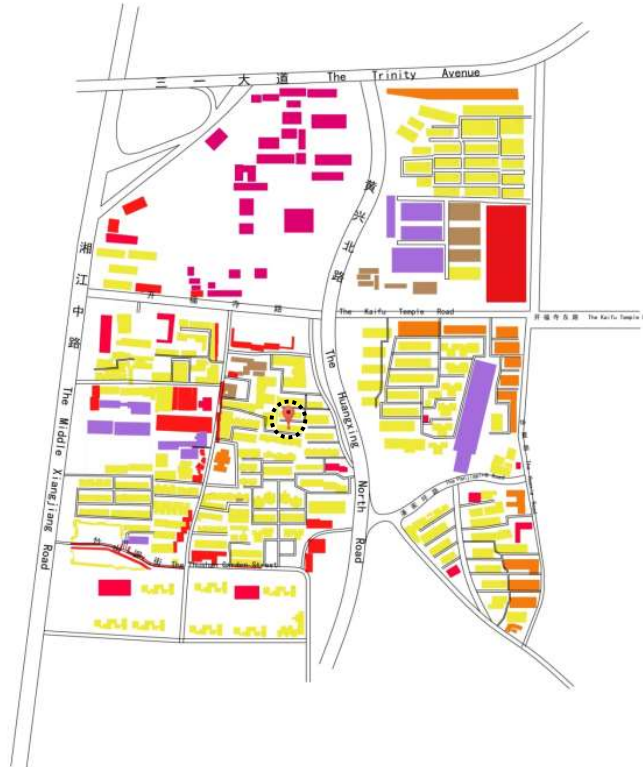
Open space and road analysis

1. 场地内围墙、私搭乱建的小房子众多，因此在地块中多断头小路，造成片区与片区之间通达性很差，以至于每个片区之间的氛围割裂。

1. There are many small houses which is build without permission, so that the connectivity between the different area is very poor, which result in the fragmented atmosphere between each area.

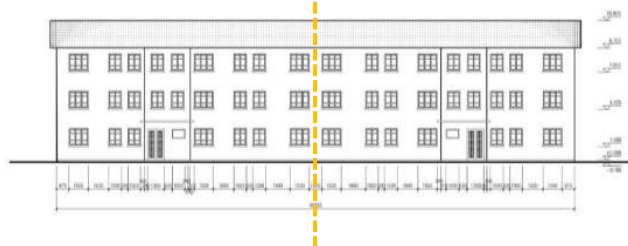
slide 012

- 1.3层，层高2.9M，较低。
- 2.对称布局
- 3.瓦面双坡屋顶（红平瓦）

Three-story building with a low Layer height about 2.9M
Symmetrical layout
A double-slope roof with tile on it.

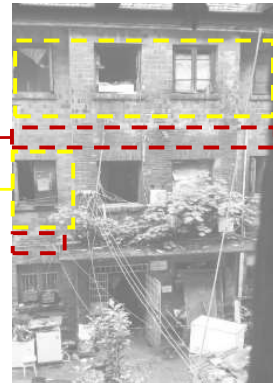
slide 013

——砖砌方式: Building methods of bricks

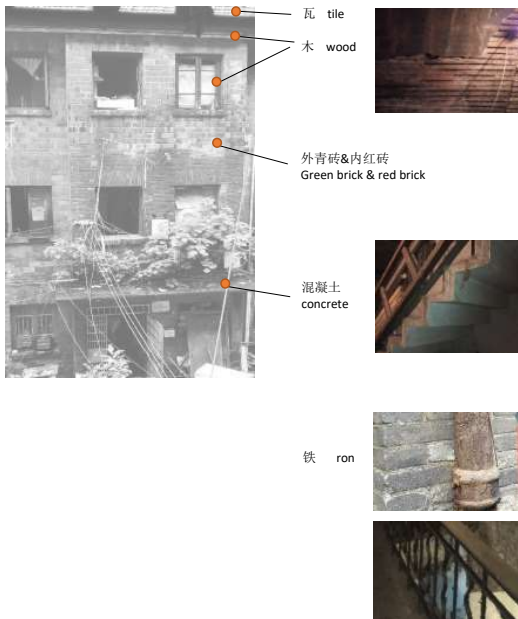
——材料 Material:

——现存问题 problems:

- 1. Damaged roofs and loose ceilings
 - 2. The exhaust fan caused the building surface to be dirty
 - 3. Indoor interior of the natural lack of light, poor ventilation
 - 4. There were two toilets each floor which is not enough and convenient to use.
 - 5. Private occupation of public space is serious, and even somebody expand the building.
- 1. 屋顶损坏天花板松动
 - 2. 外露的排风扇导致建筑表面显得很脏乱
 - 3. 室内空间的自然采光不足，通风不畅
 - 4. 厕所的数量少，不方便使用
 - 5. 私人占用公共空间严重，甚至对建筑进行了扩容改造

Adjust the internal structure of the survey building, repair the damaged areas, and clean the inside and outside of the building

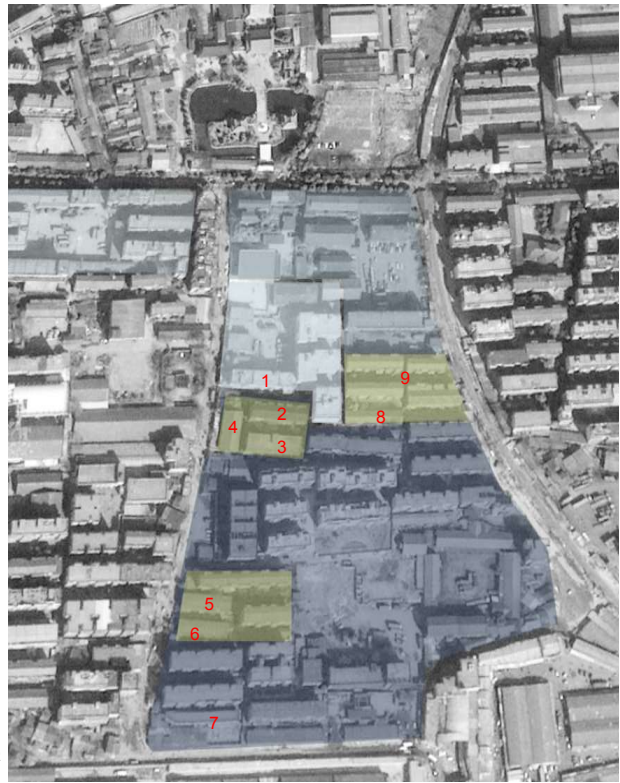
Our case building was built in 1961. According to Xiang Yun staff, in the era when people advocate 'red', the red bricks that the government give to this building is not enough, so the part of the building use green brick.

我们调研的原外运车队宿舍楼建于1961年。据湘运员工说，在崇尚红色的年代，当时政府给这栋楼批的红砖不够，所以建筑部分使用青砖（真实性待考证）。建筑现属于社区。

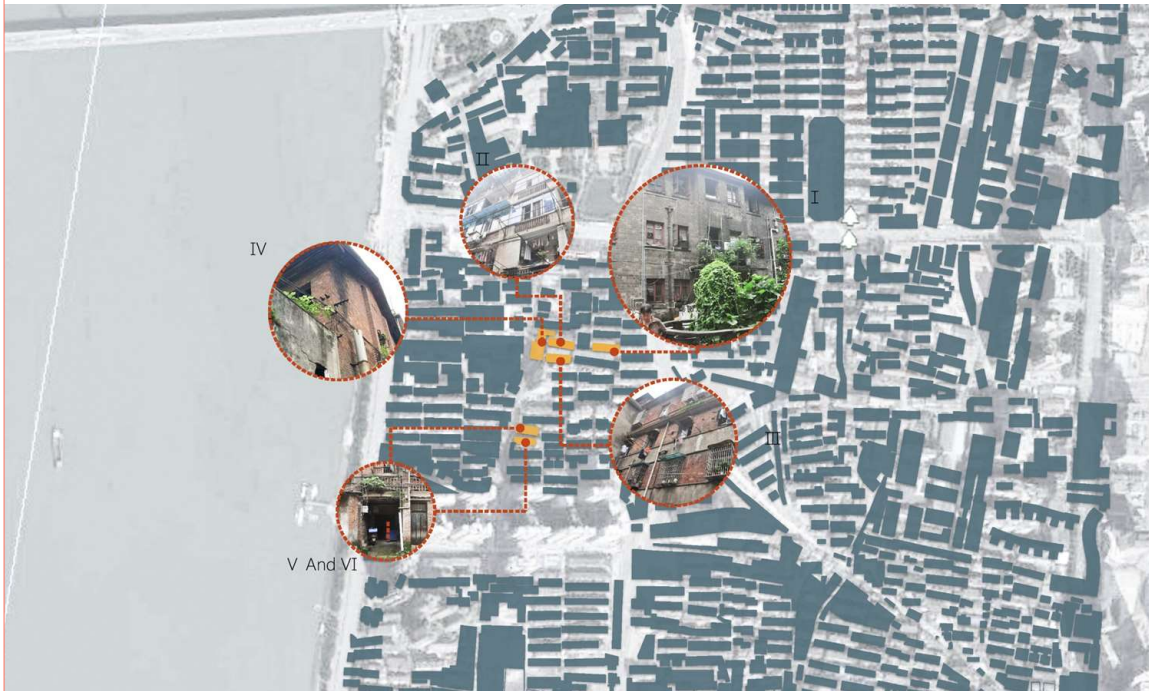
The only five old buildings of that time with certain historical significance, reflecting the conditions of Dormitory life.
场地中仅剩的5栋筒子楼，具有一定历史意义，反映当时的宿舍生活。

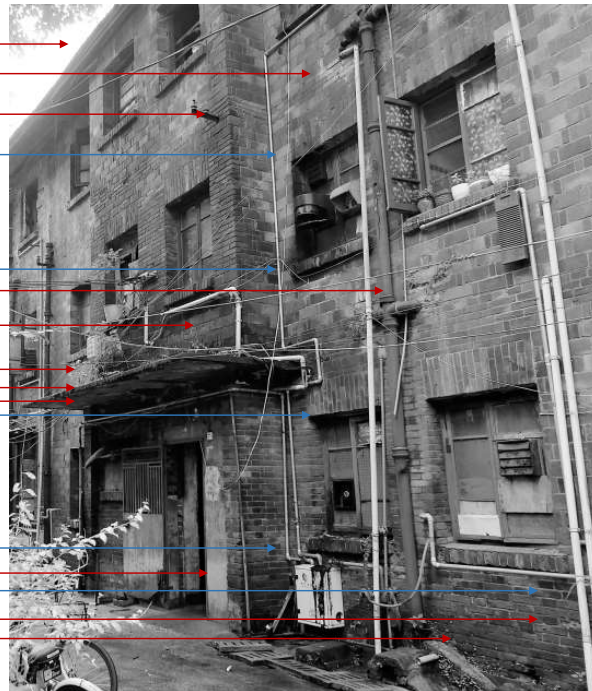
Architecture Decay
建筑问题（室外）

The building itself is solid and has no serious structural problems. But due to the daily use of the process of improper and the construction of the disrepair, there are local existence of the damage on the building.

建筑自身结构牢固，没有严重的结构问题。但由于日常使用过程中的不当和建筑的年久失修，有局部存在建筑上的残损。

Due to human activities caused by some of the building problems
由于人类活动所造成的一些建筑问题

- Damaged 破损
- Grease 油渍
- Water stains 水渍
- Grease 油渍
- Grease 油渍
- Plant 植物
- Water stains 水渍
- Plant 植物
- Moss 青苔
- Missing 缺失
- Grease 油渍
- Grease 油渍
- Water stains 水渍
- Wear 磨损
- Crisp alkali 酥碱
- Moss 青苔

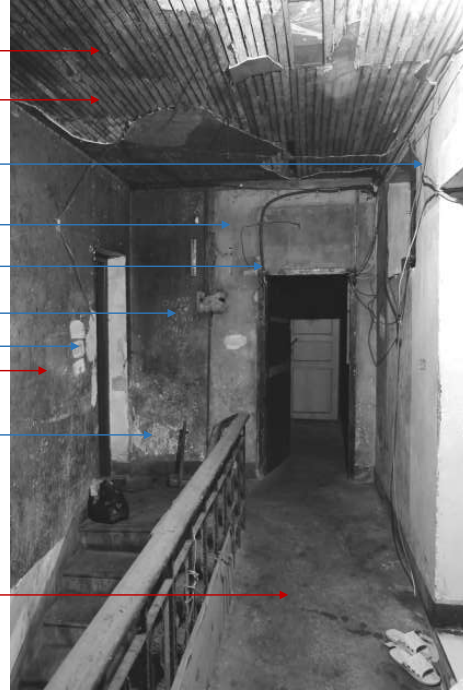
Architecture Decay
建筑问题 (室内)

The space of the building and the late construction of the household, which, to a certain extent, caused the chaos in the interior space and increased the risk of fire.

Due to human activities caused by some of the building problems
由于人类活动所造成的一些建筑问题

- Missing 缺失
- Water stains 水渍
- wire 电线
- Add wall 加建墙体
- wire 电线
- Painted 涂画
- Painted 涂画
- Stains 污渍
- Wear 磨损
- crack 裂缝

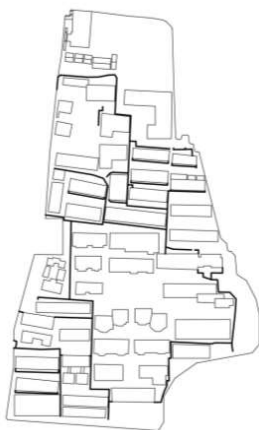
the walls Distribution
围墙分布

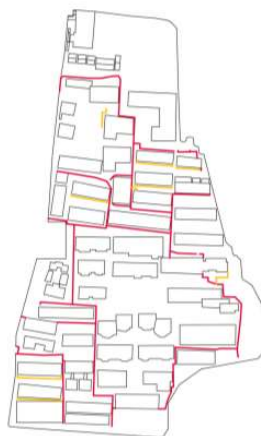
the walls Classification
围墙分类

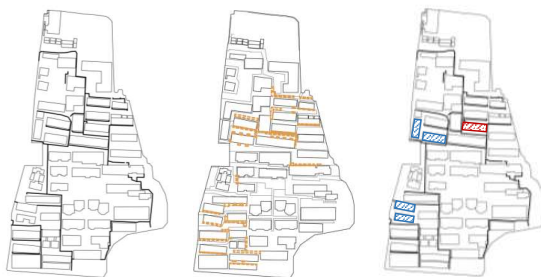
② 场地遗留历史资源 Historical Resources of the Site

围墙 the Walls 加建小屋 the Additional Houses 集体宿舍 the Dormitories

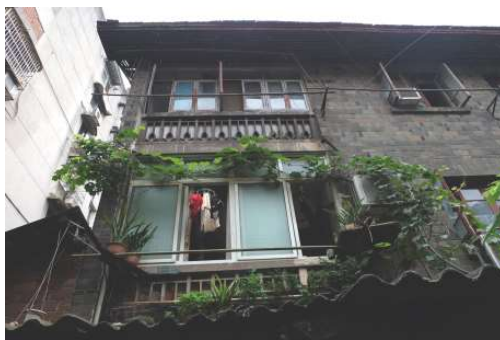
背立面花格栅栏杆
the Flower Grille Railings
in the Back Elevation

项目 Project	评价因素 Element	现状 Current Situation	保护与否 Protection Y/N	保护措施 Protection Measure
文艺价值 Literature and Art Value	装饰 Decoration	整体风格朴素，背立面与侧立面局部有花格栅栏杆与窗洞 Simple Style, Flower Grille Railings and Window Holes in the Back and the Side Elevation	√	1、保持原有风貌与原有做法； 2、保持原有建筑平面布局； 3、对残损处进行科学修复，做好必要的保护工作，防止残损产生； 4、结构避免变化，局部变化处位置及尺寸应严格控制

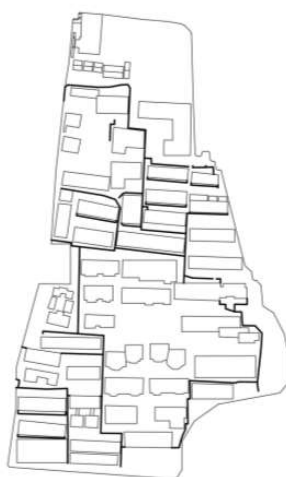
现状围墙
The Status Quo of the Wall

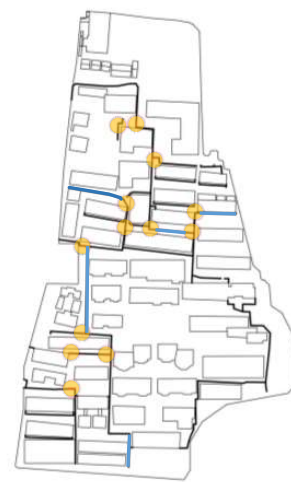
围墙设计示意
Wall Design

● 围墙拆除点 Wall Demolition Point
— 围墙展示区 Exhibition Area on the Wall

项目 Project	评价因素 Element	现状 Current Situation	保护与否 Protection Y/N	保护措施 Protection Measure
历史价值 History Value	建造年代 Date	20世纪50-60年代 1950S-1960S	—	1、保持原有风貌与原有做法； Maintain original style and original practice； 2、保留原始围墙，对于后期小区建设所加建的围墙可适当予以拆除； Retaining the original wall, the wall of the construction of the later residential area can be properly dismantled; 3、对残损处进行科学修复，做好必要的保护工作，防止残损产生； To carry out scientific repair to the damaged area, do the necessary protection work, prevent the damage; 4、结构避免变化，局部变化处位置及尺寸应严格控制。 The structure avoids change, local change location and size should be strictly controlled.
	历史背景 Background	用于分隔运输队，便于管理。但有局部为后期小区加建 Used to separate the transport team for easy management. But there are local areas for the later community	—	
科学价值 Scietific Value	材料 Material	红砖 Red Brick 水泥空心砖 concrete hollow block 石灰砂浆 Lime Mortar	√	
	细部 Detail	墙体双坡墙头，局部开门窗 Wall double slope wall head, partial open doors and Windows	√

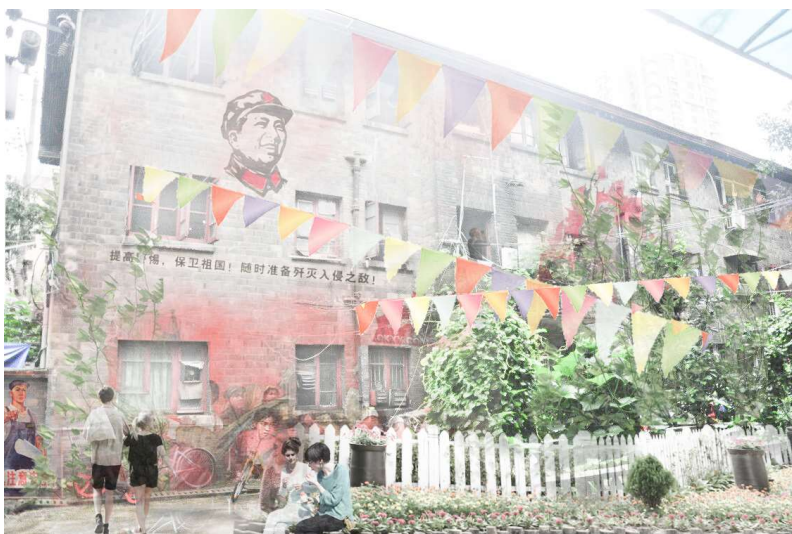
外运队宿舍改造：青旅
 Transformation of dormitory:
 youth brigade
