1. PARTHENON FRIEZE

1. SCULPTURE COURT UPPER GALLERY SOUTH WALL

1.1.1.1 DESCRIPTION OF THE OBJECT

TITLE: Parthenon Frieze, copy of the panel from Parthenon Frieze from Temple of Athena – Parthenon in Acropolis in Athens, Greece, between 443 and 438 B.C.

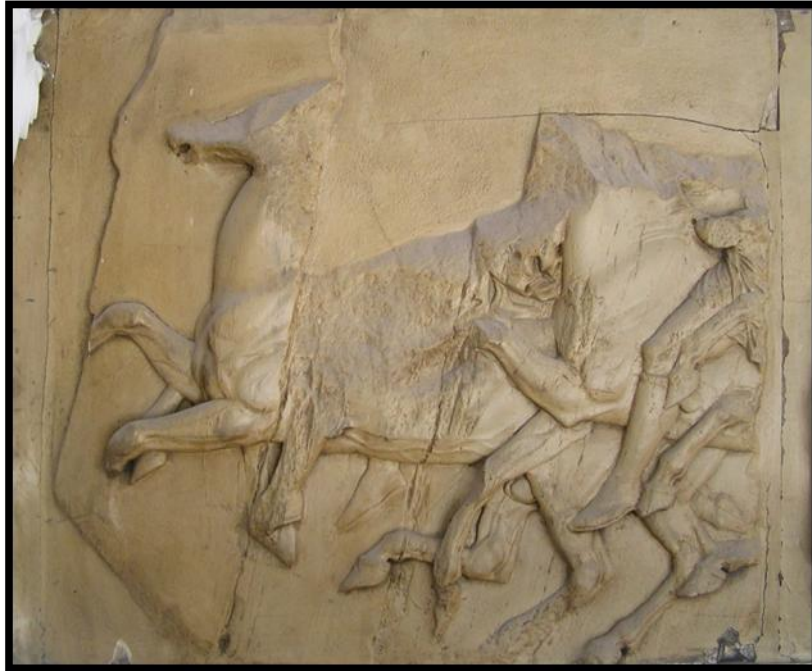
PANEL 1

Panel before conservation

STRUCTURAL STABILITY: Fair. Open cracks running alongside joints on both sides of the panel; large crack running from dexter side of panel towards centre of the cast in its upper part.

SURFACE DUST AND DIRT: Severe, 100% coverage.

VISIBLE PAINT LAYERS/UNSIGHTLY MARKINGS: Layer of cream-yellow paint on surface of the cast; small spots of paint splash mainly on sinister side of panel.

CHIPS AND LOSS: Missing areas associated with the cracks and around screws on both sides of the panel at its bottom edge.

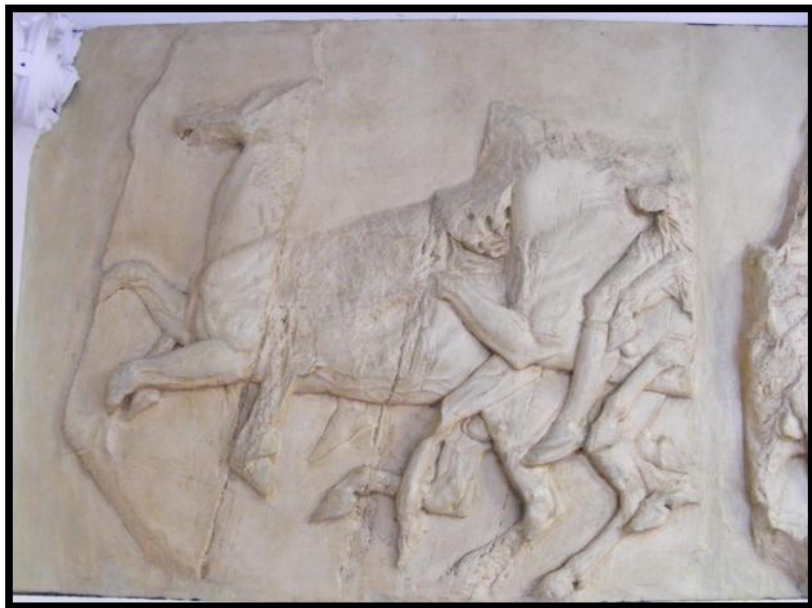
Panel after conservation

- Prior to any conservation treatment, the cast was photographed. This photographic documentation was continued throughout all conservation processes.
- Initially, the cast was dry cleaned with soft brushes and Wishab Sponges with a rubber-nozzled vacuum to pick up the loose dust and dirt.
- Following a variety of wet cleaning spot tests, the surface of the panel was cleaned with 2-5% Vulpex Liquid Soap in de-ionised water, using cotton wool swabs.

- All areas of raw plaster were given an application of 10% Paraloid B72 in acetone to provide an isolating layer between the original plaster and the repairs.
- Exposed metal fixings were treated with 5% Tannic Acid so as to stabilise the corrosion, and covered with a protective layer of 20% Paraloid B72 in acetone.
- Areas of loss, open joints and cracks were filled with white micro-balloons mixed with 12% Paraloid B72 in acetone. Larger areas of loss around the screws were filled with an inert filler to provide extra strength.

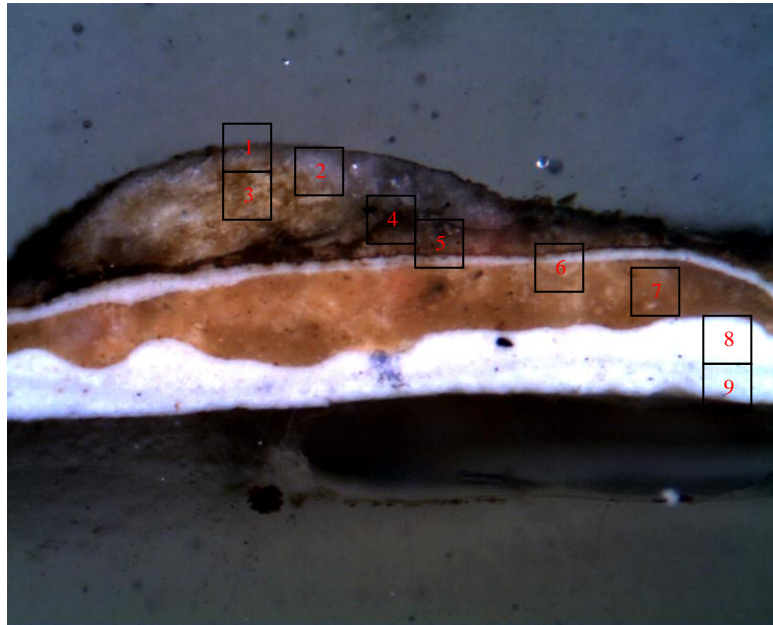
Parthenon Frieze, Upper Gallery South Wall, Panel 1 – Cross section

Figure 1 Photograph of a Cross-section of Sample 1

A cross-section (Figure 1) of the paint revealed, from the top layer downwards, the presence of several layers; a top thin dark grey/black layer which may be just dirt and blackened lead white; a white layer; a pale orange-grey layer containing white; black and orange-red pigments. There then appears to be a gap or more dirt and a further incomplete thin orange layer. Below this is a thin white layer, a further thick brown/orange layer and two bright white layers.

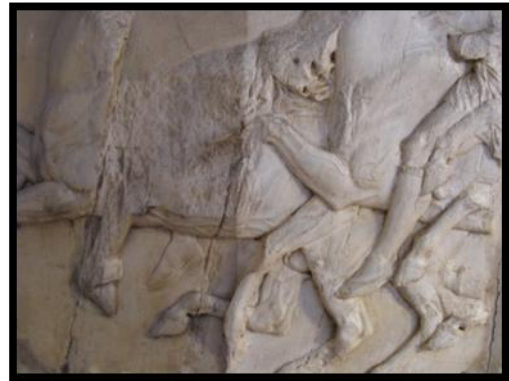
Cast during wet cleaning

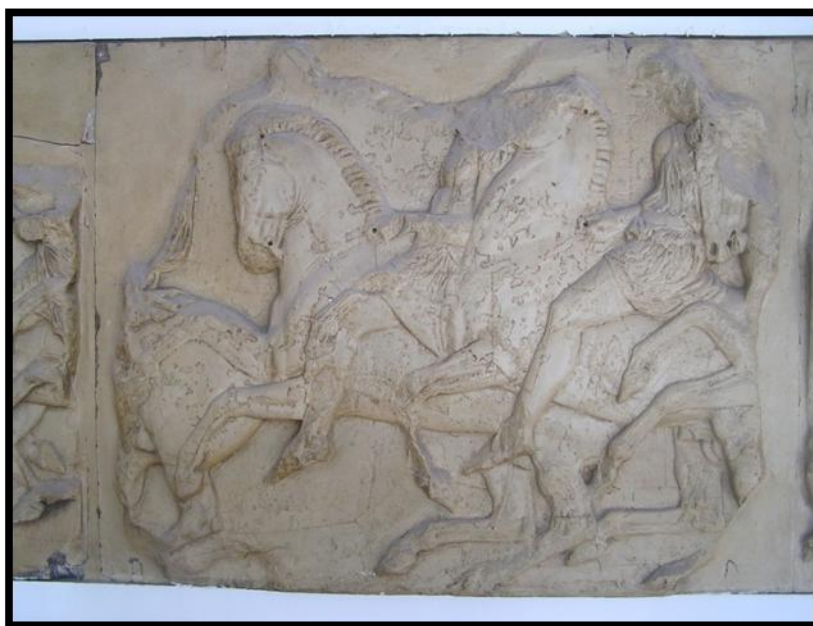
PANEL 2

Panel before conservation

STRUCTURAL STABILITY: Fair. Open cracks running alongside joints on both sides of the panel; small cracks around fixings in corners of the panel

CHIPS AND LOSS: Missing areas associated with the cracks.

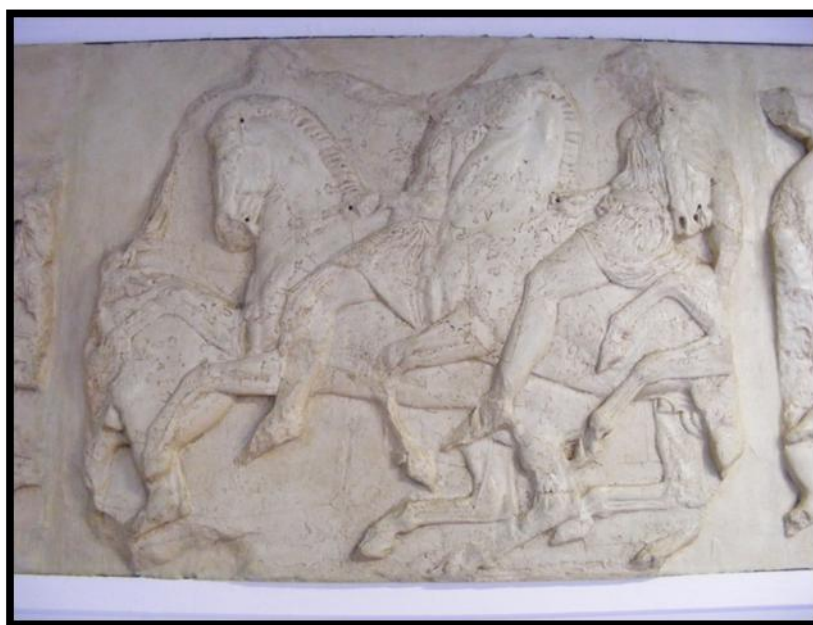
Panel after conservation

- Prior to any conservation treatment the cast was photographed. This photographic documentation was continued throughout all conservation processes.
- Initially, the cast was dry cleaned with soft brushes and Wishab Sponges with a rubber-nozzled vacuum to pick up loose dust and dirt.
- Following wet cleaning spot tests on **Panel 1**, the surface of the cast was cleaned with 2-5% Vulpex Liquid Soap in de-ionised water, using cotton wool swabs.

- All areas of raw plaster were given an application of 10% Paraloid B72 in acetone to provide an isolating layer between the original plaster and the repairs.
- Exposed metal fixings were treated with 5% Tannic Acid so as to stabilise the corrosion, and covered with a protective layer of 20% Paraloid B72 in acetone.
- Areas of loss, open joints and cracks were filled with white micro-balloons mixed with 12% Paraloid B72 in acetone. Larger areas of loss around the screws were filled with inert filler to provide extra strength.

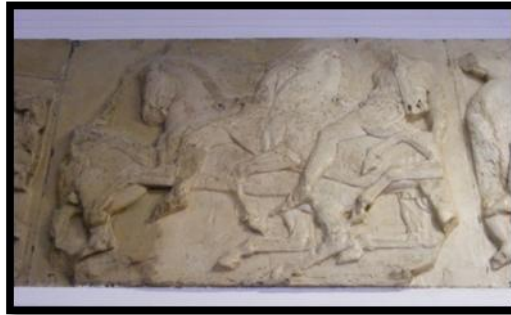
Panel during wet cleaning

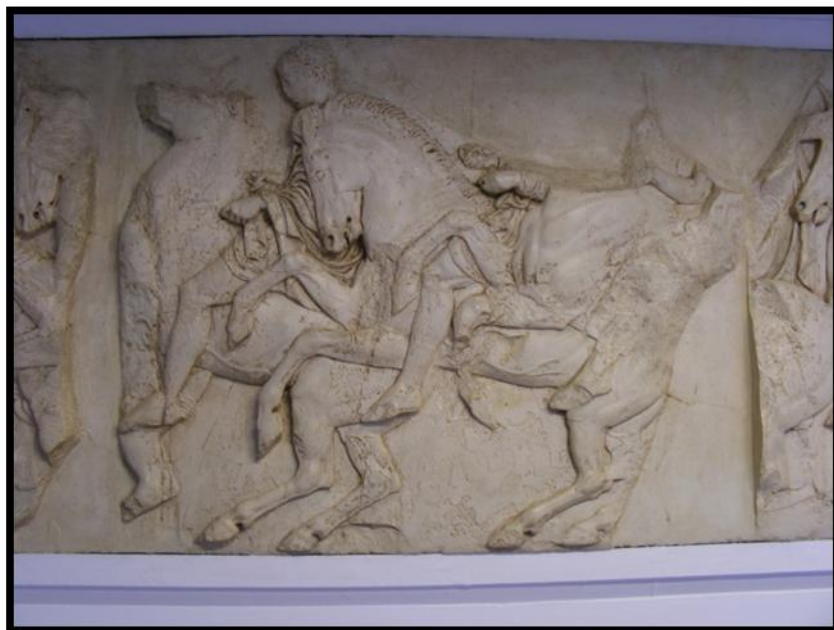
PANEL 3

Panel before conservation

STRUCTURAL STABILITY: Fair. Open cracks running alongside joints on both sides of the panel; small cracks around fixings in corners of the panel.

CHIPS AND LOSS: Missing areas associated with the cracks, the majority of which are alongside the crack on the sinister side of the panel; missing area around metal fixing in dexter bottom corner of the cast.

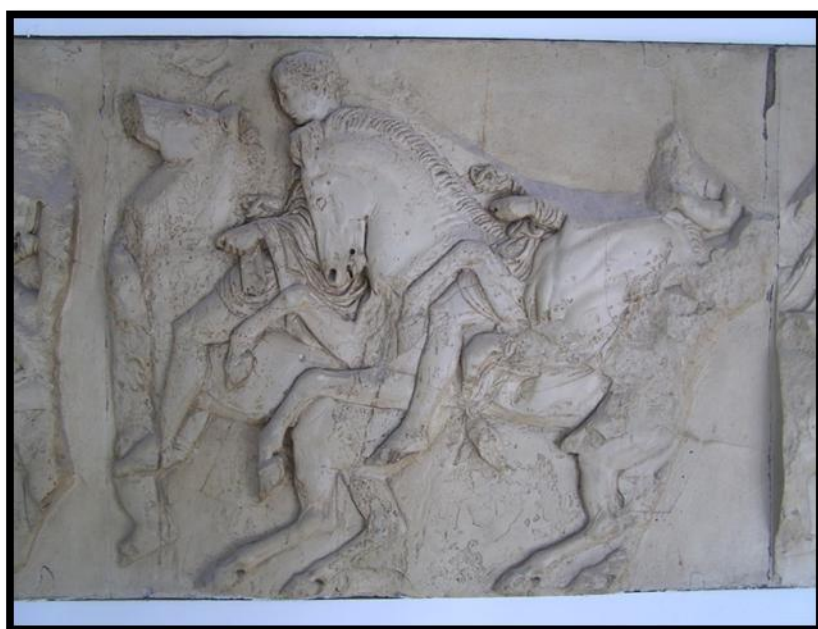
Panel after conservation

- Prior to any conservation treatment the cast was photographed. This photographic documentation was continued throughout all conservation processes.
- Initially, the cast was dry cleaned with soft brushes and Wishab Sponges with a rubber-nozzled vacuum to pick up loose dust and dirt.
- Following wet cleaning spot tests on **Panel 1**, the surface of the cast was cleaned with 2-5% Vulpex Liquid Soap in de-ionised water, using cotton wool swabs.

- Areas of flaking paint were consolidated with 5% Primal B60A in de-ionised water.
- All areas of raw plaster were given an application of 10% Paraloid B72 in acetone to provide an isolating layer between the original plaster and the repairs.
- Exposed metal fixings were treated with 5% Tannic Acid so as to stabilise the corrosion, and covered with a protective layer of 20% Paraloid B72 in acetone.
- Areas of loss, open joints and cracks were filled with white micro-balloons with 12% Paraloid B72 in acetone. Larger areas of loss around the screws were filled with inert filler to provide extra strength.
- All the fills were then toned out with acrylics, mixed with matting agent, to match the surrounding patina.
- Finally, the entire cast was given an application of micro-crystalline wax so as to protect the surface.

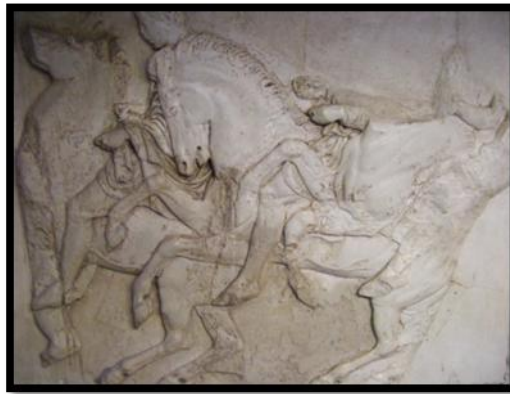
Panel during wet cleaning

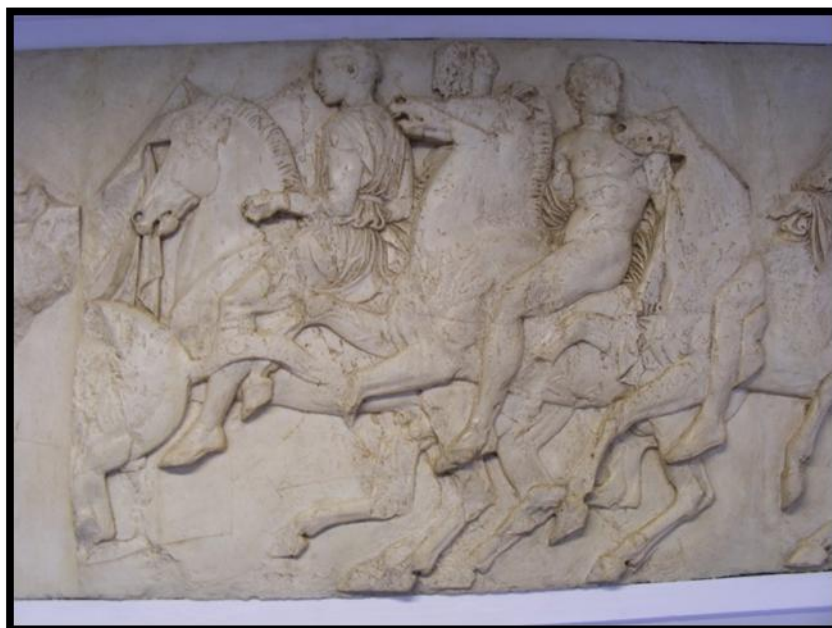
PANEL 4

Panel before conservation

STRUCTURAL STABILITY: Fair. Open cracks running alongside joints on both sides of the panel; small cracks around fixings in corners of the panel.

CHIPS AND LOSS: Missing areas associated with the cracks, the majority of which alongside crack on sinister side of the panel; missing area around metal fixing in dexter bottom corner of the cast.

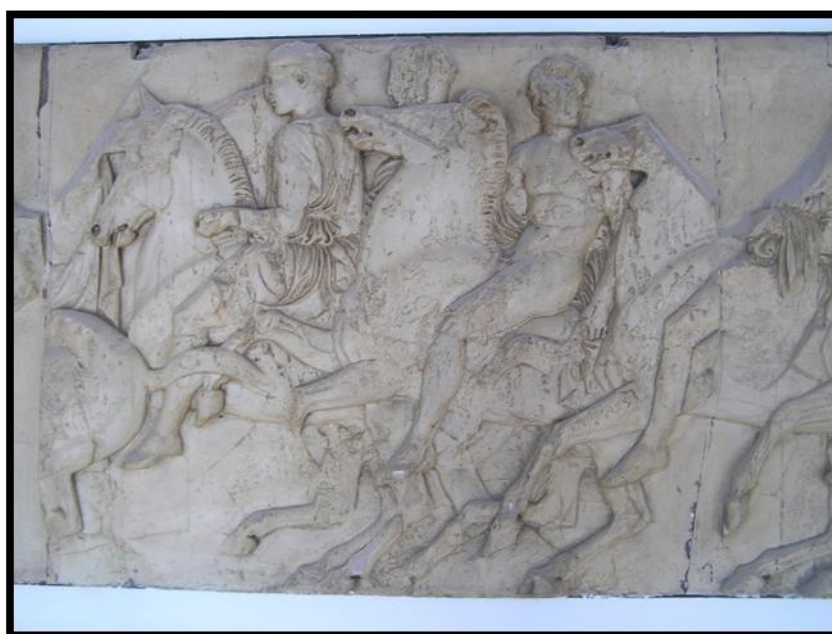
Panel after conservation

- Prior to any conservation treatment the cast was photographed. This photographic documentation was continued throughout all conservation processes.
- Initially, the cast was dry cleaned with soft brushes and Wishab Sponges with a rubber-nozzled vacuum to pick up loose dust and dirt.
- Following wet cleaning spot tests on **Panel 1**, the surface of the cast was cleaned with 2-5% Vulpex Liquid Soap in de-ionised water, using cotton wool swabs.

- Areas of flaking paint were consolidated with Primal B60A in de-ionised water.
- All areas of raw plaster were given an application of 10% Paraloid B72 in acetone to provide an isolating layer between the original plaster and the repairs.
- Exposed metal fixings were treated with 5% Tannic Acid so as to stabilise the corrosion, and covered with a protective layer of 20% Paraloid B72 in acetone.
- Areas of loss, open joints and cracks were filled with white micro-balloons with 12% Paraloid B72 in acetone. Larger areas of loss around the screws were filled with an inert filler to provide extra strength.
- All the fills were then toned out with acrylics, with matting agent, to match the surrounding patina.
- Finally, the entire cast was given an application of micro-crystalline wax so as to protect the surface.

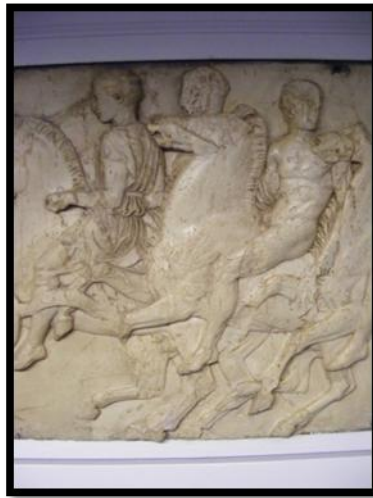
Panel during wet cleaning

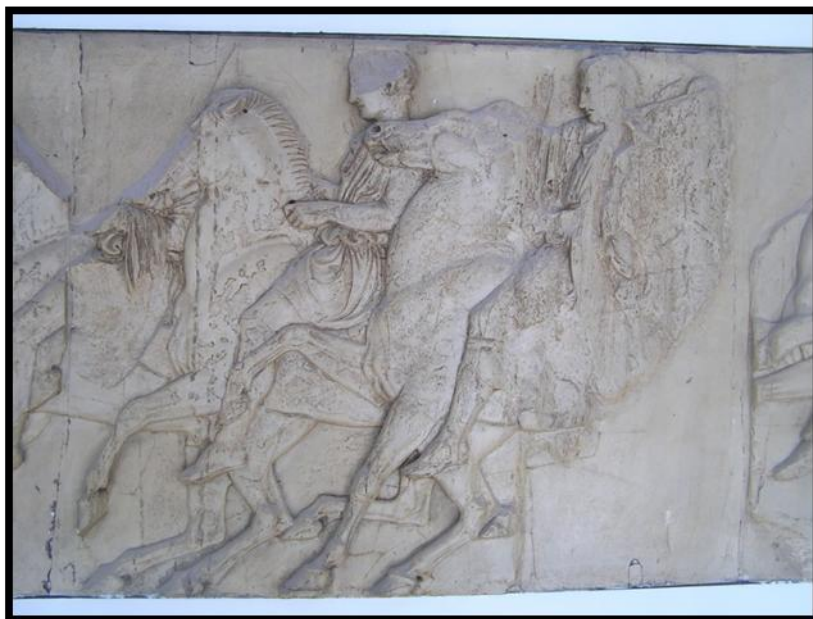
PANEL 5

Panel before conservation

STRUCTURAL STABILITY: Fair. Open cracks running alongside joints on both sides of the panel; small cracks around fixings in corner areas of the panel

CHIPS AND LOSS: Missing areas associated with the cracks, the majority of which are alongside crack on dexter side of the panel; missing area around metal fixing and alongside the crack on lower sinister side of the cast

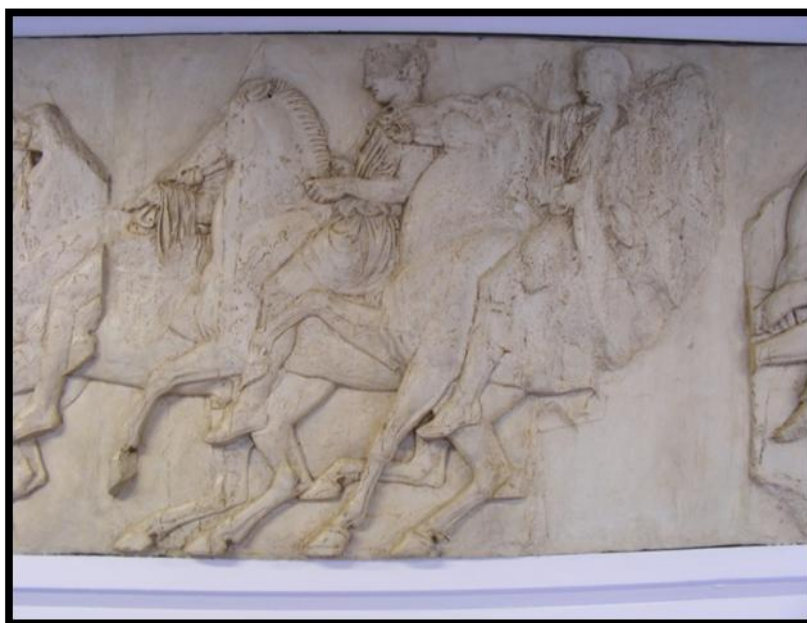
Panel after conservation

- Prior to any conservation treatment the cast was photographed. This photographic documentation was continued throughout all conservation processes.
- Initially, the cast was dry cleaned with soft brushes and Wishab Sponges with a rubber-nozzled vacuum to pick up loose dust and dirt.
- Following wet cleaning spot tests on **Panel 1**, the surface of the cast was cleaned with 2-5% Vulpex Liquid Soap in de-ionised water, using cotton wool swabs.

- All areas of raw plaster were given an application of 10% Paraloid B72 in acetone to provide an isolating layer between the original plaster and the repairs.
- Exposed metal fixings were treated with 5% Tannic Acid so as to stabilise the corrosion, and covered with a protective layer of 20% Paraloid B72 in acetone.
- Areas of loss, open joints and cracks were filled with white micro-balloons with 12% Paraloid B72 in acetone. Larger areas of loss around the screws were filled with an inert filler to provide extra strength.
- All the fills were then toned out with acrylics, with matting agent, to match the surrounding patina.
- Finally, the entire cast was given an application of micro-crystalline wax so as to protect the surface.

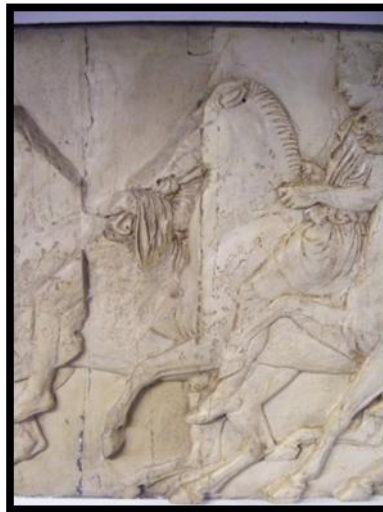
Panel during wet cleaning

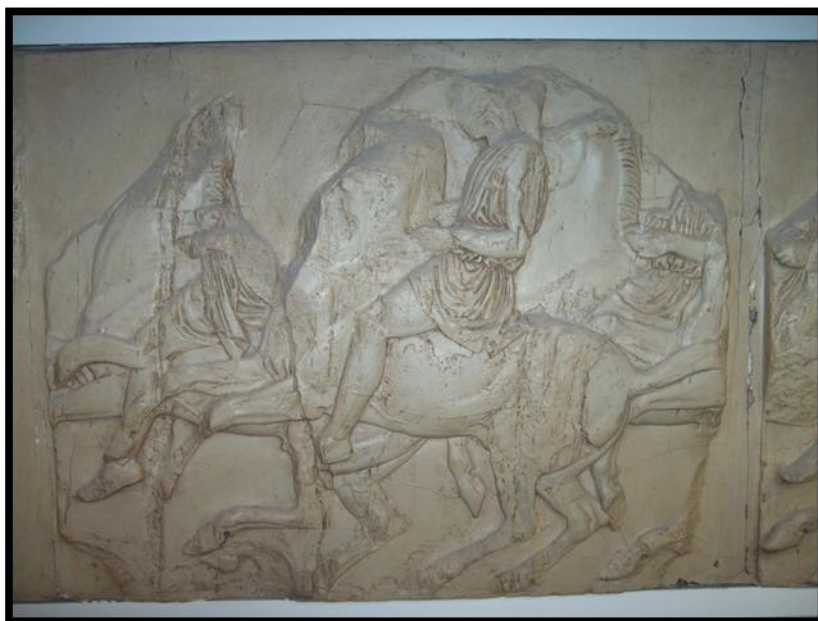
PANEL 6

Panel before conservation

STRUCTURAL STABILITY: Fair. Open cracks running alongside joints on both sides of the panel; small cracks around fixings in corner areas of the panel

CHIPS AND LOSS: Missing areas associated with the cracks, the majority of which are alongside the crack on sinister side of the panel; missing area around metal fixing on sinister side of the cast

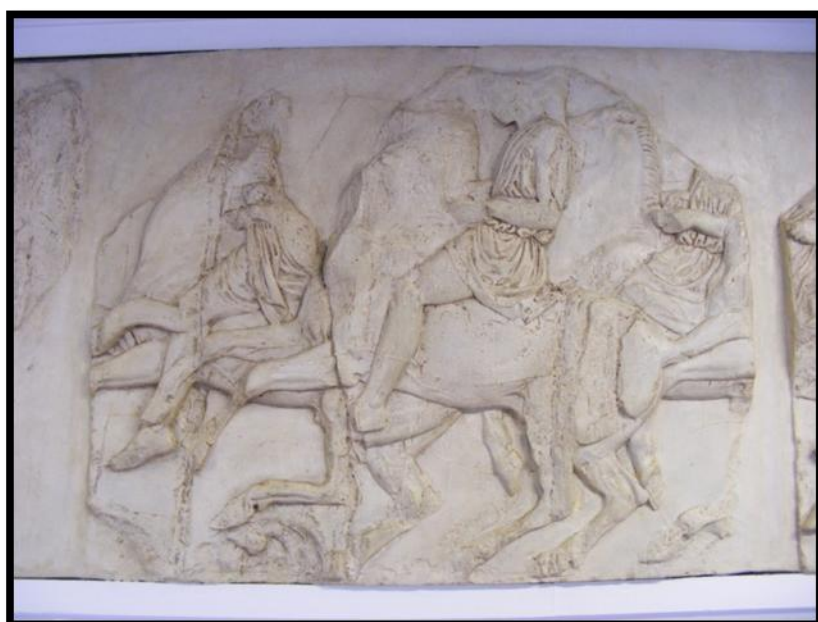
Panel after conservation

- All areas of raw plaster were given an application of 10% Paraloid B72 in acetone to provide an isolating layer between the original plaster and the repairs.

- Exposed metal fixings were treated with 5% Tannic Acid so as to stabilise the corrosion, and covered with a protective layer of 20% Paraloid B72 in acetone.

- Areas of loss, open joints and cracks were filled with white micro-balloons with 12% Paraloid B72 in acetone. Larger areas of loss around the screws were filled with an inert filler to provide extra strength.

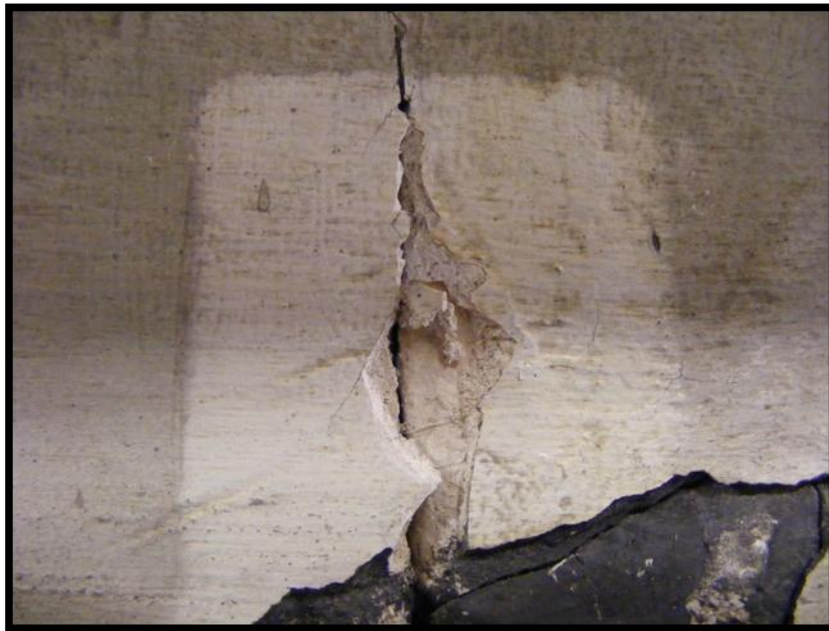
At the time of re-siting the cast collection from the Royal Scottish Academy building on Princes Street to the Edinburgh College of Art in 1913, the Parthenon Frieze panels were installed with metal fixings set into the wall. The open joints between the panels were filled with a mortar that was smeared over the adjacent edges of the panels.

A mortar analysis was carried out by Mr Bill Revie of CMC on samples of the pointing material found between the Panel 10 and 11 on Ground Floor Galley North Wall. The mortar was found to be a thick layer of lime putty, gypsum plaster and fine sand and hair, followed by a thin layer of gypsum plaster and lime putty; and finally a layer of varnish. This final layer of varnish is found over the entire two floors of the North and South Walls and yet, interestingly, for some unknown reason, it was not applied to the slabs on the East Wall.

Samples of mortar were taken for analysis

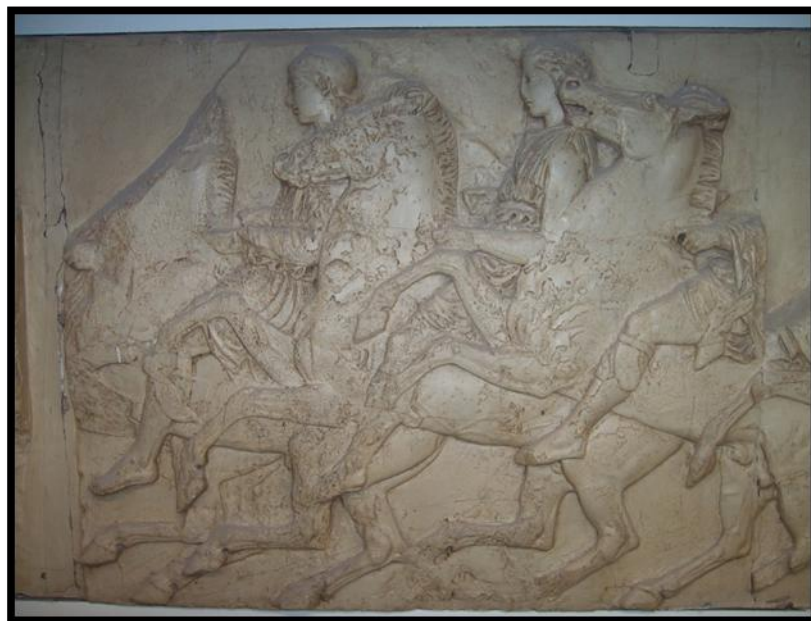
PANEL 7

Panel before conservation

STRUCTURAL STABILITY: Fair. Open cracks running alongside joints on both sides of the panel; small cracks around fixings in corner areas of the panel.

CHIPS AND LOSS: Missing areas associated with the cracks, the majority of which are alongside the crack on sinister side of the panel; missing area around metal fixing on sinister side of the cast.

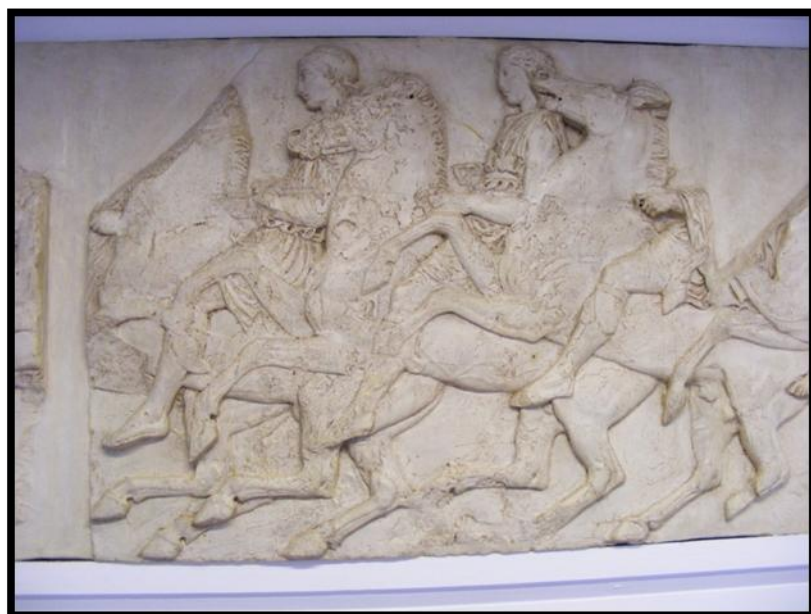
Panel after conservation

- Prior to any conservation treatment the cast was photographed. This photographic documentation was continued throughout all conservation processes.
- Initially, the cast was dry cleaned with soft brushes and Wishab Sponges with a rubber-nozzled vacuum to pick up loose dust and dirt.
- Following wet cleaning spot tests on **Panel 1**, the surface of the cast was cleaned with 2-5% Vulpex Liquid Soap in de-ionised water, using cotton wool swabs.

- All areas of raw plaster were given an application of 10% Paraloid B72 in acetone to provide an isolating layer between the original plaster and the repairs.
- Exposed metal fixings were treated with 5% Tannic Acid so as to stabilise the corrosion, and covered with a protective layer of 20% Paraloid B72 in acetone.
- Areas of loss, open joints and cracks were filled with white micro-balloons with 12% Paraloid B72 in acetone. Larger areas of loss around the screws were filled with an inert filler to provide extra strength.

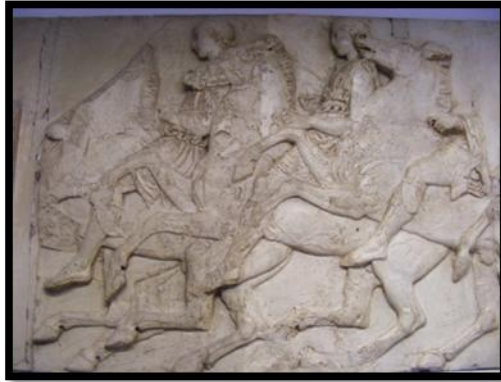
Panel during wet cleaning

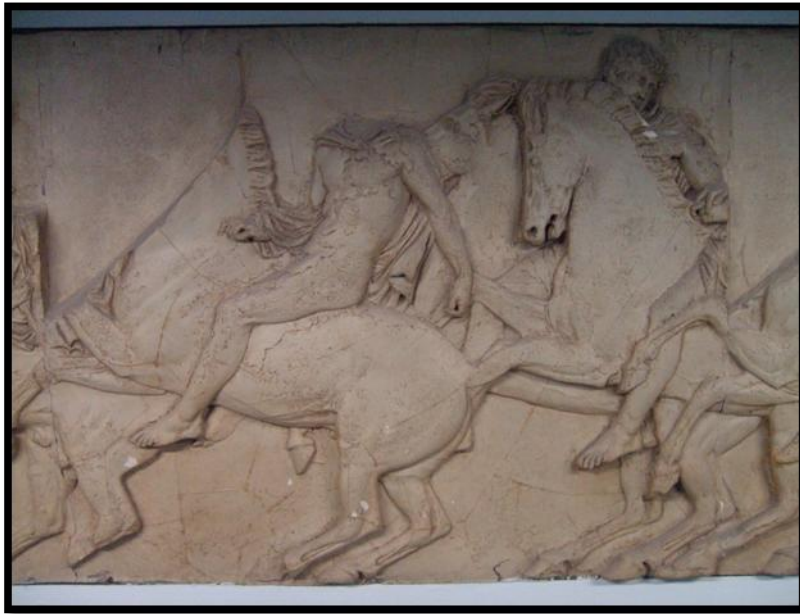
PANEL 8

Panel before conservation

STRUCTURAL STABILITY: Fair. Open cracks running alongside joints on both sides of the panel; small cracks around fixings in corner areas of the panel.

CHIPS AND LOSS: Missing areas associated with the cracks; missing area around metal fixing.

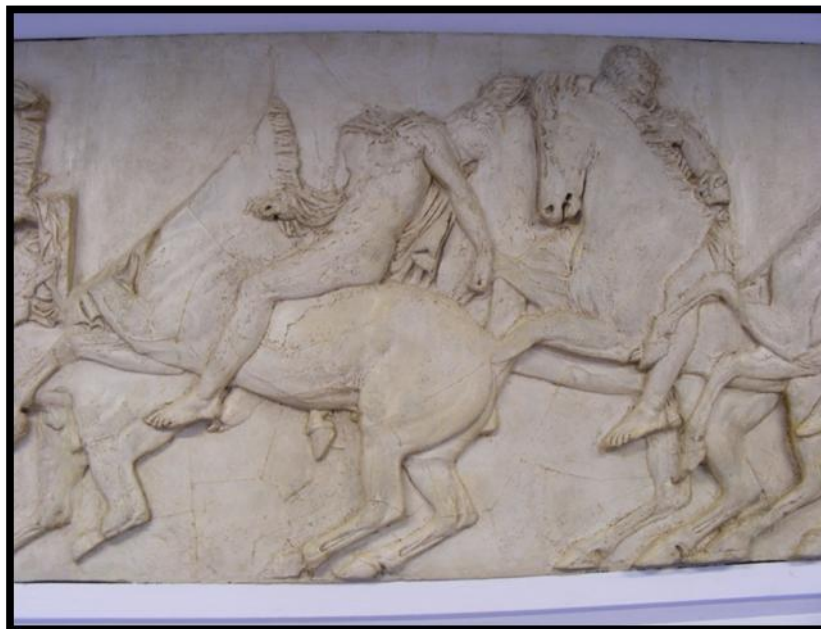
Panel after conservation

- Prior to any conservation treatment the cast was photographed. This photographic documentation was continued throughout all conservation processes.
- Initially, the cast was dry cleaned with soft brushes and Wishab Sponges with a rubber-nozzled vacuum to pick up loose dust and dirt.
- Following wet cleaning spot tests on **Panel 1**, the surface of the cast was cleaned with 2-5% Vulpex Liquid Soap in de-ionised water, using cotton wool swabs.

- Areas of flaking paint were consolidated with 5% Primal B60A in de-ionised water
- All areas of raw plaster were given an application of 10% Paraloid B72 in acetone to provide an isolating layer between the original plaster and the repairs.
- Exposed metal fixings were treated with 5% Tannic Acid so as to stabilise the corrosion, and covered with a protective layer of 20% Paraloid B72 in acetone.
- Areas of loss, open joints and cracks were filled with white micro-balloons with 12% Paraloid B72 in acetone. Larger areas of loss around the screws were filled with inert filler to provide an extra strength.
- All the fills were then toned out with acrylics mixed, with matting agent, to match the surrounding patina.
- Finally, the entire cast was given an application of micro-crystalline wax so as to protect the surface.

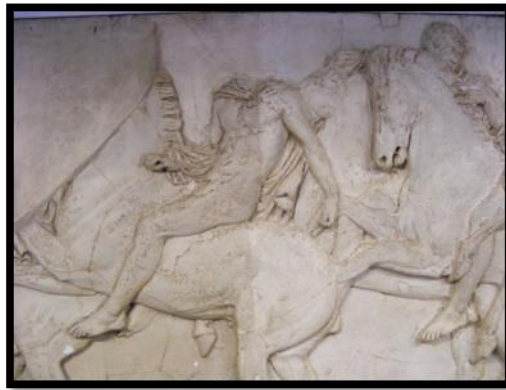
Panel during wet cleaning

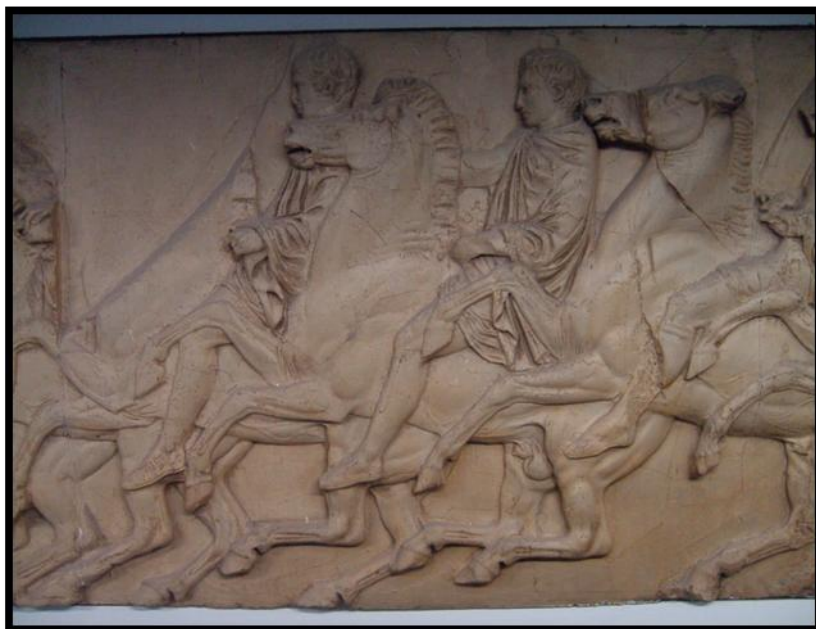
PANEL 9

Panel before conservation

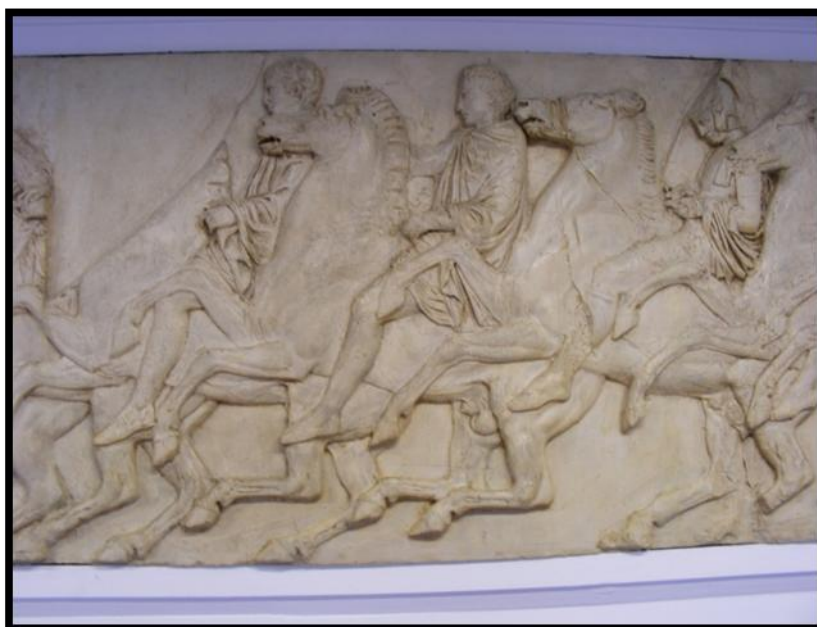
Panel after conservation

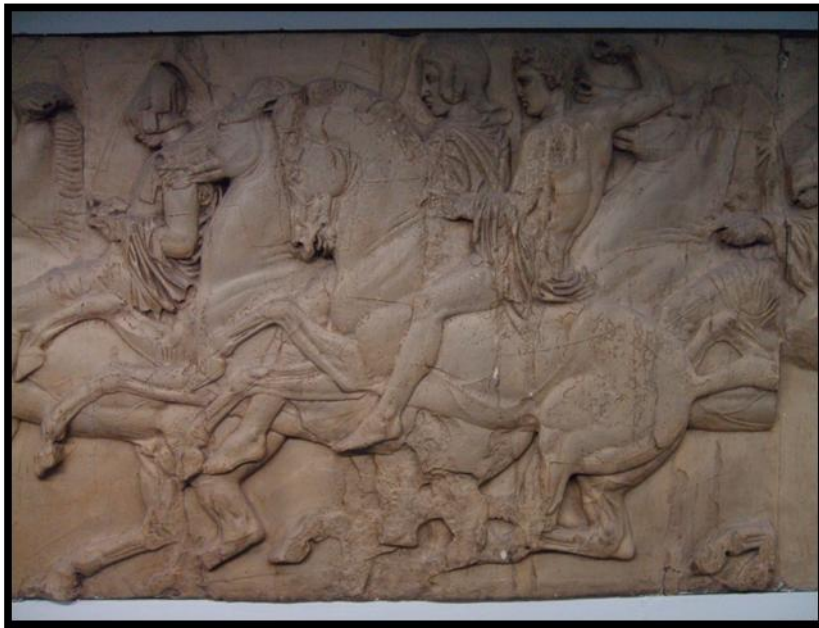
PANEL 10

Panel before conservation

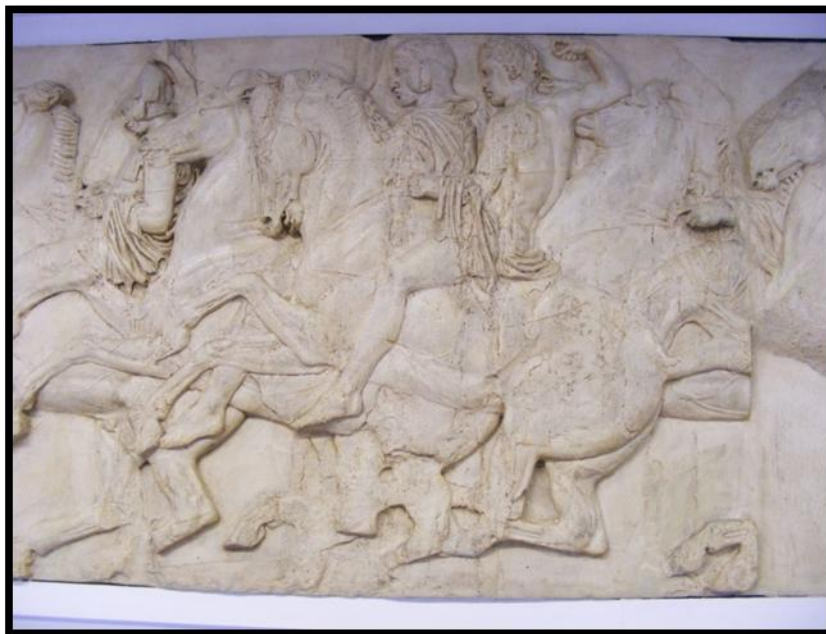
Panel after conservation

- Prior to any conservation treatment the cast was photographed. This photographic documentation was continued throughout all conservation processes.
- Initially, the cast was dry cleaned with soft brushes and Wishab Sponges with a rubber hosed vacuum to pick up loose dust and dirt.
- Following wet cleaning spot tests on **Panel 1**, the surface of the cast was cleaned with 2-5% Vulpex Liquid Soap in de-ionised water, using cotton wool swabs.

- Areas of flaking paint were consolidated with Primal B60A with de-ionised water.
- All areas of raw plaster were given an application of 10% Paraloid B72 in acetone to provide an isolating layer between the original plaster and the repairs.
- Exposed metal fixings were treated with 5% Tannic Acid so as to stabilise the corrosion, and covered with a protective layer of 20% Paraloid B72 in acetone.
- Areas of loss, open joints and cracks were filled with white micro-balloons with 12% Paraloid B72 in acetone. Larger areas of loss around the screws were filled with an inert filler to provide extra strength.
- All the fills were then toned out with acrylics, mixed with matting agent, to match the surrounding patina.
- Finally, the entire cast was given an application of micro-crystalline wax so as to protect the surface.

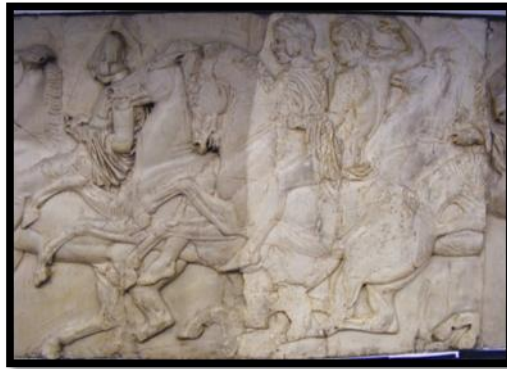
Panel during wet cleaning

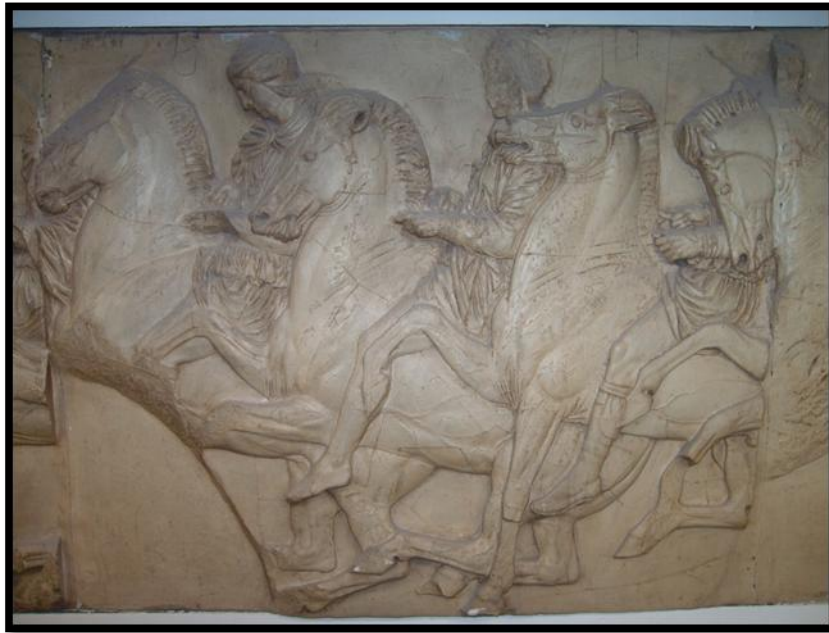
PANEL 11

Panel before conservation

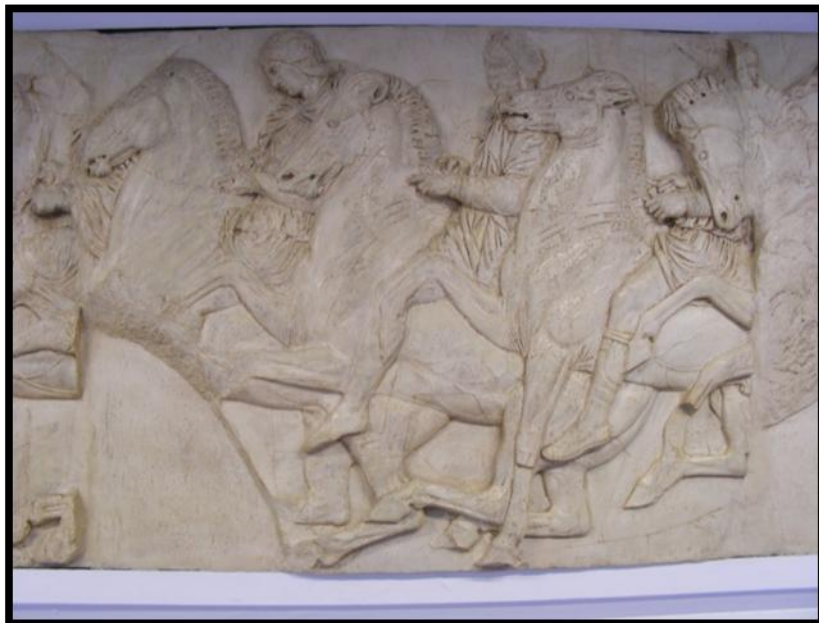
Panel after conservation

- Prior to any conservation treatment the cast was photographed. This photographic documentation was continued throughout all conservation processes.
- Initially, the cast was dry cleaned with soft brushes and Wishab Sponges with a rubber hosed vacuum to pick up loose dust and dirt.
- Following wet cleaning spot tests on **Panel 1**, the surface of the cast was cleaned with 2-5% Vulpex Liquid Soap in de-ionised water, using cotton wool swabs.

- Areas of flaking paint were consolidated with 5% Primal B60A with de-ionised water.
- All areas of raw plaster were given an application of 10% Paraloid B72 in acetone to provide an isolating layer between the original plaster and the repairs.
- Exposed metal fixings were treated with 5% Tannic Acid so as to stabilise the corrosion, and covered with a protective layer of 20% Paraloid B72 in acetone.
- Areas of loss, open joints and cracks were filled with white micro-balloons with 12% Paraloid B72 in acetone. Larger areas of loss around the screws were filled with an inert filler to provide extra strength.
- All the fills were then toned out with acrylics, mixed with matting agent, to match the surrounding patina.
- Finally, the entire cast was given an application of micro-crystalline wax so as to protect the surface.

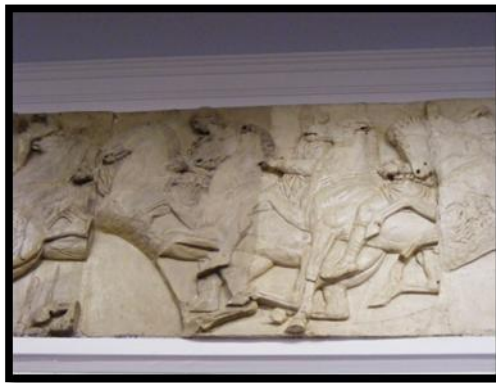
Panel during wet cleaning

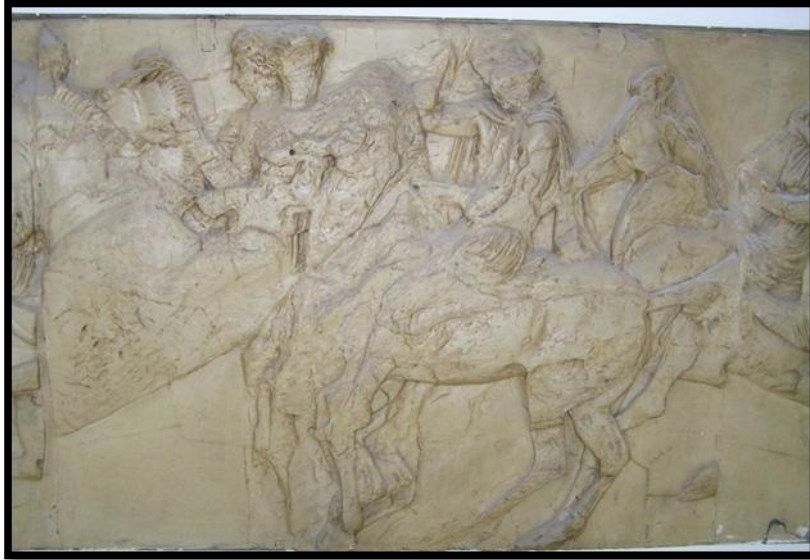
PANEL 12

Panel before conservation

STRUCTURAL STABILITY: Fair. Open cracks running alongside joints on both sides of the panel; small cracks around fixing in three corners of the panel.

CHIPS AND LOSS: Missing areas associated with the cracks; three small areas of flaking paint.

- Prior to any conservation treatment the cast was photographed. This photographic documentation was continued throughout all conservation processes.
- Initially, the cast was dry cleaned with soft brushes and Wishab Sponges with a rubber-nozzled vacuum to pick up loose dust and dirt.
- Following wet cleaning spot tests on **Panel 1**, the surface of the cast was cleaned with 2-5% Vulpex Liquid Soap in de-ionised water, using cotton wool swabs.

- Areas of flaking paint were consolidated with 5% Primal B60A with de-ionised water.
- All areas of raw plaster were given an application of 10% Paraloid B72 in acetone to provide an isolating layer between the original plaster and the repairs.
- Exposed metal fixings were treated with 5% Tannic Acid so as to stabilise the corrosion, and covered with a protective layer of 20% Paraloid B72 in acetone.
- Areas of loss, open joints and cracks were filled with white micro-balloons with 12% Paraloid B72 in acetone. Larger areas of loss around the screws were filled with an inert filler to provide extra strength.
- All the fills were then toned out with acrylics, mixed with matting agent, to match the surrounding patina.
- Finally, the entire cast was given an application of micro-crystalline wax so as to protect the surface.

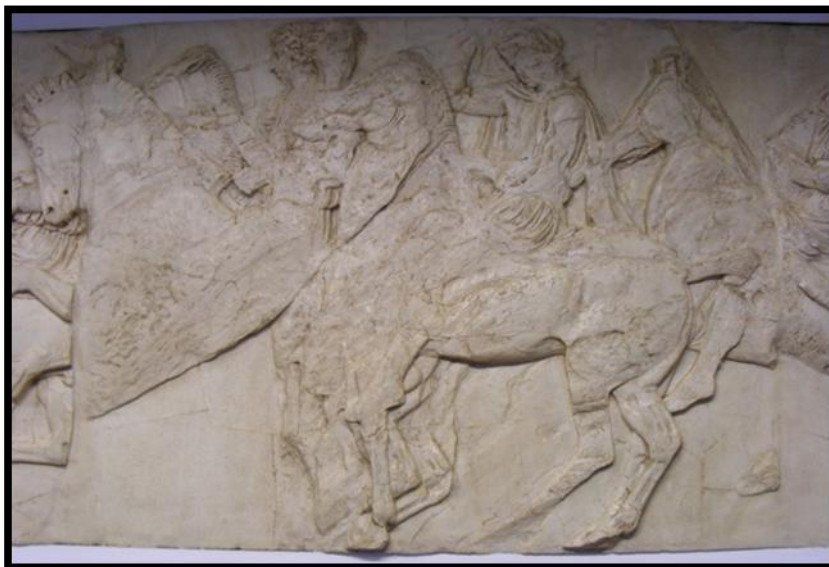
Panel after conservation

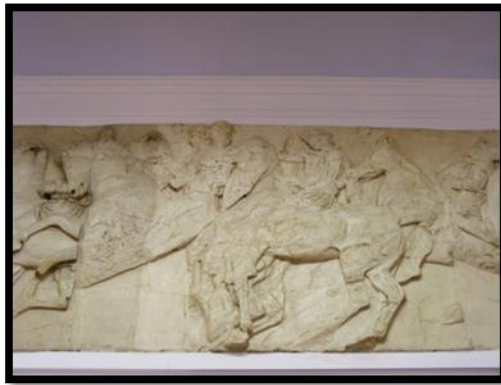
Panel during wet cleaning

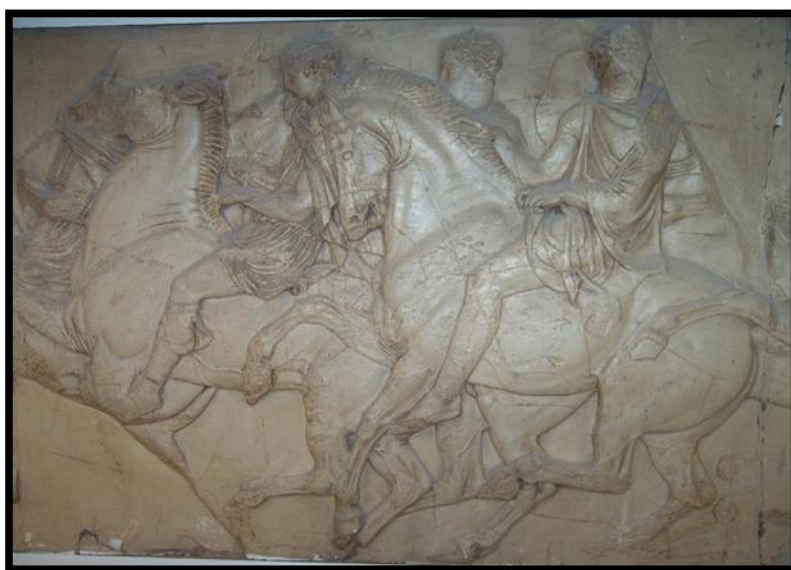
PANEL 13

Panel before conservation

STRUCTURAL STABILITY: Fair. Open cracks running alongside joints on both sides of the panel; small cracks around fixing in corners of the panel.

CHIPS AND LOSS: Missing areas associated with the cracks, especially on sinister side of the panel; missing paint in lower and middle parts of the cast.

- Prior to any conservation treatment the cast was photographed. This photographic documentation was continued throughout all conservation processes.
- Initially, the cast was dry cleaned with soft brushes and Wishab Sponges with a rubber-nozzled vacuum to pick up loose dust and dirt.
- Following wet cleaning spot tests on **Panel 1**, the surface of the cast was cleaned with 2-5% Vulpex Liquid Soap in de-ionised water, using cotton wool swabs.

- All areas of raw plaster were given an application of 10% Paraloid B72 in acetone to provide an isolating layer between the original plaster and the repairs.
- Exposed metal fixings were treated with 5% Tannic Acid so as to stabilise the corrosion, and covered with a protective layer of 20% Paraloid B72 in acetone.
- Areas of loss, open joints and cracks were filled with white micro-balloons with 12% Paraloid B72 in acetone. Larger areas of loss around the screws were filled with an inert filler to provide extra strength.

- All the fills were then toned out with acrylics, mixed with matting agent, to match the surrounding patina.
- Finally, the entire cast was given an application of micro-crystalline wax so as to protect the surface.

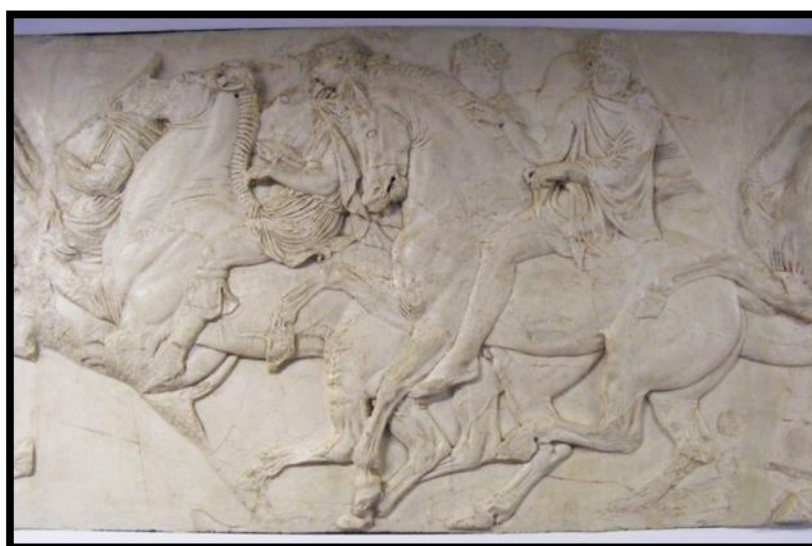
Panel after conservation

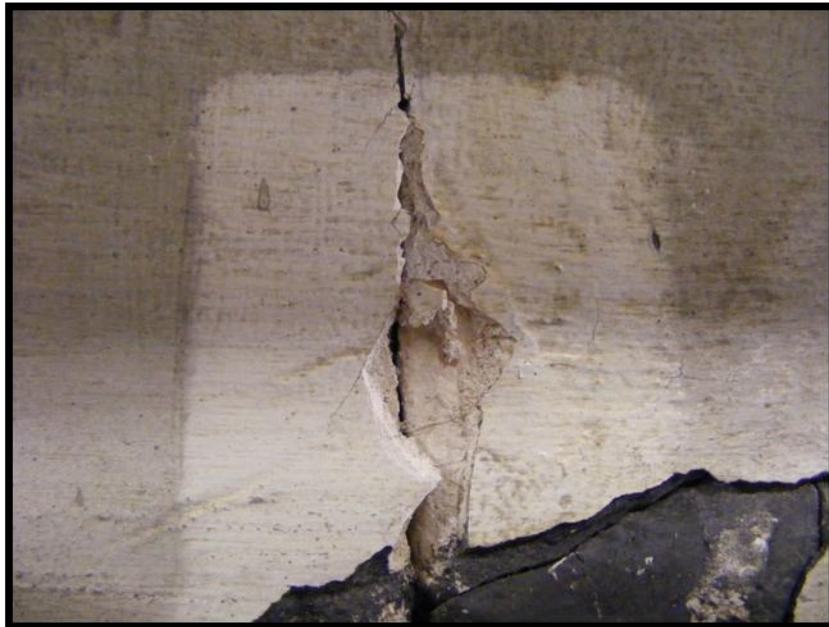
A mortar analysis was carried out by Mr Bill Revie of CMC on samples of the pointing material found between the Panel 10 and 11 on Ground Floor Galley North Wall. The mortar was found to be a thick layer of lime putty, gypsum plaster and fine sand and hair, followed by a thin layer of gypsum plaster and lime putty; and finally a layer of varnish. This final layer of varnish is found over the entire two floors of the North and South Walls and yet, interestingly, for some unknown reason, it was not applied to the slabs on the East Wall.

Samples of mortar were taken for analysis

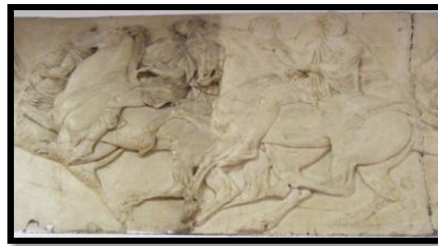
Panel during wet cleaning

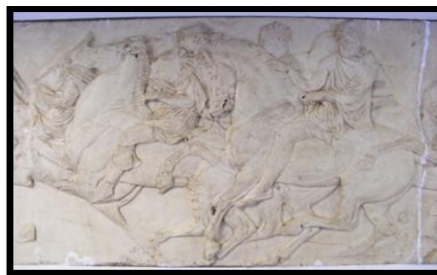
Panel during works on fills
