1. PARTHENON FRIEZE

1. SCULPTURE COURT UPPER GALLERY SOUTH WALL

1.1.1.1 DESCRIPTION OF THE OBJECT

TITLE: Parthenon Frieze, copy of the panel from Parthenon Frieze from Temple of Athena – Parthenon in Acropolis in Athens, Greece, between 443 and 438 B.C.

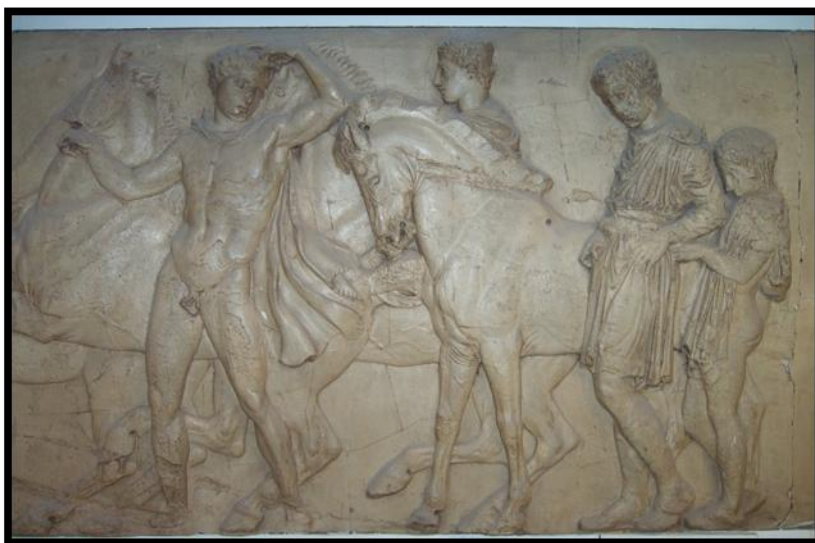
PANEL 14

Panel before conservation

STRUCTURAL STABILITY: Stable. Open cracks running alongside joints on both sides of the panel and through the middle; small cracks around fixing in top corners of the panel.

CHIPS AND LOSS: Missing areas associated with the cracks.

- Prior to any conservation treatment the cast was photographed. This photographic documentation was continued throughout all conservation processes.
- Initially, the cast was dry cleaned with soft brushes and Wishab Sponges with a rubber hosed vacuum to pick up loose dust and dirt.
- Following wet cleaning spot tests on **Panel 1**, the surface of the cast was cleaned with 2-5% Vulpex Liquid Soap in de-ionised water, using cotton wool swabs.

- Areas of flaking paint were consolidated with 5% Primal B60A with de-ionised water.
- All areas of raw plaster were given an application of 10% Paraloid B72 in acetone to provide an isolating layer between the original plaster and the repairs.
- Exposed metal fixings were treated with 5% Tannic Acid so as to stabilise the corrosion, and covered with a protective layer of 20% Paraloid B72 in acetone.
- Areas of loss, open joints and cracks were filled with white micro-balloons with 12% Paraloid B72 in acetone. Larger areas of loss around the screws were filled with an inert filler to provide extra strength.

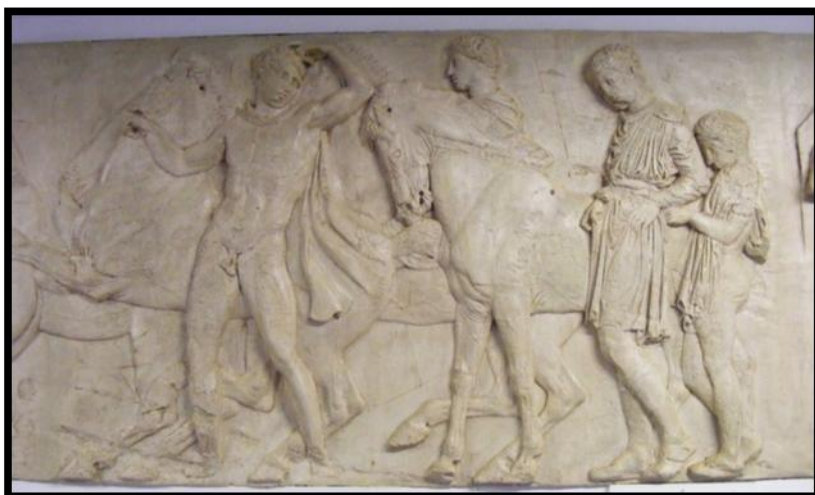
Panel after conservation

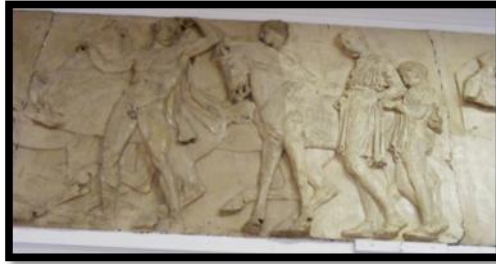
Panel during wet cleaning

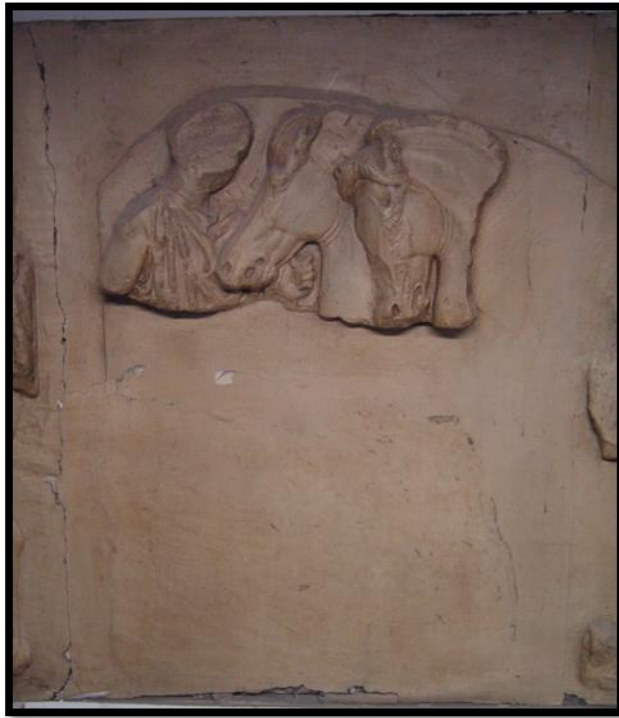
PANEL 15

Panel before conservation

STRUCTURAL STABILITY: Stable. Open cracks running alongside joints on both sides of the panel, through the middle and in sinister corner.

CHIPS AND LOSS: Missing areas associated with the cracks and on bottom edge; flaking paint in middle and top part of the cast.

- Prior to any conservation treatment the cast was photographed. This photographic documentation was continued throughout all conservation processes.
- Initially, the cast was dry cleaned with soft brushes and Wishab Sponges with a rubber-nozzled vacuum to pick up loose dust and dirt.
- Following wet cleaning spot tests on **Panel 1**, the surface of the cast was cleaned with 2-5% Vulpex Liquid Soap in de-ionised water, using cotton wool swabs.

- Areas of flaking paint were consolidated with 5% Primal B60A with de-ionised water.
- All areas of raw plaster were given an application of 10% Paraloid B72 in acetone to provide an isolating layer between the original plaster and the repairs.
- Exposed metal fixings were treated with 5% Tannic Acid so as to stabilise the corrosion, and covered with a protective layer of 20% Paraloid B72 in acetone.
- Areas of loss, open joints and cracks were filled with white micro-balloons with 12% Paraloid B72 in acetone. Larger areas of loss around the screws were filled with an inert filler to provide extra strength.

- All the fills were then toned out with acrylics with matting agent to match the surrounding patina.
- Finally, the entire cast was given an application of micro-crystalline wax so as to protect the surface.

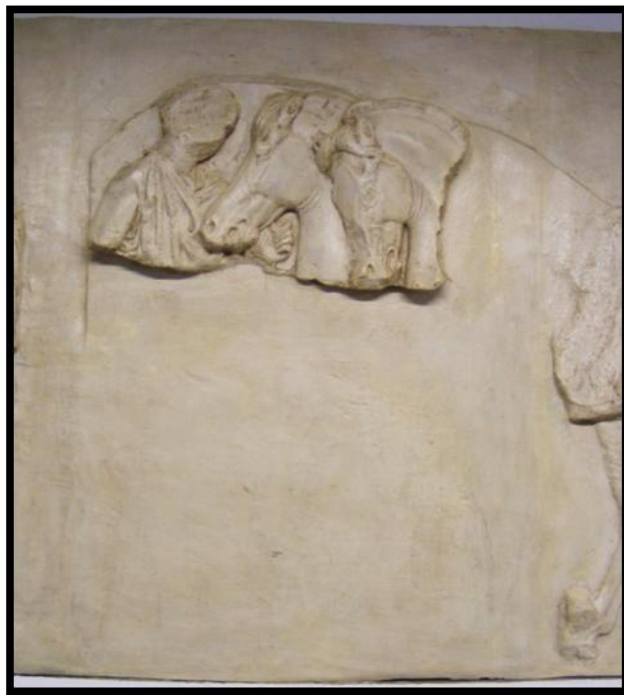
Panel after conservation

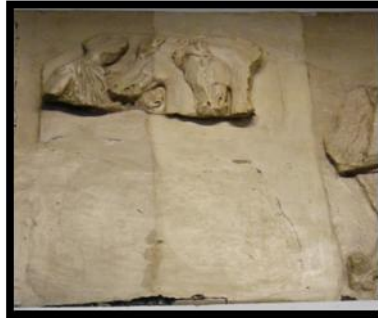
Panel during wet cleaning

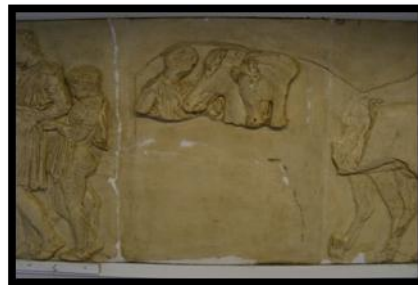
Panel during works on fills

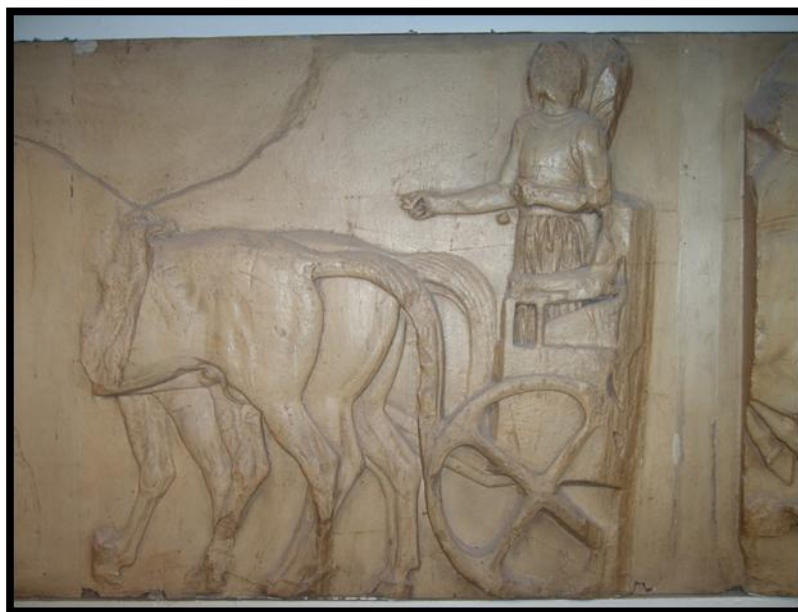
PANEL 16

Panel before conservation

STRUCTURAL STABILITY: Stable. Open cracks running alongside joints on both sides of the panel; small crack around fixings in corners of the cast.

CHIPS AND LOSS: Missing areas associated with the cracks, the majority of which are on the sinister side and two sinister corners of the panel.

- Prior to any conservation treatment the cast was photographed. This photographic documentation was continued throughout all conservation processes.
- Initially, the cast was dry cleaned with soft brushes and Wishab Sponges with a rubber-nozzled vacuum to pick up loose dust and dirt.
- Following wet cleaning spot tests on **Panel 1**, the surface of the cast was cleaned with 2-5% Vulpex Liquid Soap in de-ionised water, using cotton wool swabs.

- All areas of raw plaster were given an application of 10% Paraloid B72 in acetone to provide an isolating layer between the original plaster and the repairs.
- Exposed metal fixings were treated with 5% Tannic Acid so as to stabilise the corrosion, and covered with a protective layer of 20% Paraloid B72 in acetone.
- Areas of loss, open joints and cracks were filled with white micro-balloons with 12% Paraloid B72 in acetone. Larger areas of loss around the screws were filled with an inert filler to provide extra strength.
- All the fills were then toned out with acrylics, mixed with matting agent, to match the surrounding patina.
- Finally, the entire cast was given an application of micro-crystalline wax so as to protect the surface.

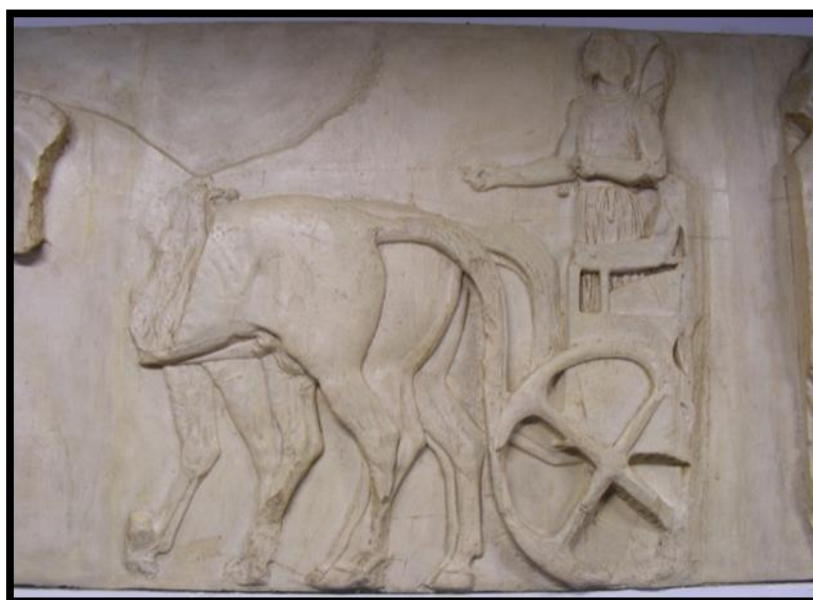
Panel after conservation

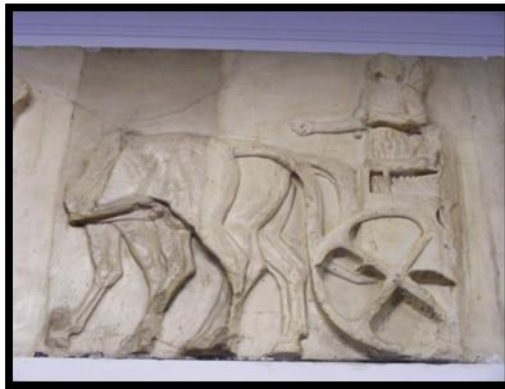
Panel during wet cleaning

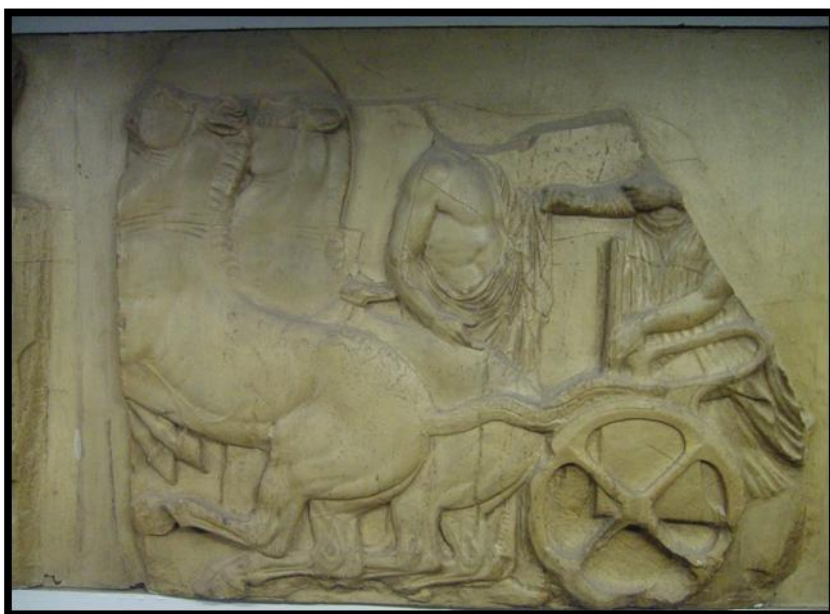
PANEL 17

Panel before conservation

STRUCTURAL STABILITY: Stable. Open cracks running alongside joints on both sides of the panel; small crack around fixings in corners of the cast.

CHIPS AND LOSS: Missing areas associated with the cracks, the majority of which are on lower part of the panel.

- Prior to any conservation treatment the cast was photographed. This photographic documentation was continued throughout all conservation processes.
- Initially, the cast was dry cleaned with soft brushes and Wishab Sponges with a rubber-nozzled vacuum to pick up loose dust and dirt.
- Following wet cleaning spot tests on **Panel 1**, the surface of the cast was cleaned with 2-5% Vulpex Liquid Soap in de-ionised water, using cotton wool swabs.

- All areas of raw plaster were given an application of 10% Paraloid B72 in acetone to provide an isolating layer between the original plaster and the repairs.
- Exposed metal fixings were treated with 5% Tannic Acid so as to stabilise the corrosion, and covered with a protective layer of 20% Paraloid B72 in acetone.
- Areas of loss, open joints and cracks were filled with white micro-balloons with 12% Paraloid B72 in acetone. Larger areas of loss around the screws were filled with an inert filler to provide extra strength.
- All the fills were then toned out with acrylics, mixed with matting agent, to match the surrounding patina.
- Finally, the entire cast was given an application of micro-crystalline wax so as to protect the surface.

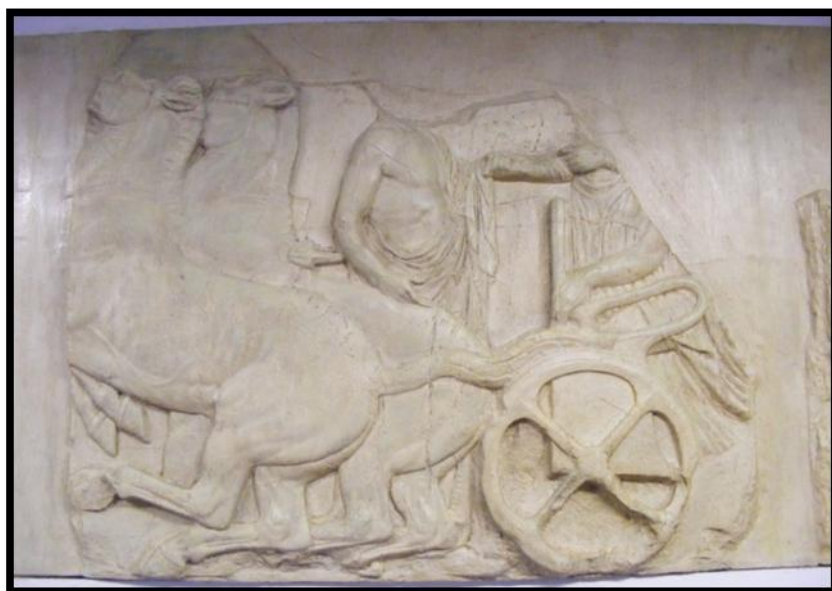
After conservation

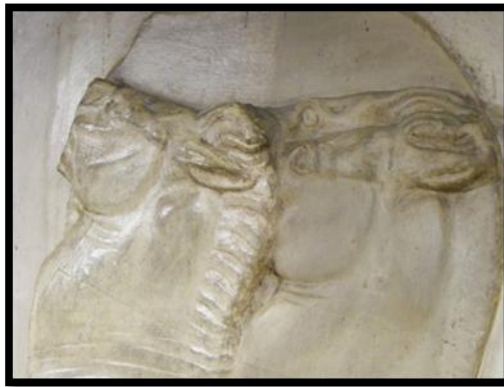
Panel during wet cleaning

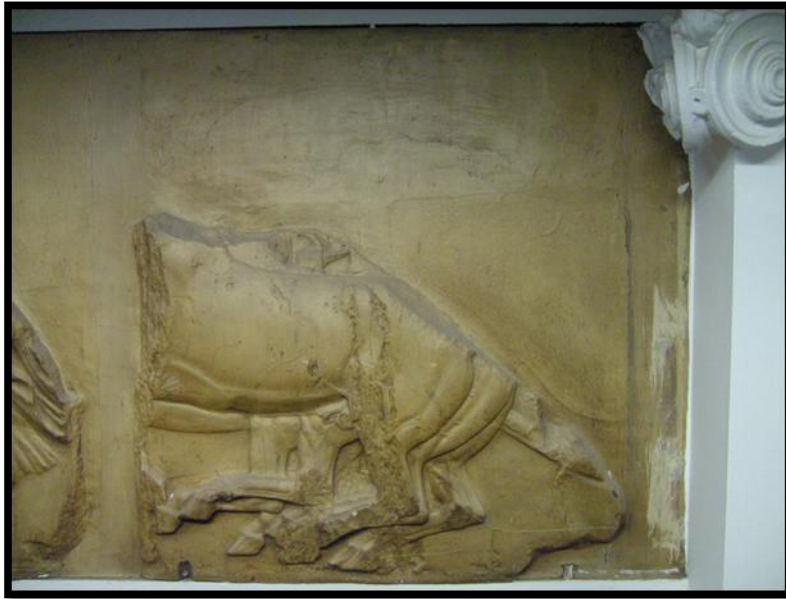
PANEL 18

Panel before conservation

STRUCTURAL STABILITY: Stable. Open cracks running alongside joints on both sides of the panel and through the panel in its upper part; small crack around fixings in two bottom corners of the cast.

CHIPS AND LOSS: Missing areas associated with the cracks, the majority of which are on the upper part of the panel.

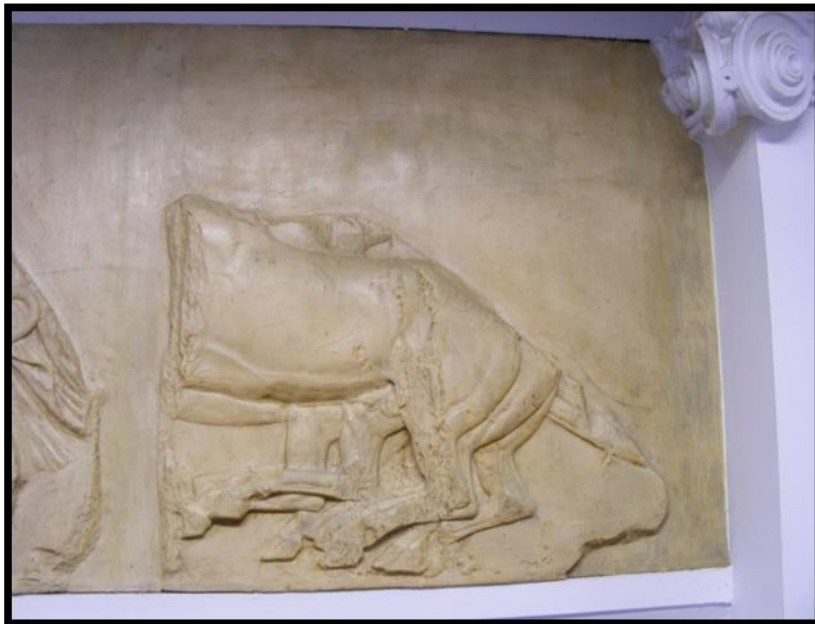
Panel after conservation
