1.2 SCULPTURE COURT UPPER GALLERY NORTH WALL

TITLE: Parthenon Frieze, copy of panel from the Frieze at temple of Athena in Acropolis, Athens, Greece (443 – 438 BC).

TYPE OF OBJECT: Relief, plaster cast with a metal structure inside, attached to the wall with 3 metal fixings.

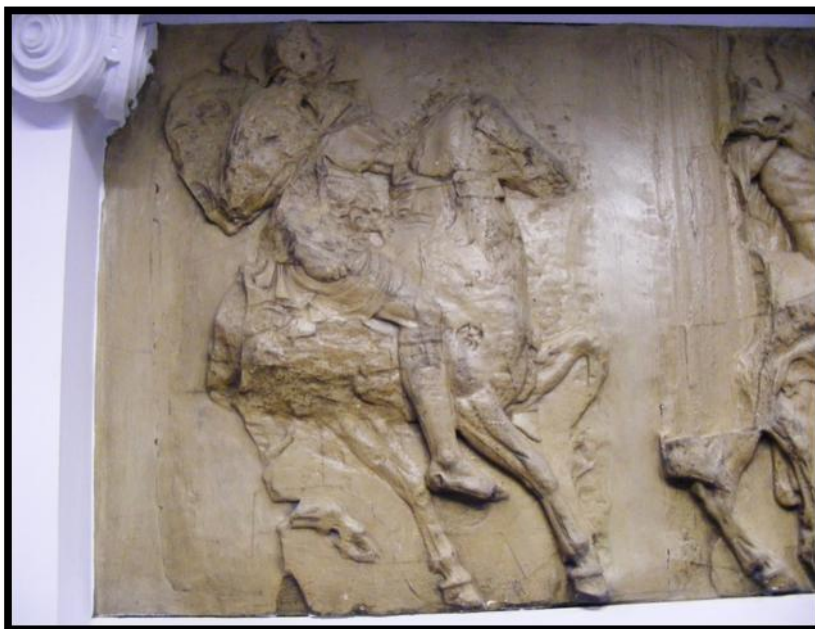
PANEL 1

Panel before conservation

STRUCTURAL STABILITY: Fair. Open cracks running alongside joints on both sides of the panel; cracks around fixing on top of the panel.

SURFACE DUST AND DIRT: Severe, 100% coverage.

VISIBLE PAINT LAYERS/UNSIGHTLY MARKINGS: Layer of cream-yellow paint/varnish on surface of the cast; small spots of paint splashes scattered on surface of the panel mainly on its dexter and bottom edges.

CHIPS AND LOSS: Missing areas associated with the cracks.

- Prior to any conservation treatment, the cast was photographed. This photographic documentation was continued throughout all conservation processes.
- Initially, the cast was dry cleaned with soft brushes and Wishab Sponges with a rubber-nozzled vacuum to pick up loose dust and dirt.
- Following a variety of wet cleaning spot tests, the surface of the panel was cleaned with 2-5% Vulpex Liquid Soap in de-ionised water, using cotton wool swabs.

- All areas of raw plaster were given an application of 10% Paraloid B72 in acetone to provide an isolating layer between the original plaster and the repairs.
- Exposed metal fixings were treated with 5% Tannic Acid so as to stabilise the corrosion, and covered with a protective layer of 20% Paraloid B72 in acetone.
- Areas of loss, open joints and cracks were filled with white micro-balloons with 12% Paraloid B72 in acetone. Larger areas of loss around the screws were filled with an inert filler to provide extra strength.
- All the fills were then toned out with acrylics, mixed with matting agent, to match the surrounding patina.
- Finally, the entire cast was given an application of micro-crystalline wax so as to protect the surface.

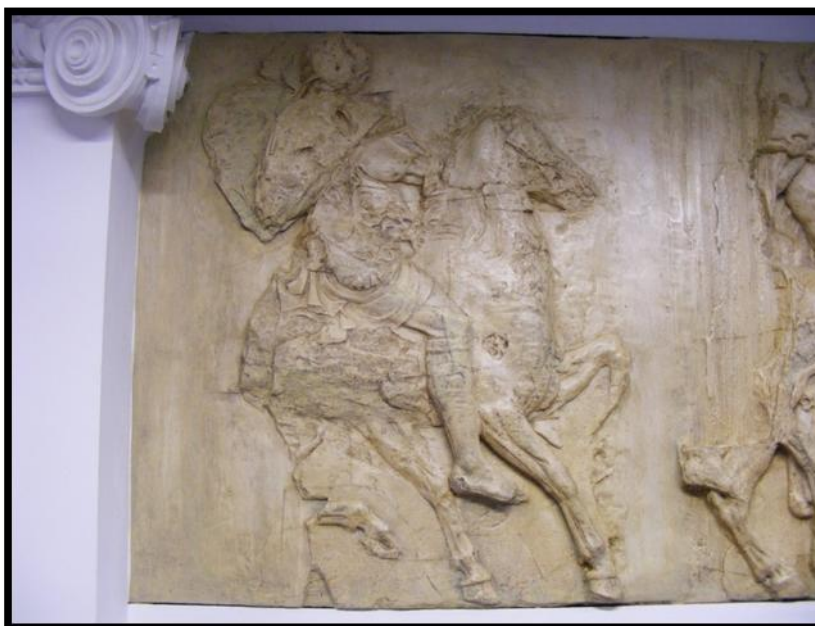
Panel after conservation

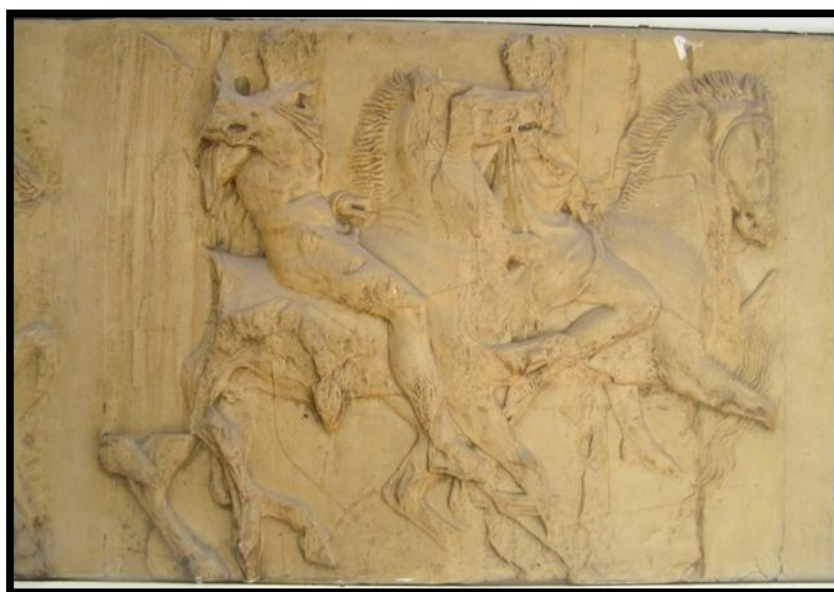
PANEL 2

Panel before conservation

STRUCTURAL STABILITY: Fair. Open cracks running alongside joints on both sides of the panel.

CHIPS AND LOSS: Missing areas associated with the cracks.

- Prior to any conservation treatment, the cast was photographed. This photographic documentation was continued throughout all conservation processes.
- Initially, the cast was dry cleaned with soft brushes and Wishab Sponges with a rubber-nozzled vacuum to pick up loose dust and dirt.
- Following a variety of wet cleaning spot tests, the surface of the panel was cleaned with 2-5% Vulpex Liquid Soap in de-ionised water, using cotton wool swabs.

- All areas of raw plaster were given an application of 10% Paraloid B72 in acetone to provide an isolating layer between the original plaster and the repairs.
- Exposed metal fixings were treated with 5% Tannic Acid so as to stabilise the corrosion, and covered with a protective layer of 20% Paraloid B72 in acetone.
- Areas of loss, open joints and cracks were filled with white micro-balloons with 12% Paraloid B72 in acetone. Larger areas of loss around the screws were filled with an inert filler to provide extra strength.
- All the fills were then toned out with acrylics, mixed with matting agent, to match the surrounding patina.
- Finally, the entire cast was given an application of micro-crystalline wax so as to protect the surface.

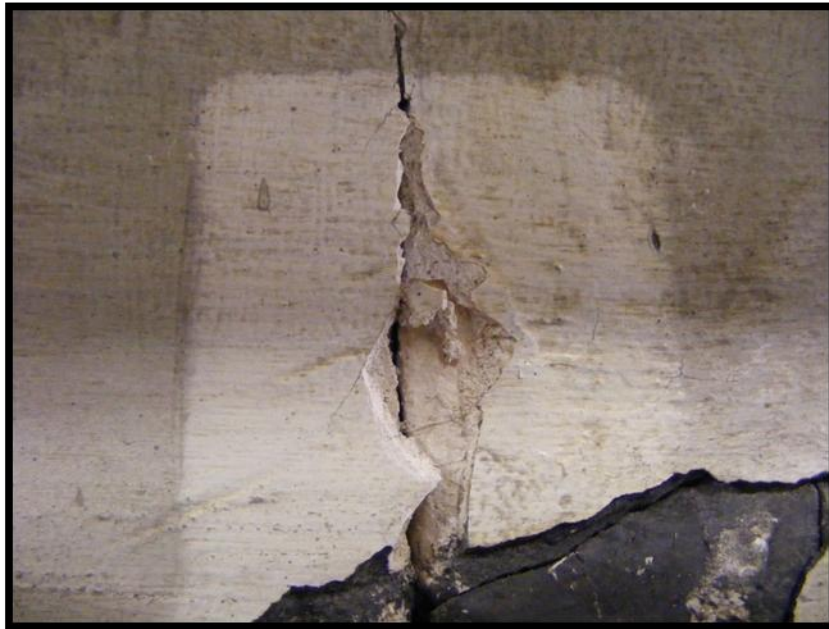
A mortar analysis was carried out by Mr Bill Revie of CMC on samples of the pointing material found between the Panel 10 and 11 on Ground Floor Galley North Wall. The mortar was found to be a thick layer of lime putty, gypsum plaster and fine sand and hair, followed by a thin layer of gypsum plaster and lime putty; and finally a layer of varnish. This final layer of varnish is found over the entire two floors of the North and South Walls and yet, interestingly, for some unknown reason, it was not applied to the slabs on the East Wall.

Samples of mortar were taken for analysis

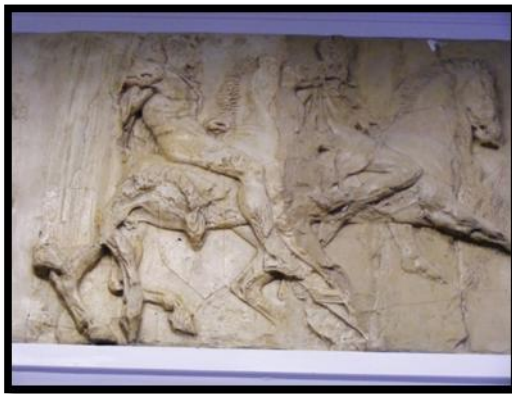
Cast during wet cleaning

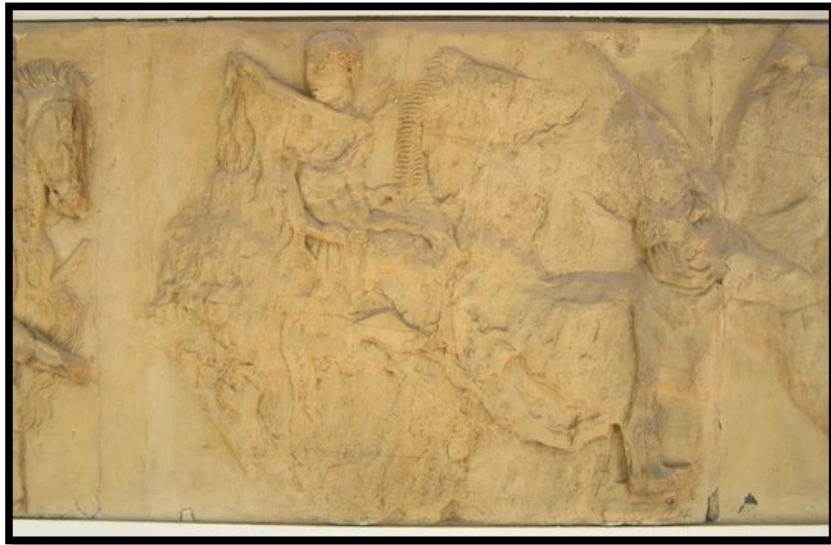
PANEL 3

Panel before conservation

STRUCTURAL STABILITY: Fair. Open cracks running alongside joints on both sides of the panel small cracks around fixings in corners of the cast.

CHIPS AND LOSS: Missing areas associated with the cracks, especially alongside crack at the sinister side of the panel.

ABRASIONS: Missing surface plaster and paint layer in two areas in middle of the panel.

- Prior to any conservation treatment, the cast was photographed. This photographic documentation was continued throughout all conservation processes.
- Initially, the cast was dry cleaned with soft brushes and Wishab Sponges with a rubber-nozzled vacuum to pick up loose dust and dirt.
- Following wet cleaning spot tests the surface of the panel was cleaned with 2-5% Vulpex Liquid Soap in de-ionised water, using cotton wool swabs.

- All areas of raw plaster were given an application of 10% Paraloid B72 in acetone to provide an isolating layer between the original plaster and the repairs.
- Exposed metal fixings were treated with 5% Tannic Acid so as to stabilise the corrosion, and covered with a protective layer of 20% Paraloid B72 in acetone.
- Areas of loss, open joints and cracks were filled with white micro-balloons with 12% Paraloid B72 in acetone. Larger areas of loss around the screws were filled with an inert filler to provide extra strength.
- All the fills were then toned out with acrylics, mixed with matting agent, to match the surrounding patina.
- Finally, the entire cast was given an application of micro-crystalline wax so as to protect the surface.

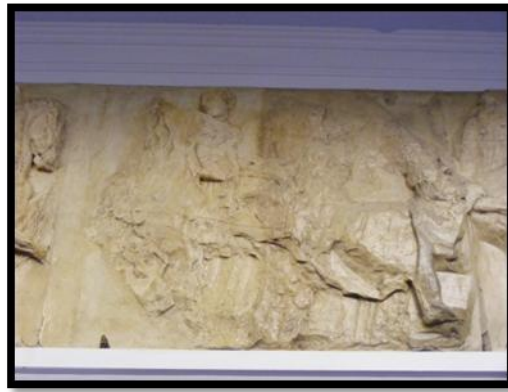
Cast during wet cleaning

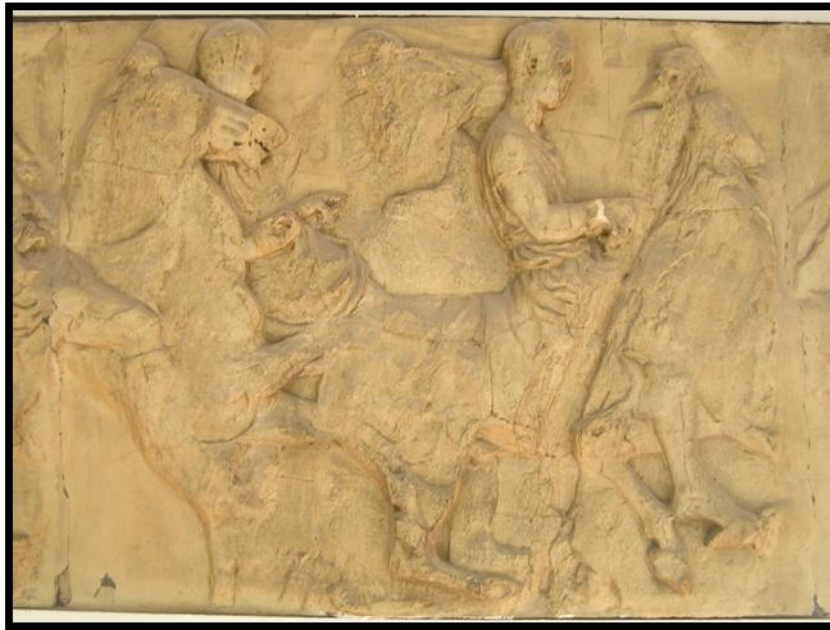
PANEL 4

Panel before conservation

STRUCTURAL STABILITY: Fair. Open cracks running alongside joints on both sides of the panel; small cracks around fixings in two corners of the cast.

CHIPS AND LOSS: Missing areas associated with the cracks; large missing area on the hand of a rider on sinister side.

ABRASIONS: Missing surface plaster and paint layer in two areas in middle of the panel.

- Prior to any conservation treatment, the cast was photographed. This photographic documentation was continued throughout all conservation processes.
- Initially, the cast was dry cleaned with soft brushes and Wishab Sponges with a rubber-nozzled vacuum to pick up loose dust and dirt.
- Following wet cleaning spot tests, the surface of the panel was cleaned with 2-5% Vulpex Liquid Soap in de-ionised water, using cotton wool swabs.

- All areas of raw plaster were given an application of 10% Paraloid B72 in acetone to provide an isolating layer between the original plaster and the repairs.
- Exposed metal fixings were treated with 5% Tannic Acid so as to stabilise the corrosion, and covered with a protective layer of 20% Paraloid B72 in acetone.
- Areas of loss, open joints and cracks were filled with white micro-balloons with 12% Paraloid B72 in acetone. Larger areas of loss around the screws were filled with an inert filler to provide extra strength.
- All the fills were then toned out with acrylics, mixed with matting agent, to match the surrounding patina.
- Finally, the entire cast was given an application of micro-crystalline wax so as to protect the surface.

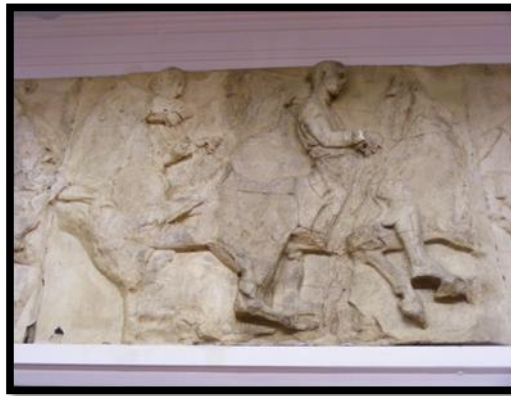
Cast during wet cleaning

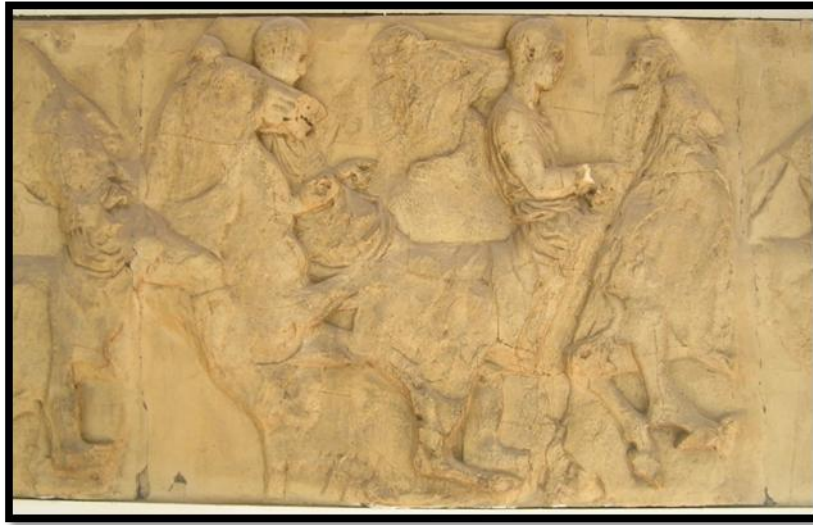
PANEL 5

Panel before conservation

STRUCTURAL STABILITY: Fair. Open cracks running alongside joints on both sides of the panel; small cracks around fixings in three corners of the cast.

CHIPS AND LOSS: Missing areas associated with the cracks.

- Prior to any conservation treatment, the cast was photographed. This photographic documentation was continued throughout all conservation processes.
- Initially, the cast was dry cleaned with soft brushes and Wishab Sponges with a rubber-nozzled vacuum to pick up loose dust and dirt.
- Following wet cleaning spot tests, the surface of the panel was cleaned with 2-5% Vulpex Liquid Soap in de-ionised water, using cotton wool swabs.

- All areas of raw plaster were given an application of 10% Paraloid B72 in acetone to provide an isolating layer between the original plaster and the repairs.
- Exposed metal fixings were treated with 5% Tannic Acid so as to stabilise the corrosion, and covered with a protective layer of 20% Paraloid B72 in acetone.
- Areas of loss, open joints and cracks were filled with white micro-balloons with 12% Paraloid B72 in acetone. Larger areas of loss around the screws were filled with an inert filler to provide extra strength.
- All the fills were then toned out with acrylics, mixed with matting agent, to match the surrounding patina.
- Finally, the entire cast was given an application of micro-crystalline wax so as to protect the surface.

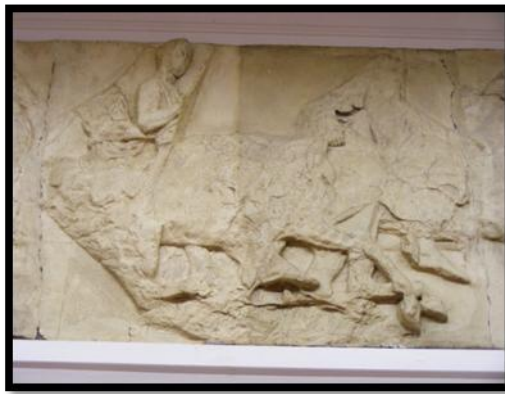
Cast during wet cleaning

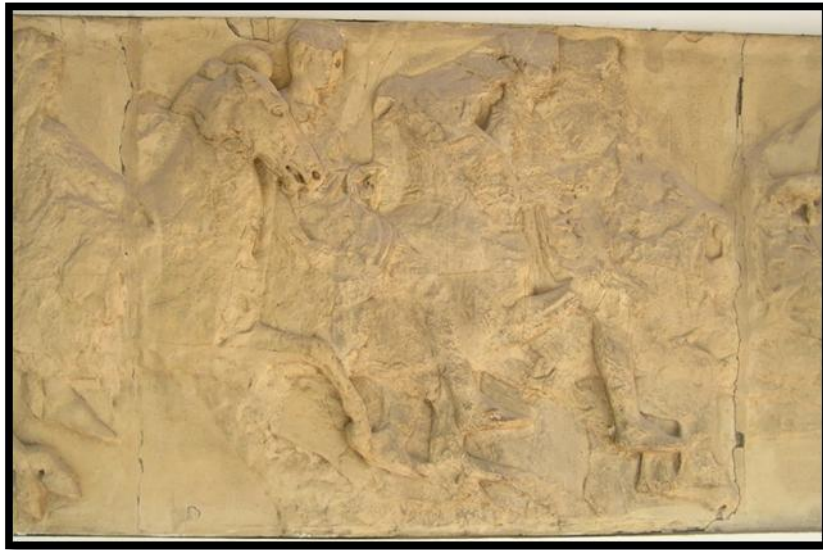
PANEL 6

Panel before conservation

STRUCTURAL STABILITY: Fair. Open cracks running alongside joints on both sides of the panel and at top dexter corner; small cracks around fixings in three corners of the cast.

CHIPS AND LOSS: Missing areas associated with the cracks.

- Prior to any conservation treatment, the cast was photographed. This photographic documentation was continued throughout all conservation processes.
- Initially, the cast was dry cleaned with soft brushes and Wishab Sponges with a rubber-nozzled vacuum to pick up loose dust and dirt.

- Following wet cleaning spot tests, the surface of the panel was cleaned with 2-5% Vulpex Liquid Soap in de-ionised water, using cotton wool swabs.
- All areas of raw plaster were given an application of 10% Paraloid B72 in acetone to provide an isolating layer between the original plaster and the repairs.

- Exposed metal fixings were treated with 5% Tannic Acid so as to stabilise the corrosion, and covered with a protective layer of 20% Paraloid B72 in acetone.

- Areas of loss, open joints and cracks were filled with white micro-balloons with 12% Paraloid B72 in acetone. Larger areas of loss around the screws were filled with an inert filler to provide extra strength.

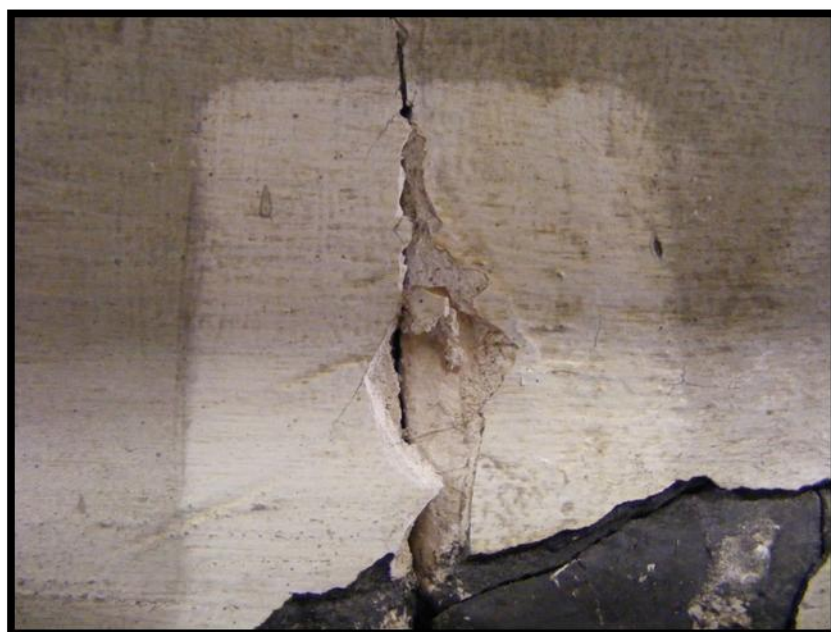
A mortar analysis was carried out by Mr Bill Revie of CMC on samples of the pointing material found between the Panel 10 and 11 on Ground Floor Galley North Wall. The mortar was found to be a thick layer of lime putty, gypsum plaster and fine sand and hair, followed by a thin layer of gypsum plaster and lime putty; and finally a layer of varnish. This final layer of varnish is found over the entire two floors of the North and South Walls and yet, interestingly, for some unknown reason, it was not applied to the slabs on the East Wall.

Samples of mortar were taken for analysis

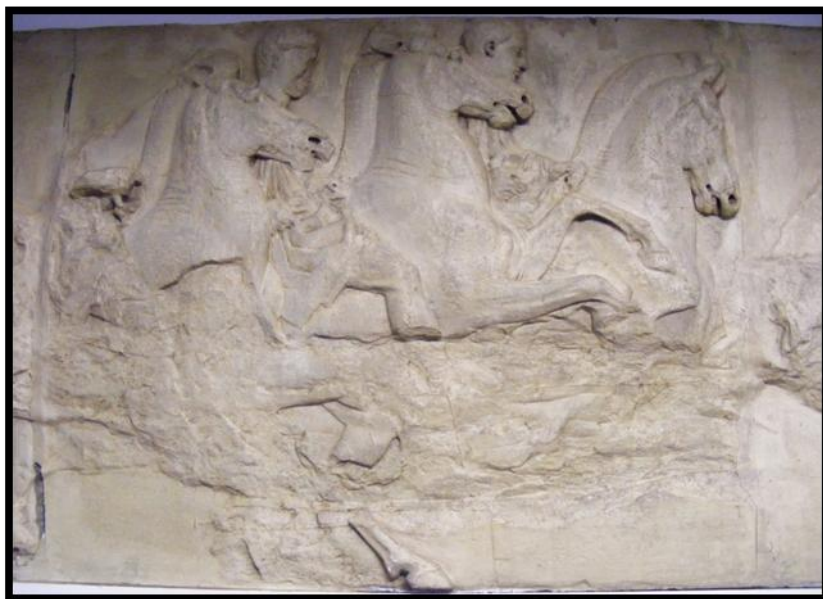
PANEL 7

Panel before conservation

STRUCTURAL STABILITY: Fair. Open cracks running alongside joints on both sides of the panel; large crack running from dexter side of panel towards centre of the cast in its upper part.

CHIPS AND LOSS: Missing areas associated with the cracks and around screws on both sides of the panel at its lower edge.

- Prior to any conservation treatment, the cast was photographed. This photographic documentation was continued throughout all conservation processes.
- Initially, the cast was dry cleaned with soft brushes and Wishab Sponges with a rubber-nozzled vacuum to pick up the loose dust and dirt.
- Following a variety of wet cleaning spot tests, the surface of the panel was cleaned with 2-5% Vulpex Liquid Soap in de-ionised water, using cotton wool swabs.

- All areas of raw plaster were given an application of 10% Paraloid B72 in acetone to provide an isolating layer between the original plaster and the repairs.
- Exposed metal fixings were treated with 5% Tannic Acid so as to stabilise the corrosion, and covered with a protective layer of 20% Paraloid B72 in acetone.
- Areas of loss, open joints and cracks were filled with white micro-balloons mixed with 12% Paraloid B72 in acetone. Larger areas of loss around the screws were filled with an inert filler to provide extra strength.

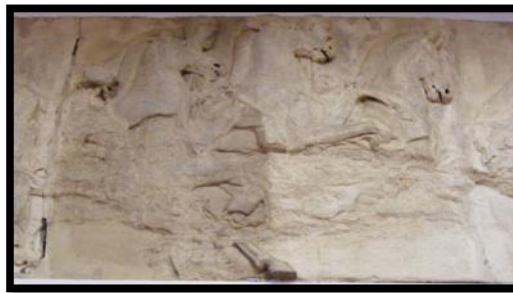
Cast during wet cleaning

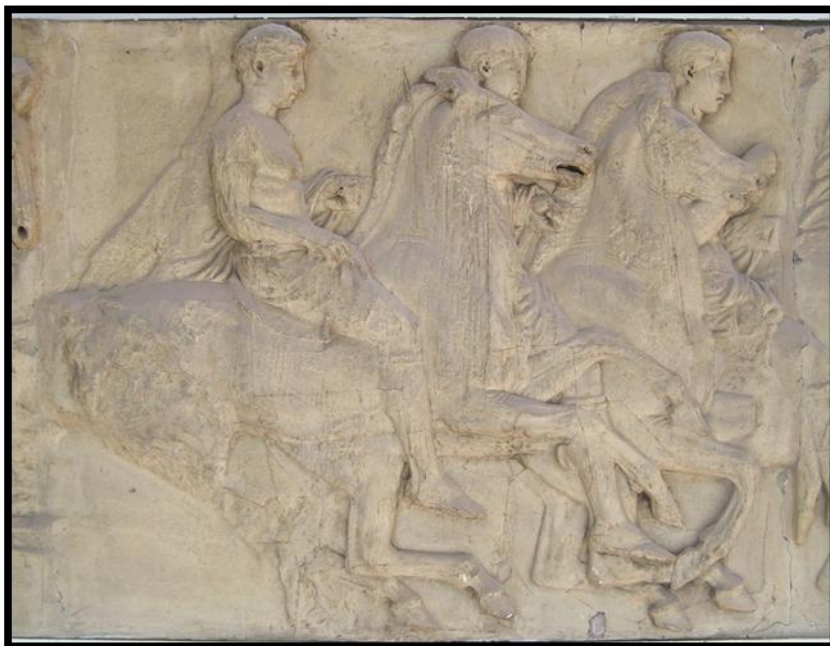
PANEL 8

Panel before conservation

STRUCTURAL STABILITY: Fair. Open cracks running alongside joints on both sides of the panel; small cracks around fixings in three corners of the cast.

CHIPS AND LOSSES: Missing areas associated with the cracks.

- Prior to any conservation treatment, the cast was photographed. This photographic documentation was continued throughout all conservation processes.
- Initially, the cast was dry cleaned with soft brushes and Wishab Sponges with a rubber-nozzled vacuum to pick up the loose dust and dirt.
- Following a variety of wet cleaning spot tests, the surface of the panel was cleaned with 2-5% Vulpex Liquid Soap in de-ionised water, using cotton wool swabs.

- All areas of raw plaster were given an application of 10% Paraloid B72 in acetone to provide an isolating layer between the original plaster and the repairs.
- Exposed metal fixings were treated with 5% Tannic Acid so as to stabilise the corrosion, and covered with a protective layer of 20% Paraloid B72 in acetone.
- Areas of loss, open joints and cracks were filled with white micro-balloons mixed with 12% Paraloid B72 in acetone. Larger areas of loss around the screws were filled with an inert filler to provide extra strength.

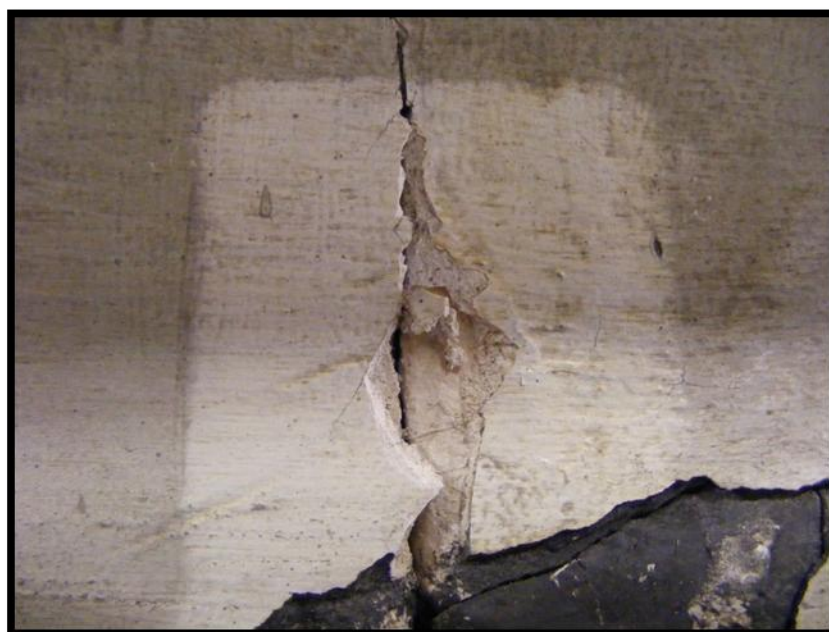
A mortar analysis was carried out by Mr Bill Revie of CMC on samples of the pointing material found between the Panel 10 and 11 on Ground Floor Galley North Wall. The mortar was found to be a thick layer of lime putty, gypsum plaster and fine sand and hair, followed by a thin layer of gypsum plaster and lime putty; and finally a layer of varnish. This final layer of varnish is found over the entire two floors of the North and South Walls and yet, interestingly, for some unknown reason, it was not applied to the slabs on the East Wall.

Samples of mortar were taken for analysis

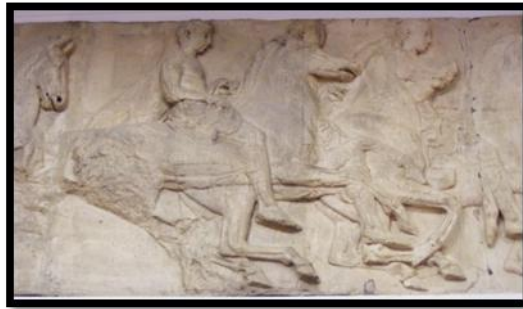
Cast during wet cleaning

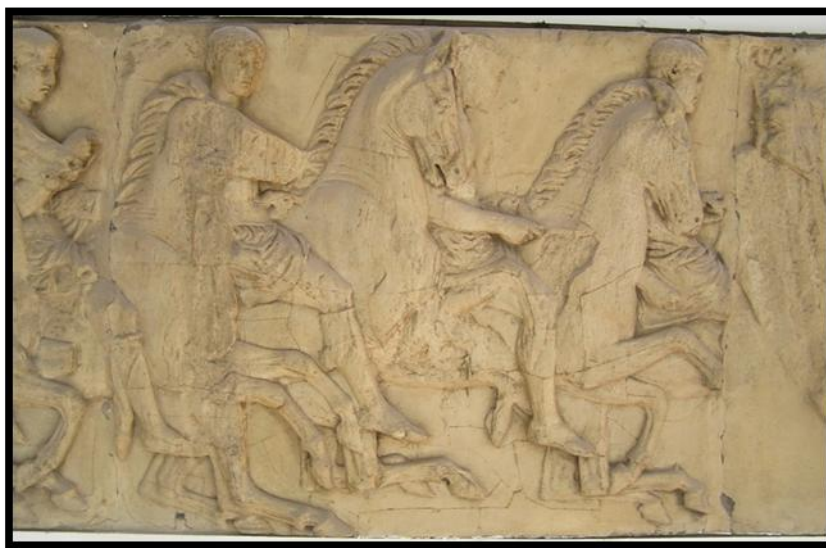
PANEL 9

Panel before conservation

- Prior to any conservation treatment, the cast was photographed. This photographic documentation was continued throughout all conservation processes.
- Initially, the cast was dry cleaned with soft brushes and Wishab Sponges with a rubber-nozzled vacuum to pick up the loose dust and dirt.
- Following a variety of wet cleaning spot tests, the surface of the panel was cleaned with 2-5% Vulpex Liquid Soap in de-ionised water, using cotton wool swabs.

- All areas of raw plaster were given an application of 10% Paraloid B72 in acetone to provide an isolating layer between the original plaster and the repairs.
- Exposed metal fixings were treated with 5% Tannic Acid so as to stabilise the corrosion, and covered with a protective layer of 20% Paraloid B72 in acetone.
- Areas of loss, open joints and cracks were filled with white micro-balloons mixed with 12% Paraloid B72 in acetone. Larger areas of loss around the screws were filled with an inert filler to provide extra strength.

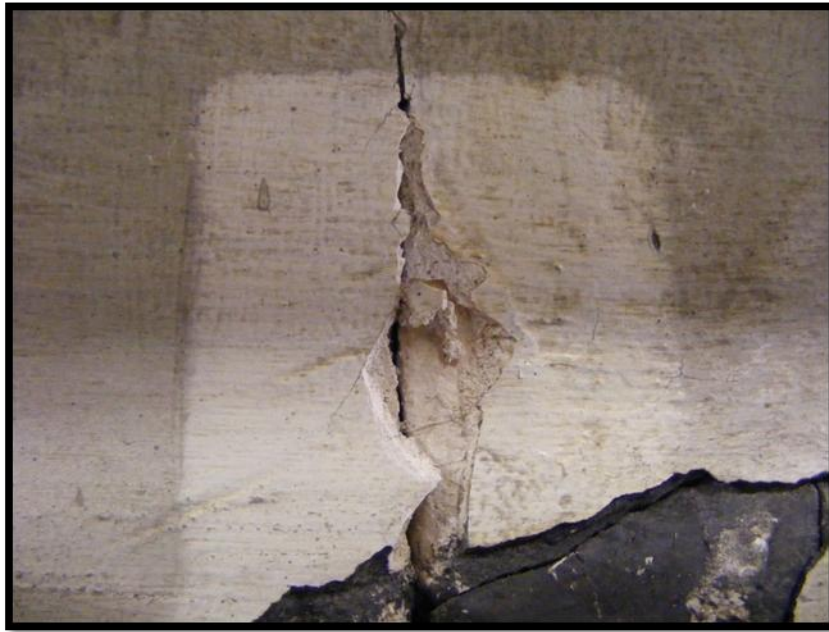
A mortar analysis was carried out by Mr Bill Revie of CMC on samples of the pointing material found between the Panel 10 and 11 on Ground Floor Galley North Wall. The mortar was found to be a thick layer of lime putty, gypsum plaster and fine sand and hair, followed by a thin layer of gypsum plaster and lime putty; and finally a layer of varnish. This final layer of varnish is found over the entire two floors of the North and South Walls and yet, interestingly, for some unknown reason, it was not applied to the slabs on the East Wall.

Samples of mortar were taken for analysis

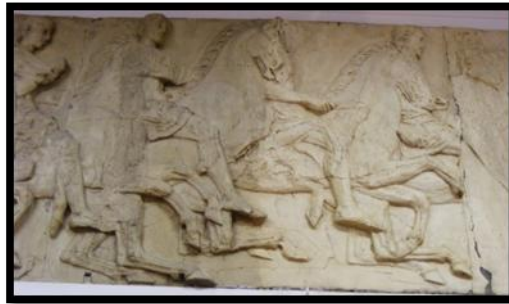
Cast during wet cleaning

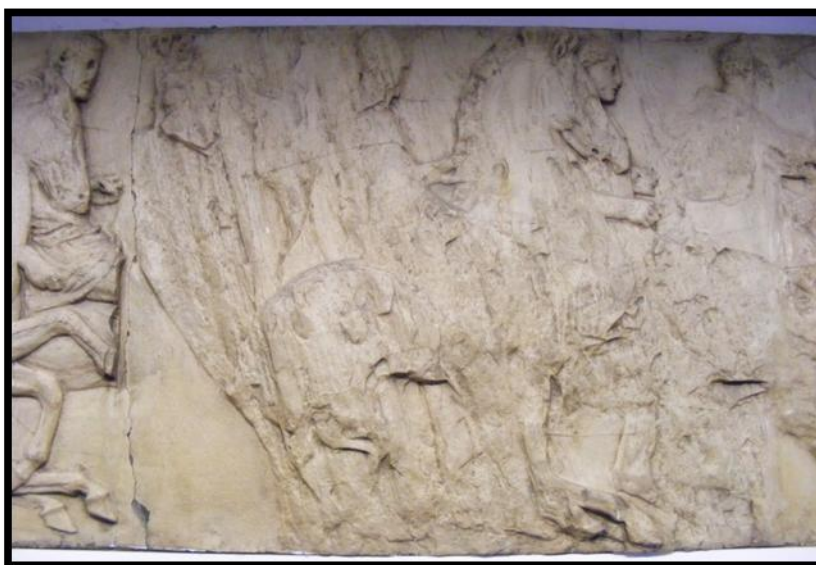
PANEL 10

Panel before conservation

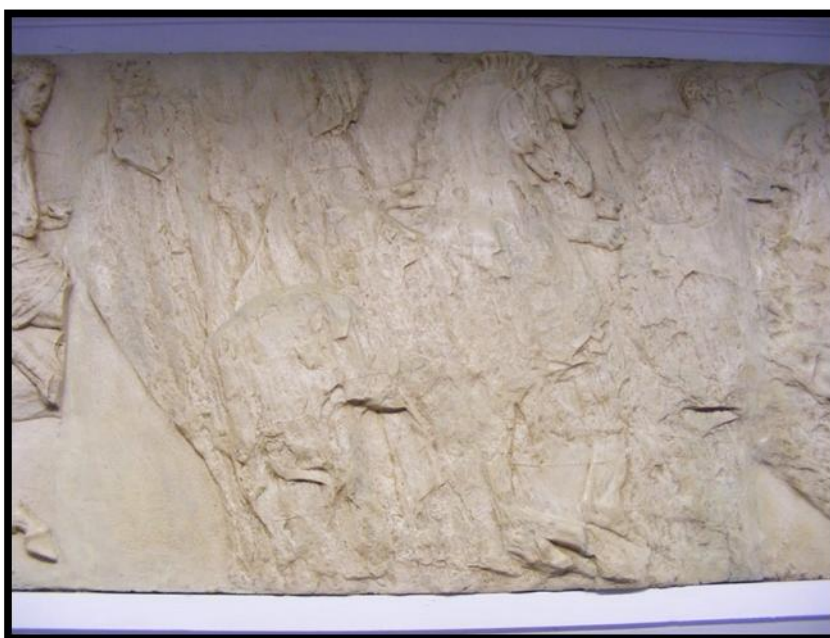
Panel after conservation

STRUCTURAL STABILITY: Fair. Open cracks running alongside joints on both sides of the panel; small cracks around fixings on top part of the panel.

CHIPS AND LOSS: Missing areas associated with the cracks, mainly on dexter side.

- Prior to any conservation treatment, the cast was photographed. This photographic documentation was continued throughout all conservation processes.
- Initially, the cast was dry cleaned with soft brushes and Wishab Sponges with a rubber-nozzled vacuum to pick up the loose dust and dirt.
- Following a variety of wet cleaning spot tests, the surface of the panel was cleaned with 2-5% Vulpex Liquid Soap in de-ionised water, using cotton wool swabs.

- Areas of flaking paint were consolidated with 5% Primal B60A in de-ionised water.
- All areas of raw plaster were given an application of 10% Paraloid B72 in acetone to provide an isolating layer between the original plaster and the repairs.
- Exposed metal fixings were treated with 5% Tannic Acid so as to stabilise the corrosion, and covered with a protective layer of 20% Paraloid B72 in acetone.
- Areas of loss, open joints and cracks were filled with white micro-balloons mixed with 12% Paraloid B72 in acetone. Larger areas of loss around the screws were filled with an inert filler to provide extra strength.
- All the fills were then toned out with acrylics, mixed with matting agent, to match the surrounding patina.
- Finally, the entire cast was given an application of micro-crystalline wax so as to protect the surface.

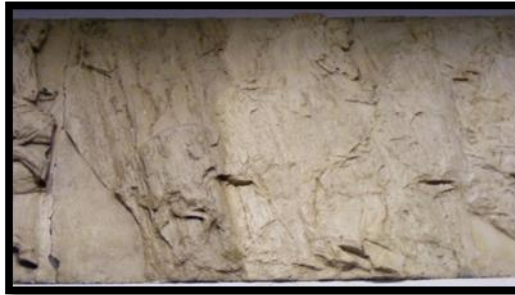
Cast during wet cleaning

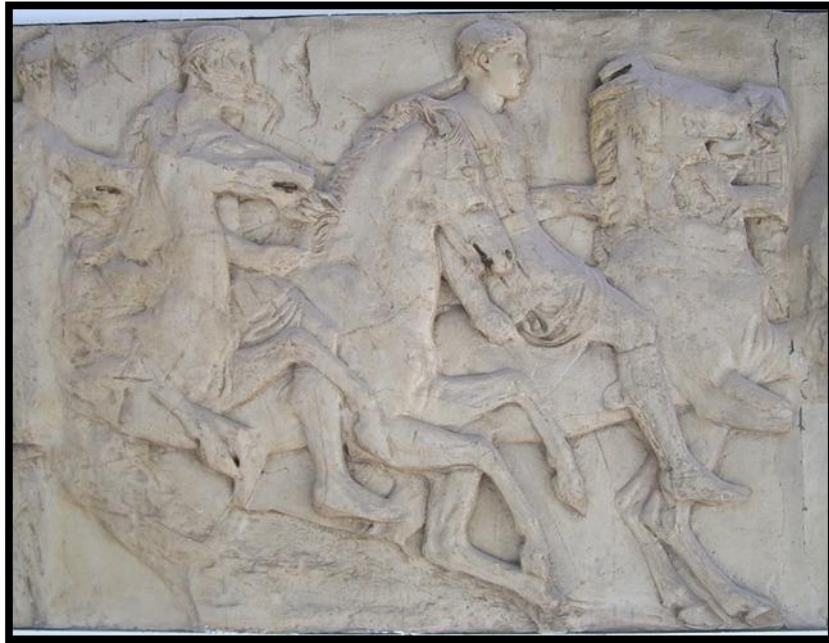
Panel before conservation

STRUCTURAL STABILITY: Fair. Open cracks running alongside joints on both sides of the panel; small cracks around fixings on top part of the cast.

CHIPS AND LOSS: Missing areas associated with the cracks, mainly on sinister side of the panel.

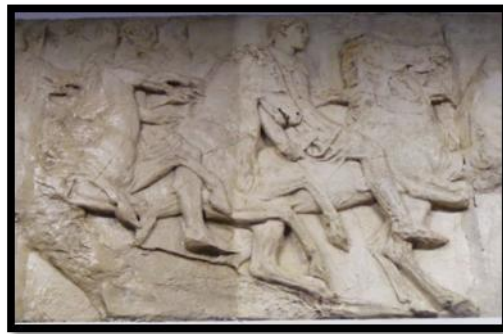
Cast during wet cleaning

- Prior to any conservation treatment, the cast was photographed. This photographic documentation was continued throughout all conservation processes.
- Initially, the cast was dry cleaned with soft brushes and Wishab Sponges with a rubber-nozzled vacuum to pick up the loose dust and dirt.
- Following a variety of wet cleaning spot tests, the surface of the panel was cleaned with 2-5% Vulpex Liquid Soap in de-ionised water, using cotton wool swabs.

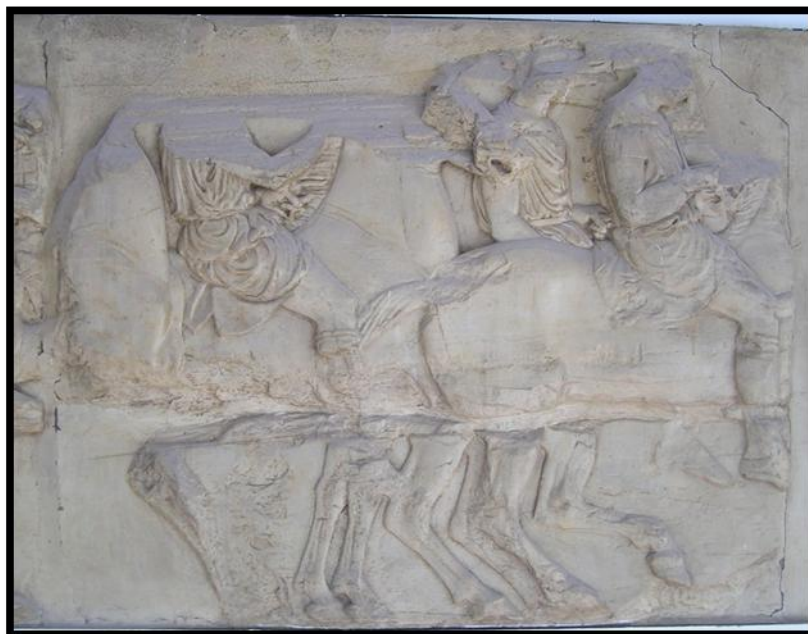
Panel before conservation

STRUCTURAL STABILITY: Fair. Open cracks running alongside joints on both sides of the panel, and through the cast on its lower part; small cracks around the fixings.

CHIPS AND LOSS: Missing areas associated with the cracks, mainly on dexter side of the panel.

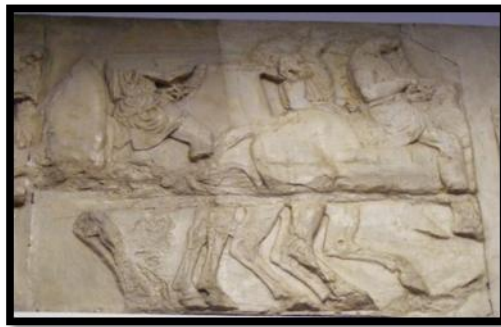
Cast during wet cleaning

- Prior to any conservation treatment, the cast was photographed. This photographic documentation was continued throughout all conservation processes.
- Initially, the cast was dry cleaned with soft brushes and Wishab Sponges with a rubber-nozzled vacuum to pick up the loose dust and dirt.
- Following a variety of wet cleaning spot tests, the surface of the panel was cleaned with 2-5% Vulpex Liquid Soap in de-ionised water, using cotton wool swabs.

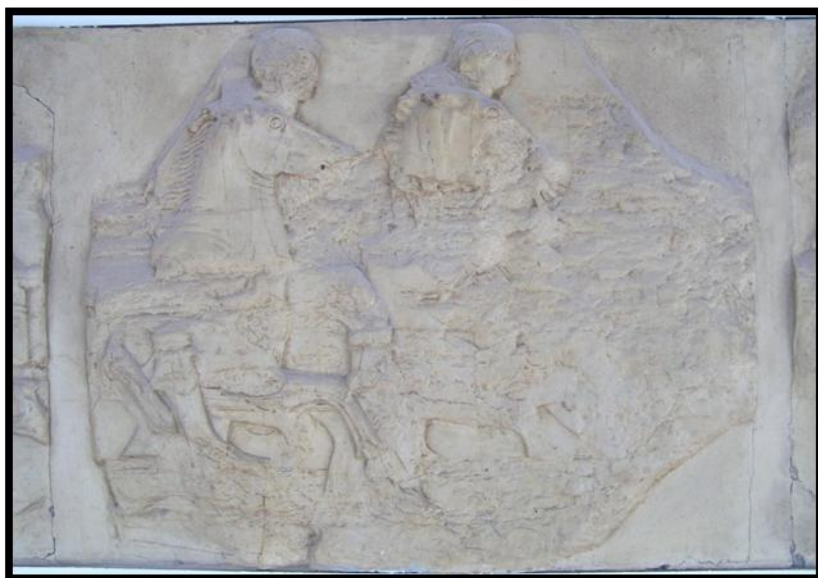
Panel before conservation

STRUCTURAL STABILITY: Fair. Open cracks running alongside joints on both sides of the panel, and through the cast on its lower part; small cracks around the fixings.

CHIPS AND LOSS: Missing areas associated with the cracks.

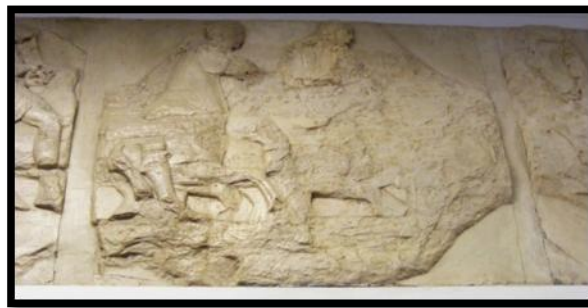
Cast during wet cleaning

- Prior to any conservation treatment, the cast was photographed. This photographic documentation was continued throughout all conservation processes.
- Initially, the cast was dry cleaned with soft brushes and Wishab Sponges with a rubber-nozzled vacuum to pick up the loose dust and dirt.
- Following a variety of wet cleaning spot tests, the surface of the panel was cleaned with 2-5% Vulpex Liquid Soap in de-ionised water, using cotton wool swabs.

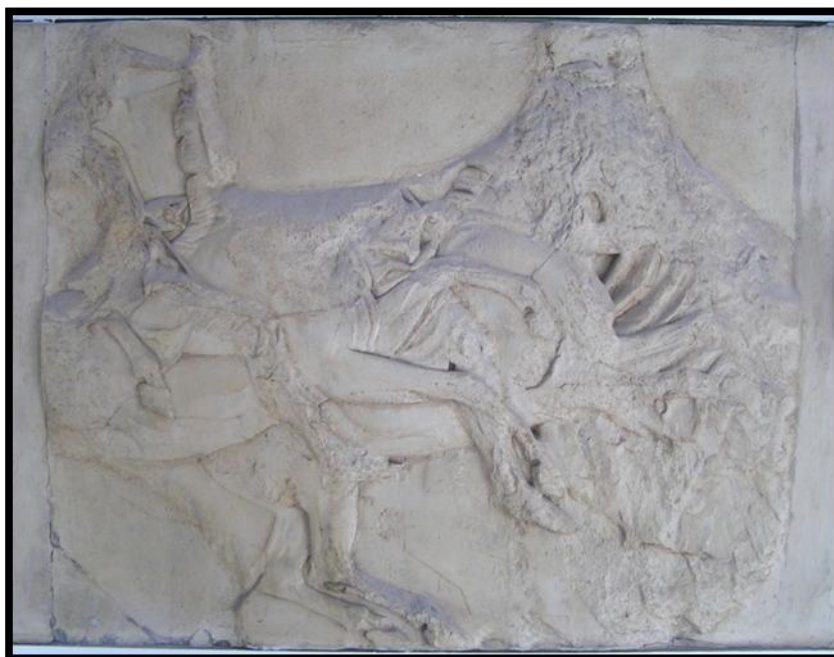
Panel before conservation

STRUCTURAL STABILITY: Fair. Open cracks running alongside joints on both sides of the panel; small cracks around the fixings in lower part of the cast.

CHIPS AND LOSS: Missing areas associated with the cracks by bottom edge of the panel.

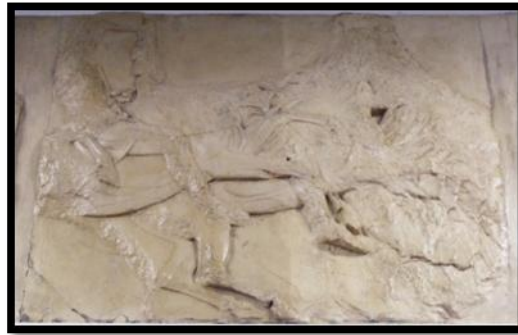
Cast during wet cleaning

- Prior to any conservation treatment, the cast was photographed. This photographic documentation was continued throughout all conservation processes.
- Initially, the cast was dry cleaned with soft brushes and Wishab Sponges with a rubber-nozzled vacuum to pick up the loose dust and dirt.
- Following a variety of wet cleaning spot tests, the surface of the panel was cleaned with 2-5% Vulpex Liquid Soap in de-ionised water, using cotton wool swabs.

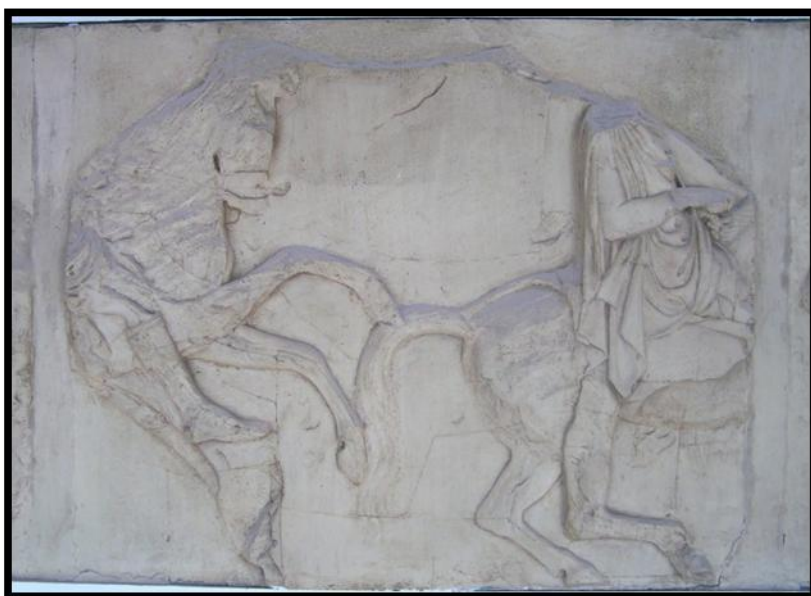
Panel before conservation

STRUCTURAL STABILITY: Fair. Open cracks running alongside joints on both sides of the panel; small cracks around the fixings.

CHIPS AND LOSS: Missing areas associated with the cracks at lower edge of the panel.

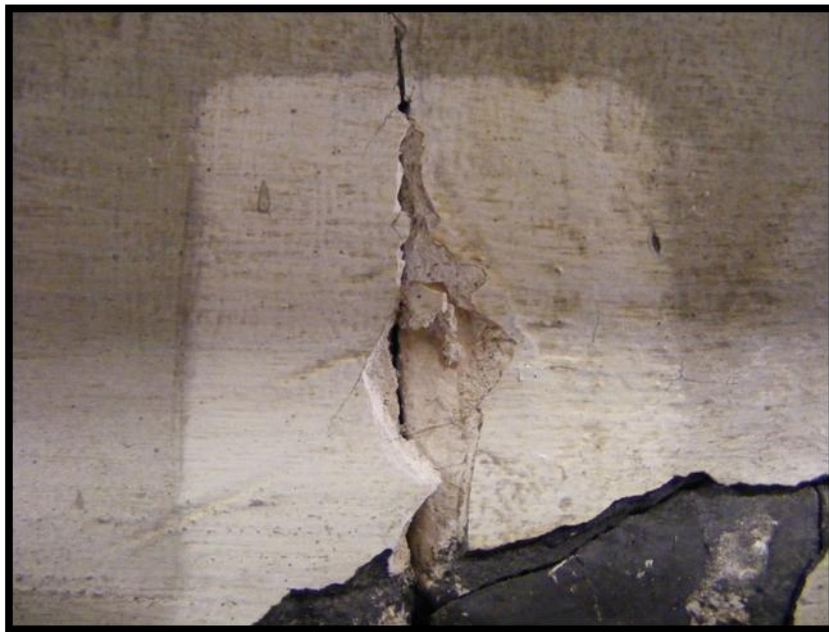
At the time of re-siting the cast collection from the Royal Scottish Academy building on Princes Street to the Edinburgh College of Art in 1913, the Parthenon Frieze panels were installed with metal fixings set into the wall. The open joints between the panels were filled with a mortar that was smeared over the adjacent edges of the panels.

A mortar analysis was carried out by Mr Bill Revie of CMC on samples of the pointing material found between the Panel 10 and 11 on Ground Floor Galley North Wall. The mortar was found to be a thick layer of lime putty, gypsum plaster and fine sand and hair, followed by a thin layer of gypsum plaster and lime putty; and finally a layer of varnish. This final layer of varnish is found over the entire two floors of the North and South Walls and yet, interestingly, for some unknown reason, it was not applied to the slabs on the East Wall.

Samples of mortar were taken for analysis

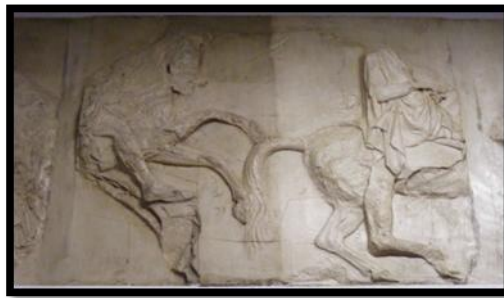
Cast during wet cleaning

- Prior to any conservation treatment, the cast was photographed. This photographic documentation was continued throughout all conservation processes.
- Initially, the cast was dry cleaned with soft brushes and Wishab Sponges with a rubber-nozzled vacuum to pick up the loose dust and dirt.
- Following a variety of wet cleaning spot tests, the surface of the panel was cleaned with 2-5% Vulpex Liquid Soap in de-ionised water, using cotton wool swabs.

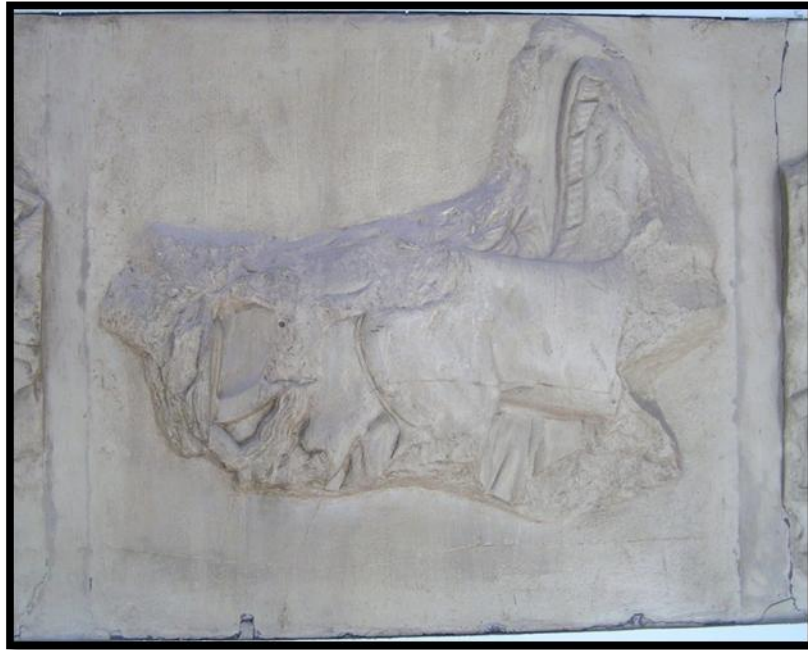
Panel before conservation

STRUCTURAL STABILITY: Fair. Open cracks running alongside joints on both sides of the panel; small cracks around the fixings in lower part of the panel.

CHIPS AND LOSS: Missing areas associated with the cracks mainly by the bottom edge of the panel.

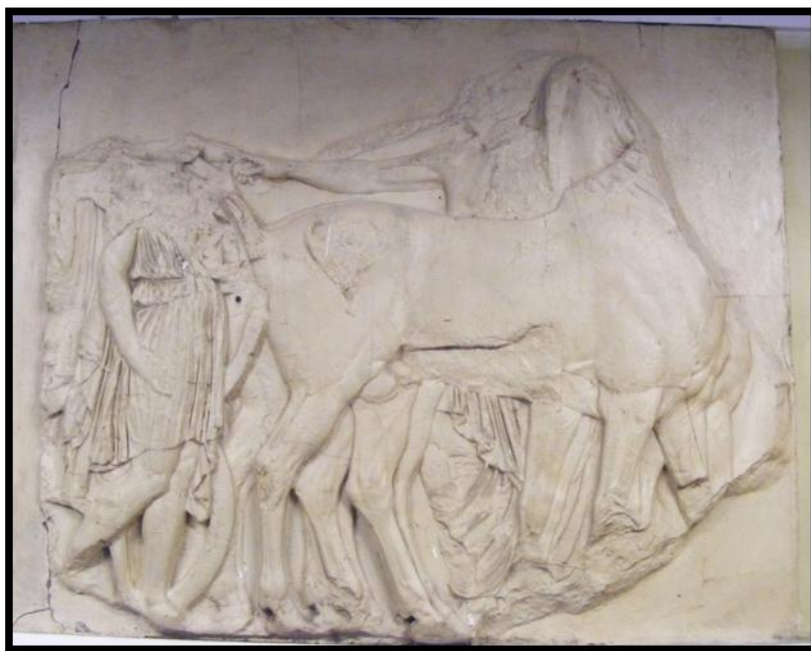
Panel before conservation

STRUCTURAL STABILITY: Fair. Open cracks running alongside joints on both sides of the panel; small cracks around the fixings in upper part of the panel.

CHIPS AND LOSS: Missing areas associated with the cracks mainly at the lower edge of the panel; flaking paint in lower, dexter part of the panel.

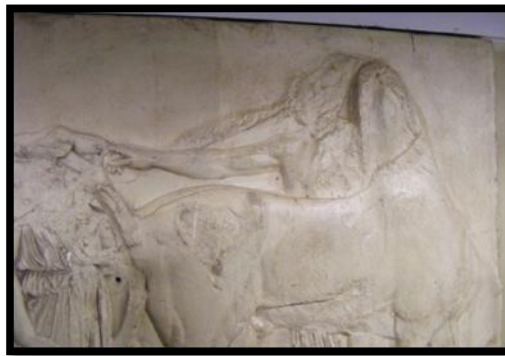
Panel during wet cleaning

- Prior to any conservation treatment, the cast was photographed. This photographic documentation was continued throughout all conservation processes.
- Initially, the cast was dry cleaned with soft brushes and Wishab Sponges with a rubber-nozzled vacuum to pick up the loose dust and dirt.
- Following a variety of wet cleaning spot tests, the surface of the panel was cleaned with 2-5% Vulpex Liquid Soap in de-ionised water, using cotton wool swabs.
