1. PARTHENON FRIEZE

1.3 SCULPTURE COURT LOWER GALLERY SOUTH WALL

PANEL 1

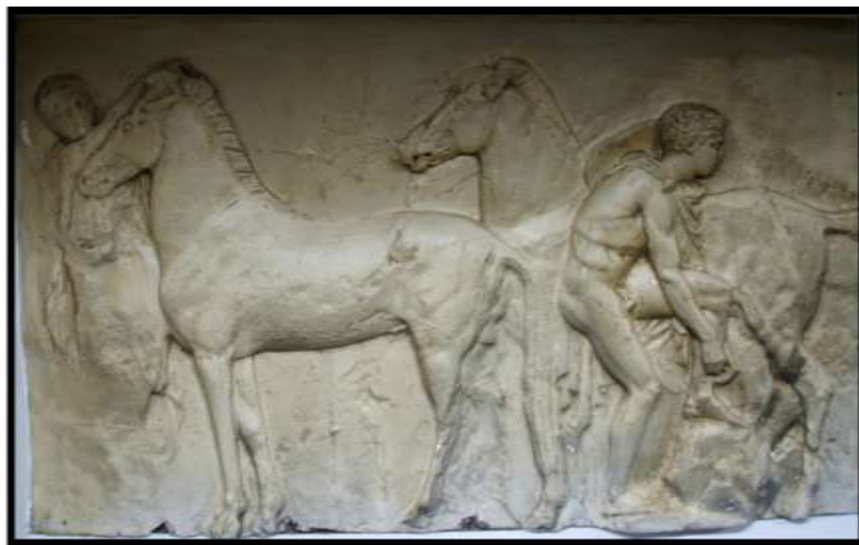
Panel before conservation

STRUCTURAL STABILITY: Fair. Open crack running alongside joint on sinister side of the panel; crack running from dexter side towards centre of the cast, and from the top towards centre of the panel on its sinister side; small cracks around fixings at lower edge.

SURFACE DUST AND DIRT: Severe, 100% coverage

VISIBLE PAINT LAYERS/UNSIGHTLY MARKINGS: Layer of cream-yellow paint/varnish on surface of the cast; the surface polychrome is discoloured and damaged on lower part of the panel probably by strip of lights which used to run just under the Frieze alongside the South and North walls on the Ground Floor Gallery; small spots of paint splash mainly at dexter and at lower edge of the panel; flaking and missing paint area on lower part of the panel.

CHIPS AND LOSS: Missing areas associated with the cracks and around screws at lower edge of the panel.

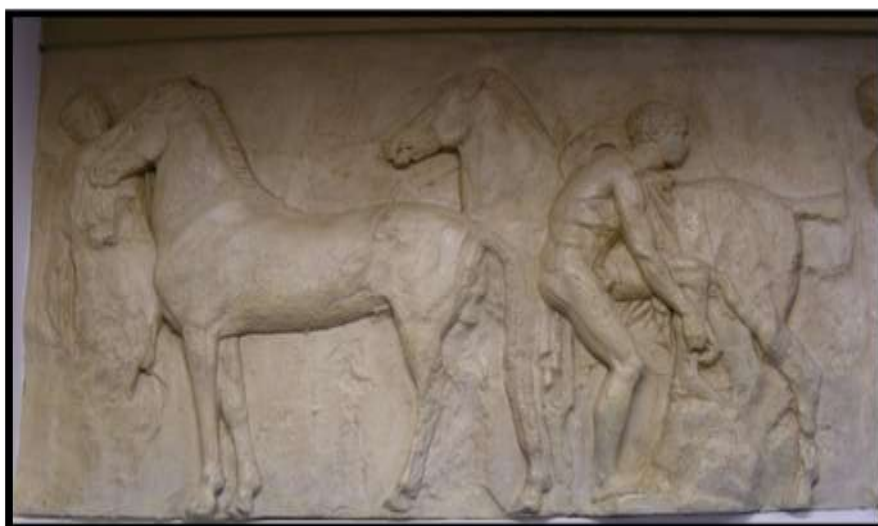
Panel after conservation

- Prior to any conservation treatment, the cast was photographed. This photographic documentation was continued throughout all conservation processes.
- Initially, the cast was dry cleaned with soft brushes and Wishab Sponges with a rubber-nozzled vacuum to pick up the loose dust and dirt.
- Following wet cleaning spot tests on **Panel 1 on Upper Gallery South Wall**, the surface of the cast was cleaned with 2-5% Vulpex Liquid Soap in de-ionised water, using cotton wool swabs.

- Areas of flaking paint were consolidated with 5% Primal B60A in de-ionised water.
- All areas of raw plaster were given an application of 10% Paraloid B72 in acetone to provide an isolating layer between the original plaster and the repairs.
- Exposed metal fixings were treated with 5% Tannic Acid so as to stabilise the corrosion, and covered with a protective layer of 20% Paraloid B72 in acetone.
- Areas of loss, open joints and cracks were filled with white micro-balloons mixed with 12% Paraloid B72 in acetone. Larger areas of loss around the screws were filled with an inert filler to provide extra strength.
- All the fills and areas of discoloured paint were then toned out with acrylics, mixed with matting agent, to match the surrounding patina.
- Finally, the entire cast was given an application of micro-crystalline wax so as to protect the surface.

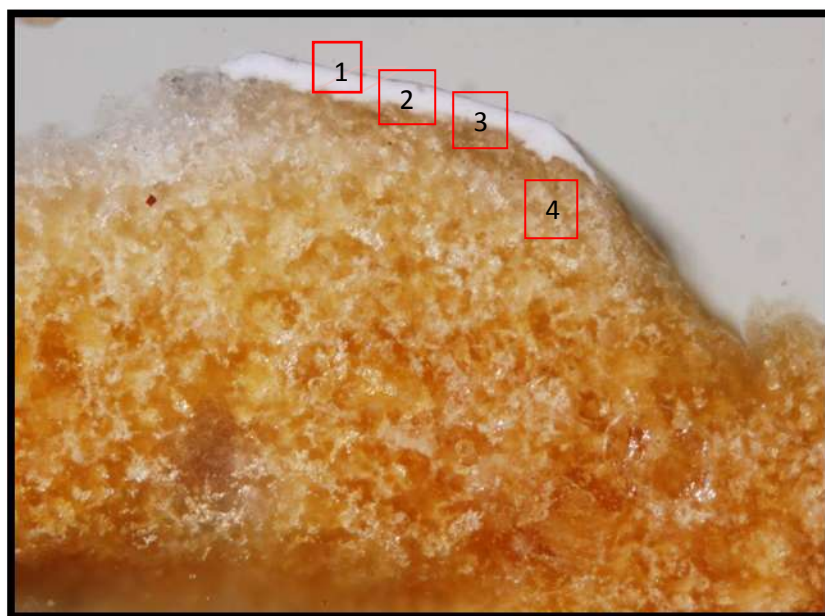
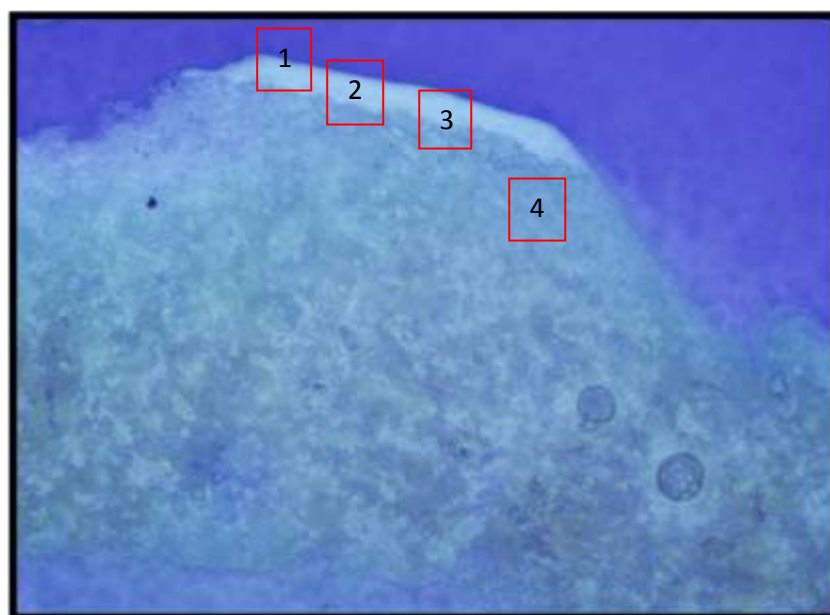
Parthenon Frieze, Lower Gallery South Wall, Panel 1 – Cross-section 1

Photograph of the Cross-section 1, paint sample from Panel 1

Photograph of Cross-section 1, paint sample from Panel 1 in UV light

The cross-section showed a thin black dirt layer on a bright white layer on top of a slightly more creamy white paint layer. Below this is a thick layer of orange coloured plaster. Both paint layers fluoresced blue-white in UV light indicating lead white. The orange material appeared to have a yellowish fluorescence hence GC-MS was carried out in order to look for shellac.

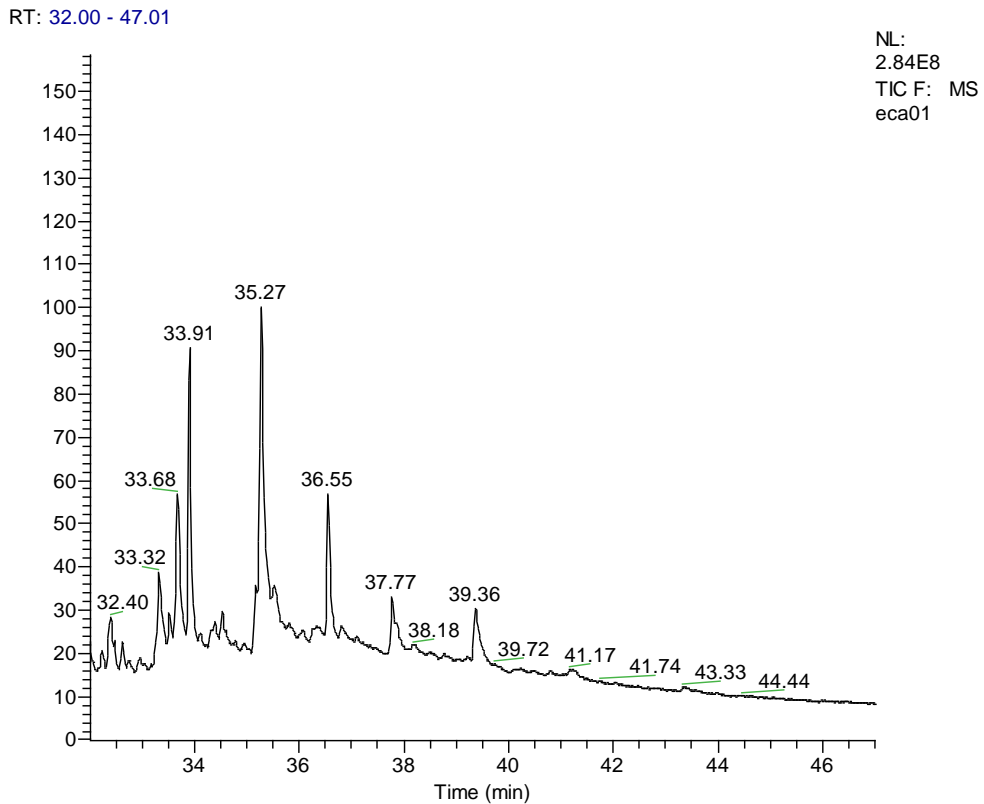
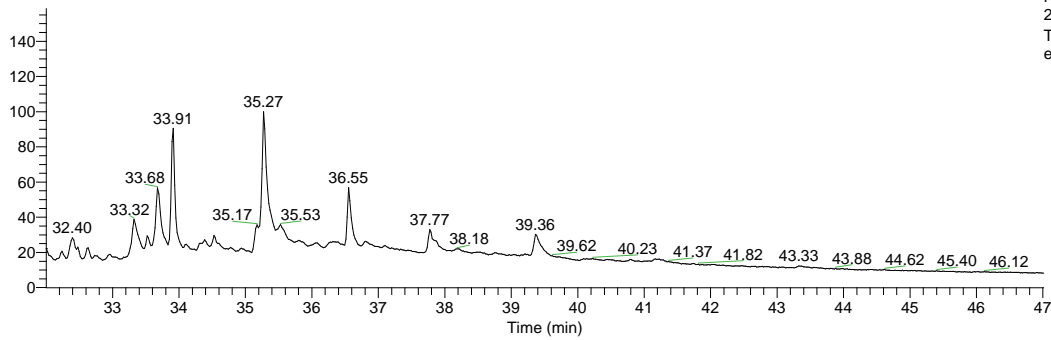
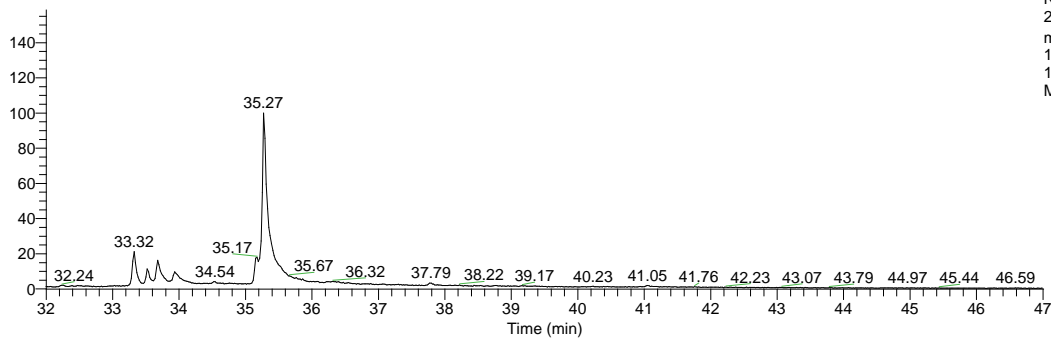
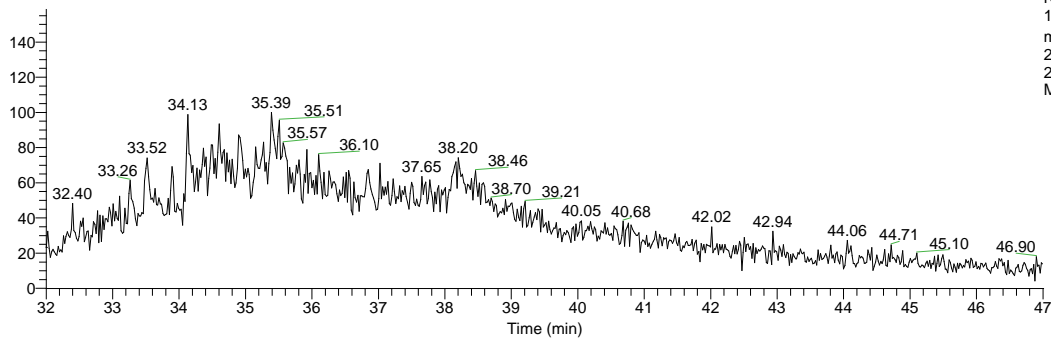
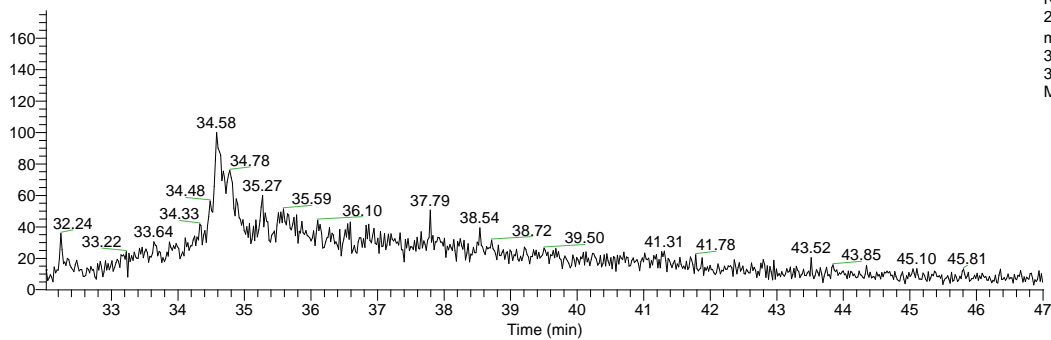
An attempt was made to find indicative components for shellac by displaying single ion chromatographs (Figure 18). Mills and White report³ that shellac can be identified by characteristic, but unidentified compounds, showing a 276 ion and a 308 ion. Compounds containing a 155 ion are also abundant in shellac. However this sample did not yield compounds peaks at similar retention times with a mass 276 ion (Figure 18) and also with a mass 308 ion (Figure 18). There are abundant peaks with a 155 ion count (Figure 18) but these were found to be due to epoxy-carboxylic acids, these, being oxidation products of the oil.

Chromatogram of sample 1 from Panel 1, detail; 33 - 46 minutes

Single ion chromatographs from sample 1 from Panel 1.

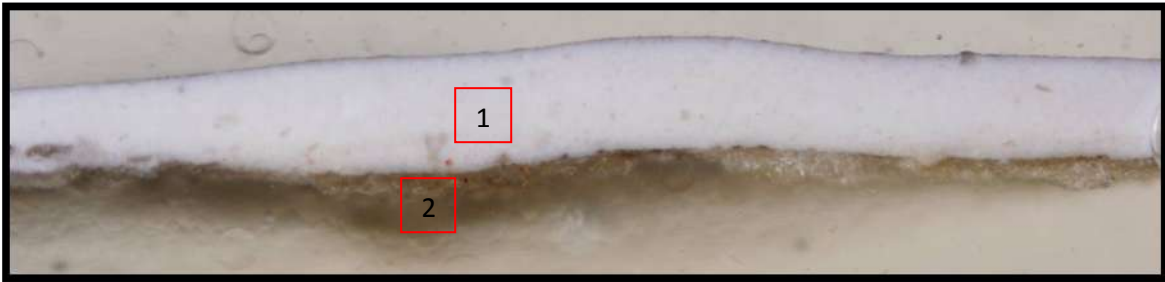
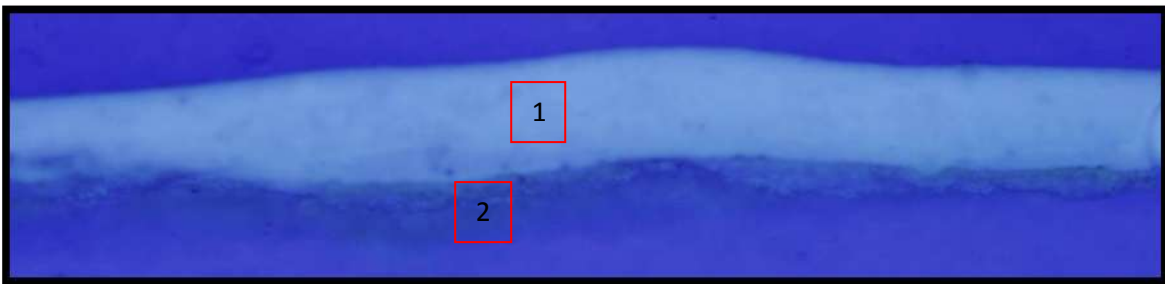
Parthenon Frieze, Lower Gallery South Wall, Panel 1 – Cross-section 2

Photograph of the Cross-section 2, paint sample from Panel 1

Photograph of Cross-section 2, paint sample from Panel 1 in UV light

This cross-section showed a trace of the plaster layer and what appears to be a single layer of white paint, which gives a blue-white fluorescence under UV and therefore probably contains lead white.

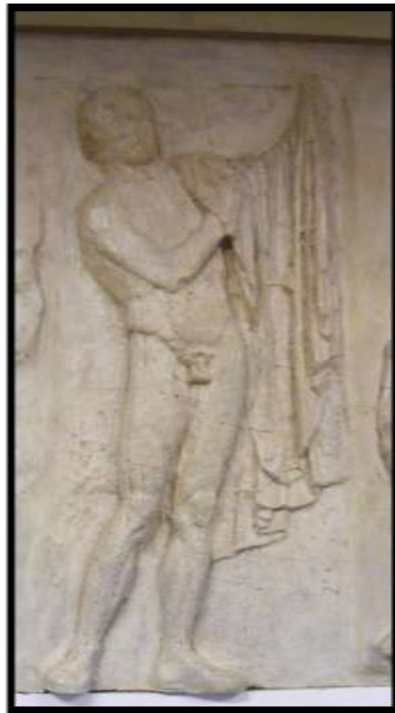
Panel after conservation

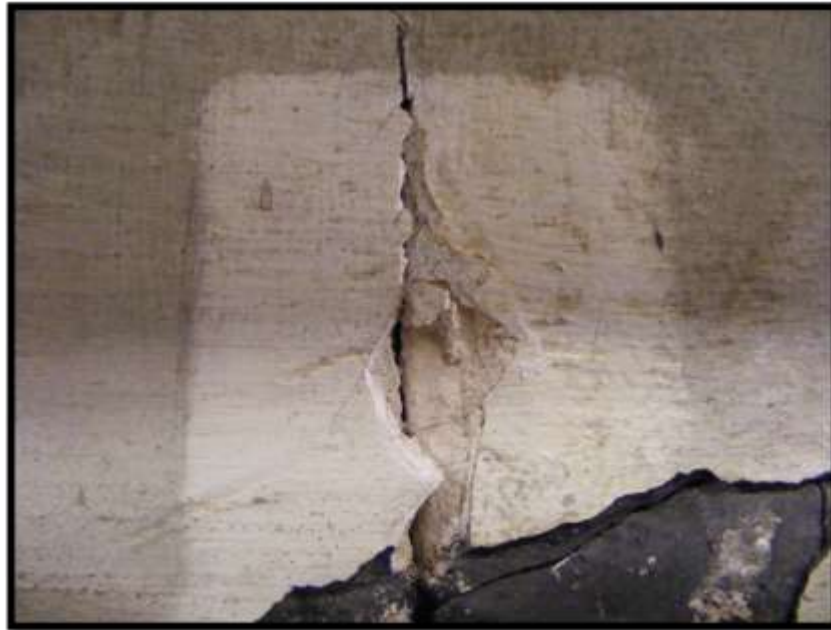
A mortar analysis was carried out by Mr Bill Revie of CMC on samples of the pointing material found between the Panel 10 and 11 on Ground Floor Galley North Wall. The mortar was found to be a thick layer of lime putty, gypsum plaster and fine sand and hair, followed by a thin layer of gypsum plaster and lime putty; and finally a layer of varnish. This final layer of varnish is found over the entire two floors of the North and South Walls and yet, interestingly, for some unknown reason, it was not applied to the slabs on the East Wall.

Samples of mortar were taken for analysis

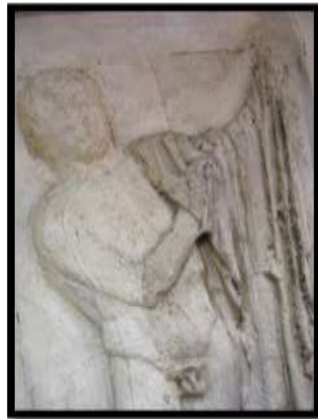
Panel during wet cleaning

- Prior to any conservation treatment the cast was photographed. This photographic documentation was continued throughout all conservation processes.
- Initially, the cast was dry cleaned with soft brushes and Wishab Sponges with a rubber-nozzled vacuum to pick up loose dust and dirt.
- Following wet cleaning spot tests on **Panel 1 on Upper Gallery South Wall**, the surface of the cast was cleaned with 2-5% Vulpex Liquid Soap in de-ionised water, using cotton wool swabs.

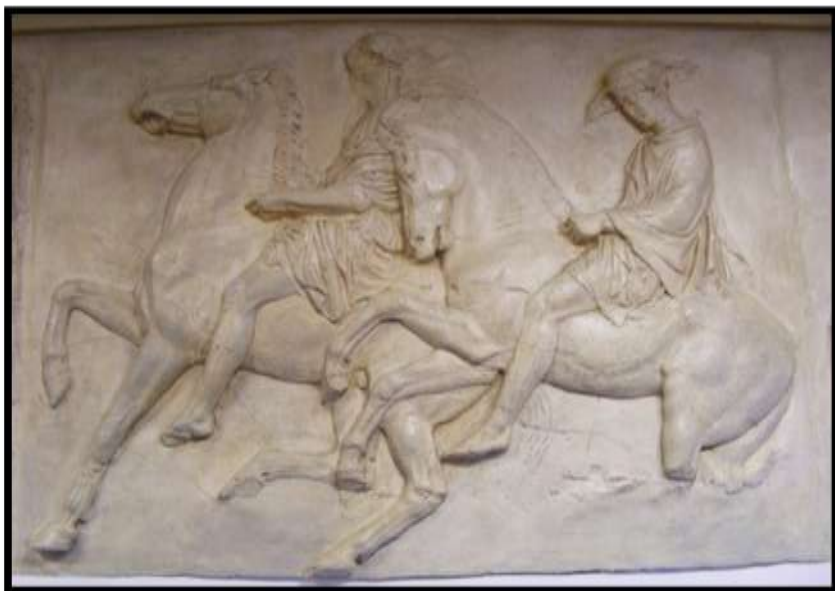
Panel after conservation

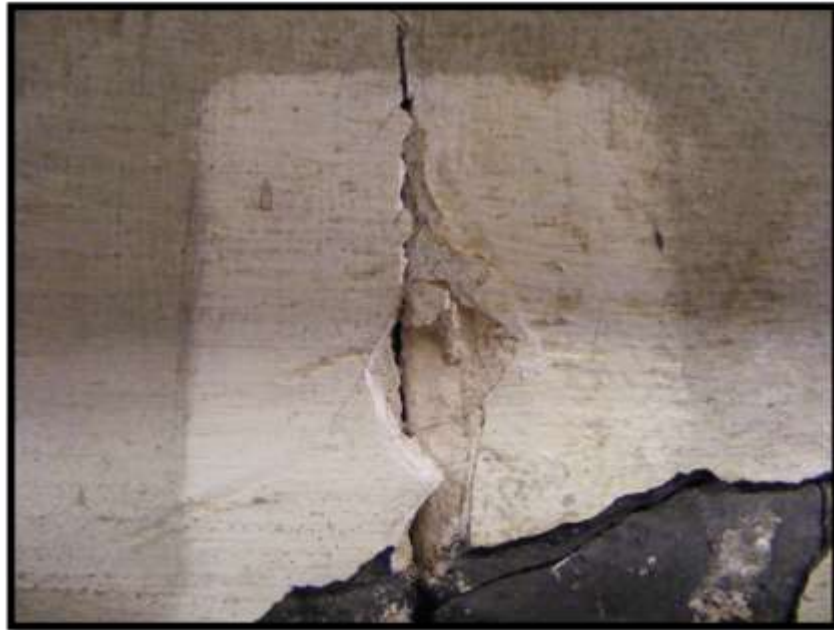
A mortar analysis was carried out by Mr Bill Revie of CMC on samples of the pointing material found between the Panel 10 and 11 on Ground Floor Galley North Wall. The mortar was found to be a thick layer of lime putty, gypsum plaster and fine sand and hair, followed by a thin layer of gypsum plaster and lime putty; and finally a layer of varnish. This final layer of varnish is found over the entire two floors of the North and South Walls and yet, interestingly, for some unknown reason, it was not applied to the slabs on the East Wall.

Samples of mortar were taken for analysis

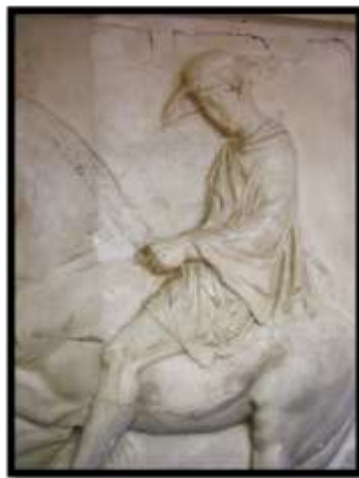
Panel during wet cleaning

- Prior to any conservation treatment the cast was photographed. This photographic documentation was continued throughout all conservation processes.
- Initially, the cast was dry cleaned with soft brushes and Wishab Sponges with a rubber-nozzled vacuum to pick up loose dust and dirt.
- Following wet cleaning spot tests on **Panel 1 on Upper Gallery South Wall**, the surface of the cast was cleaned with 2-5% Vulpex Liquid Soap in de-ionised water, using cotton wool swabs.

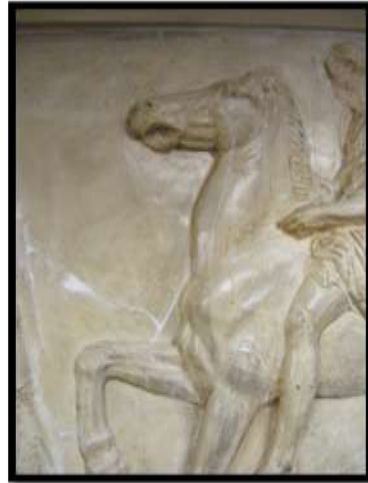
Details of fill repairs

- Areas of flaking paint were consolidated with 5% Primal B60A in de-ionised water.
- All areas of raw plaster were given an application of 10% Paraloid B72 in acetone to provide an isolating layer between the original plaster and the repairs.
- Exposed metal fixings were treated with 5% Tannic Acid so as to stabilise the corrosion, and covered with a protective layer of 20% Paraloid B72 in acetone.
- Areas of loss, open joints and cracks were filled with white micro-balloons with 12% Paraloid B72 in acetone. Larger areas of loss around the screws were filled with an inert filler to provide extra strength.

- All the fills and areas of discoloured paint were then toned out with acrylics, mixed with matting agent, to match the surrounding patina.
- Finally, the entire cast was given an application of micro-crystalline wax so as to protect the surface.

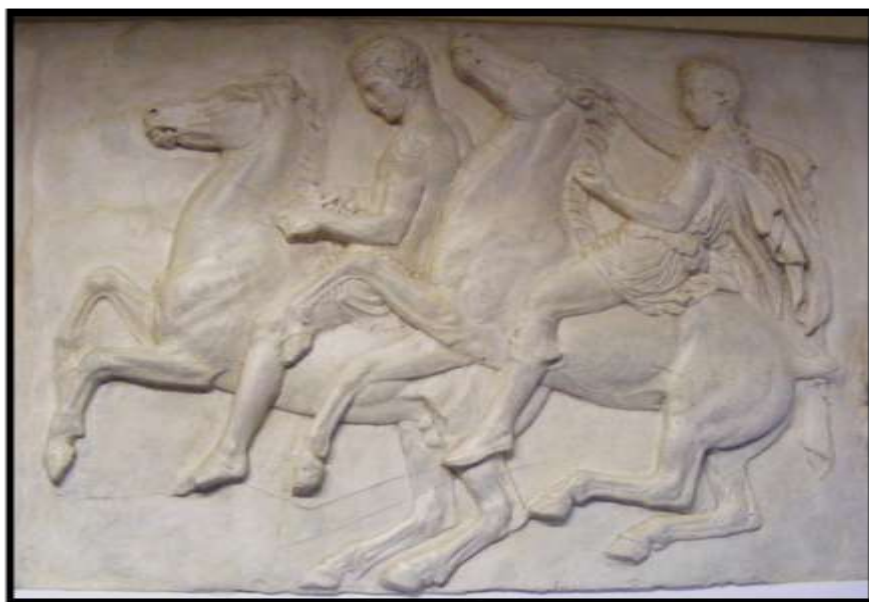
Panel after conservation

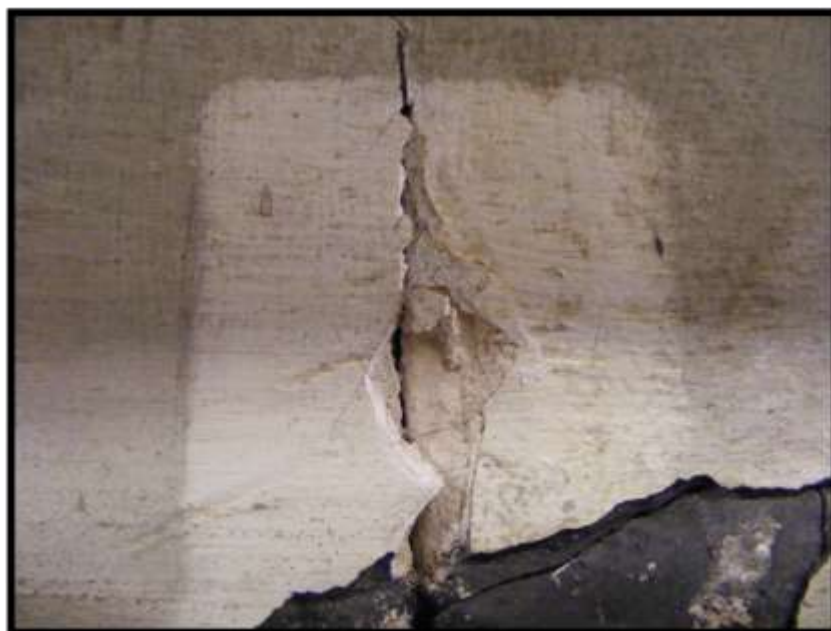
A mortar analysis was carried out by Mr Bill Revie of CMC on samples of the pointing material found between the Panel 10 and 11 on Ground Floor Galley North Wall. The mortar was found to be a thick layer of lime putty, gypsum plaster and fine sand and hair, followed by a thin layer of gypsum plaster and lime putty; and finally a layer of varnish. This final layer of varnish is found over the entire two floors of the North and South Walls and yet, interestingly, for some unknown reason, it was not applied to the slabs on the East Wall.

Samples of mortar were taken for analysis

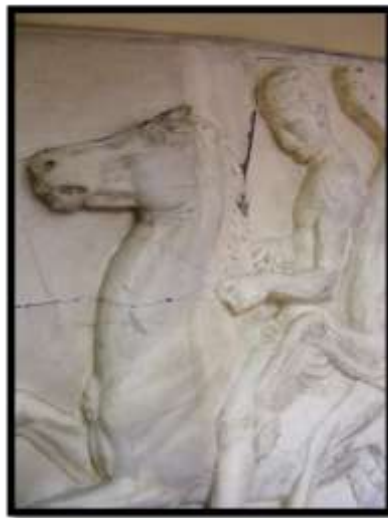
Panel during wet cleaning

- Prior to any conservation treatment the cast was photographed. This photographic documentation was continued throughout all conservation processes.
- Initially, the cast was dry cleaned with soft brushes and Wishab Sponges with a rubber-nozzled vacuum to pick up loose dust and dirt.
- Following wet cleaning spot tests on **Panel 1 on Upper Gallery South Wall**, the surface of the cast was cleaned with 2-5% Vulpex Liquid Soap in de-ionised water, using cotton wool swabs.

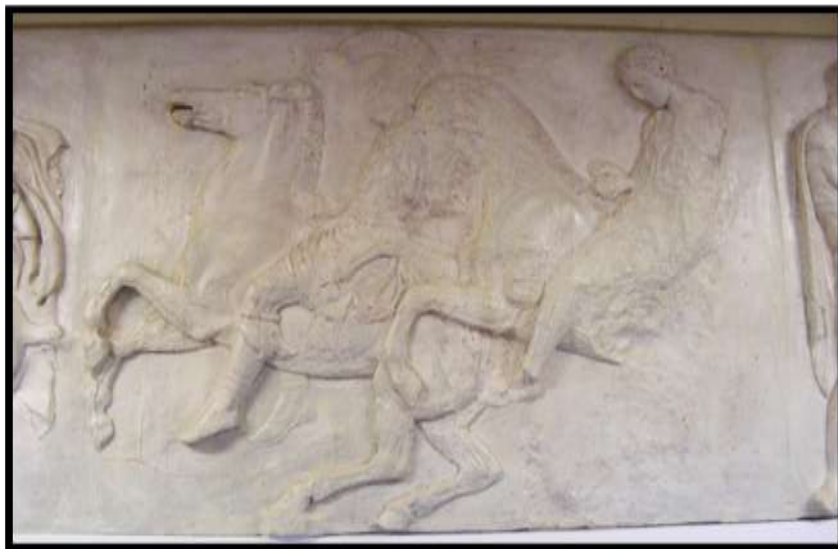
Panel after conservation

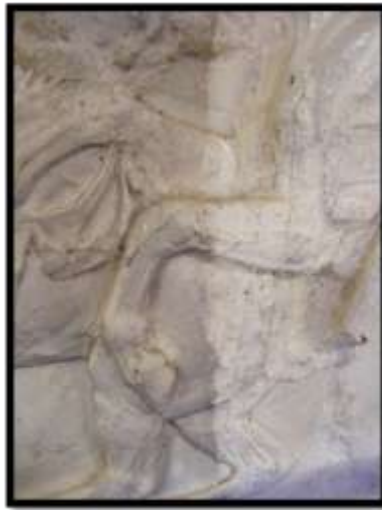
Panel during wet cleaning

- Prior to any conservation treatment the cast was photographed. This photographic documentation was continued throughout all conservation processes.
- Initially, the cast was dry cleaned with soft brushes and Wishab Sponges with a rubber-nozzled vacuum to pick up loose dust and dirt.
- Following wet cleaning spot tests on **Panel 1 on Upper Gallery South Wall**, the surface of the cast was cleaned with 2-5% Vulpex Liquid Soap in de-ionised water, using cotton wool swabs.

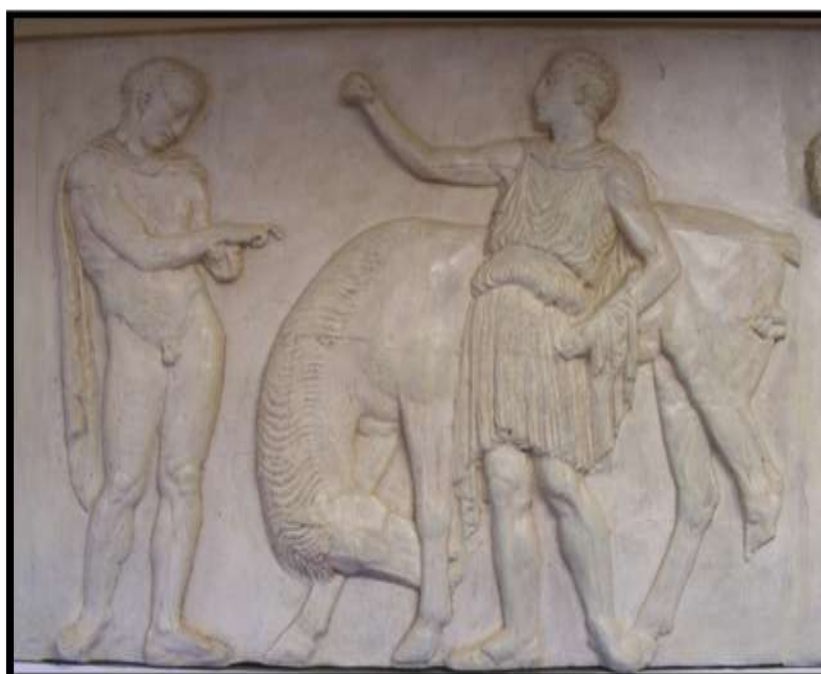
Panel after conservation

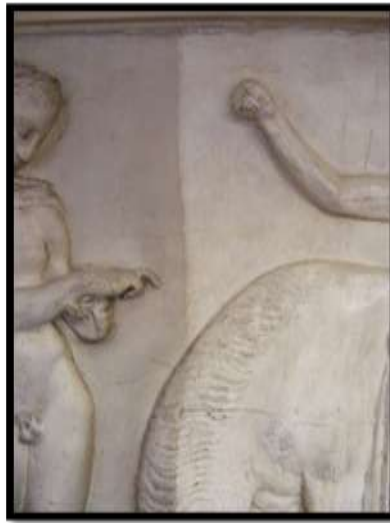
Panel during wet cleaning

- Prior to any conservation treatment the cast was photographed. This photographic documentation was continued throughout all conservation processes.
- Initially, the cast was dry cleaned with soft brushes and Wishab Sponges with a rubber-nozzled vacuum to pick up loose dust and dirt.
- Following wet cleaning spot tests on **Panel 1 on Upper Gallery South Wall**, the surface of the cast was cleaned with 2-5% Vulpex Liquid Soap in de-ionised water, using cotton wool swabs.

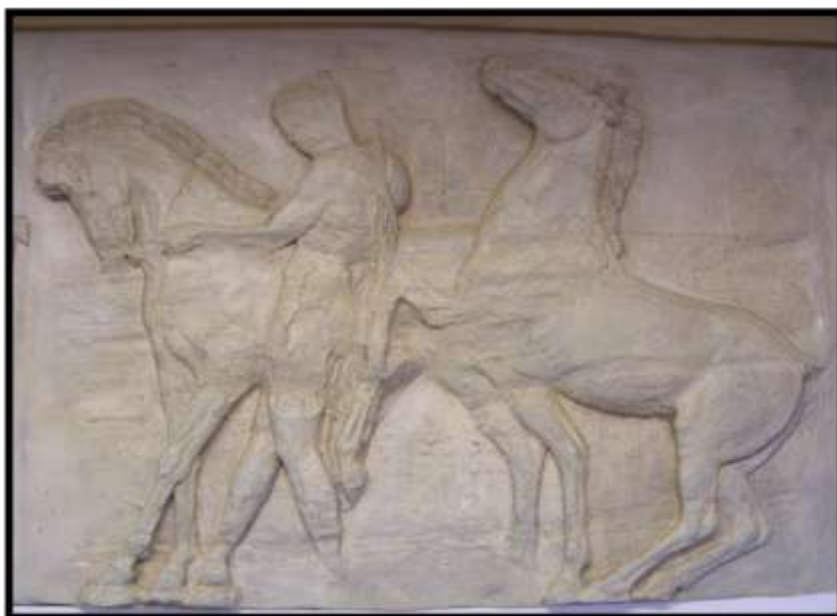
Panel after conservation

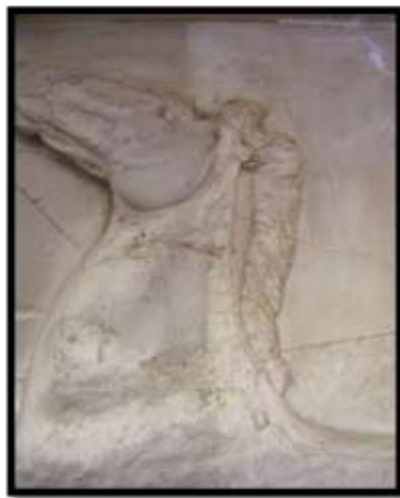
Panel during wet cleaning

- Prior to any conservation treatment the cast was photographed. This photographic documentation was continued throughout all conservation processes.
- Initially, the cast was dry cleaned with soft brushes and Wishab Sponges with a rubber-nozzled vacuum to pick up loose dust and dirt.
- Following wet cleaning spot tests on **Panel 1 on Upper Gallery South Wall**, the surface of the cast was cleaned with 2-5% Vulpex Liquid Soap in de-ionised water, using cotton wool swabs.

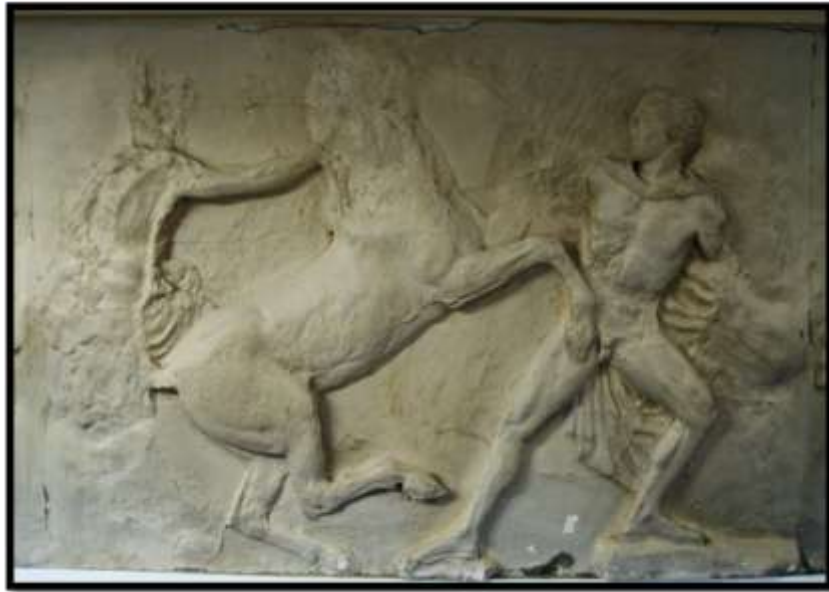
PANEL 8

Panel before conservation

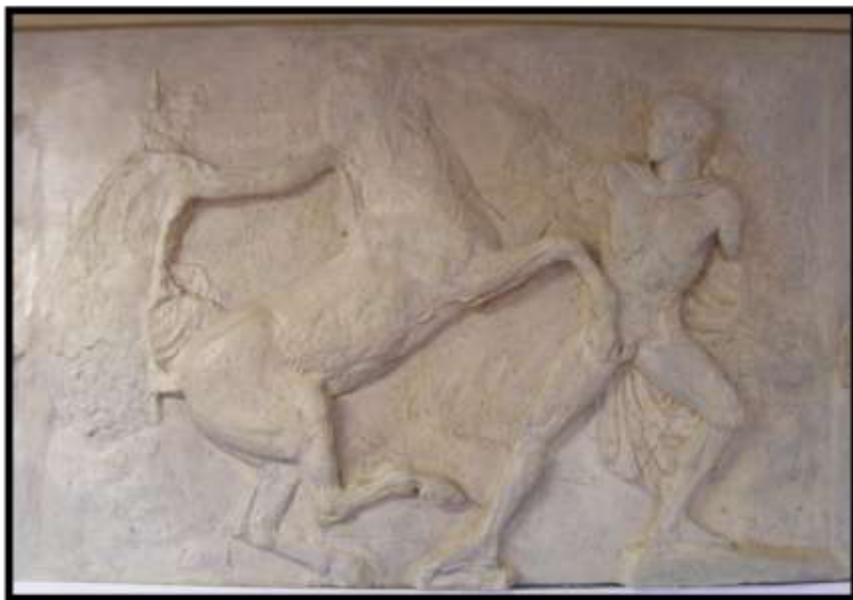
Panel after conservation

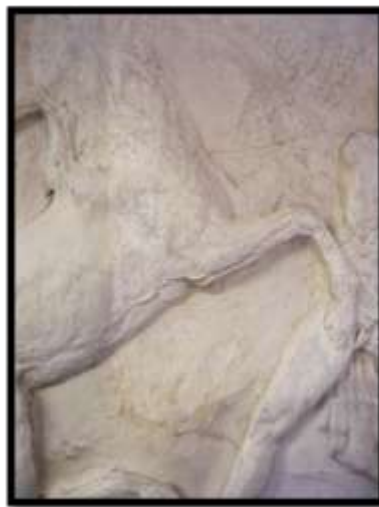
Panel during wet cleaning

- Prior to any conservation treatment the cast was photographed. This photographic documentation was continued throughout all conservation processes.
- Initially, the cast was dry cleaned with soft brushes and Wishab Sponges with a rubber-nozzled vacuum to pick up loose dust and dirt.
- Following wet cleaning spot tests on **Panel 1 on Upper Gallery South Wall**, the surface of the cast was cleaned with 2-5% Vulpex Liquid Soap in de-ionised water, using cotton wool swabs.

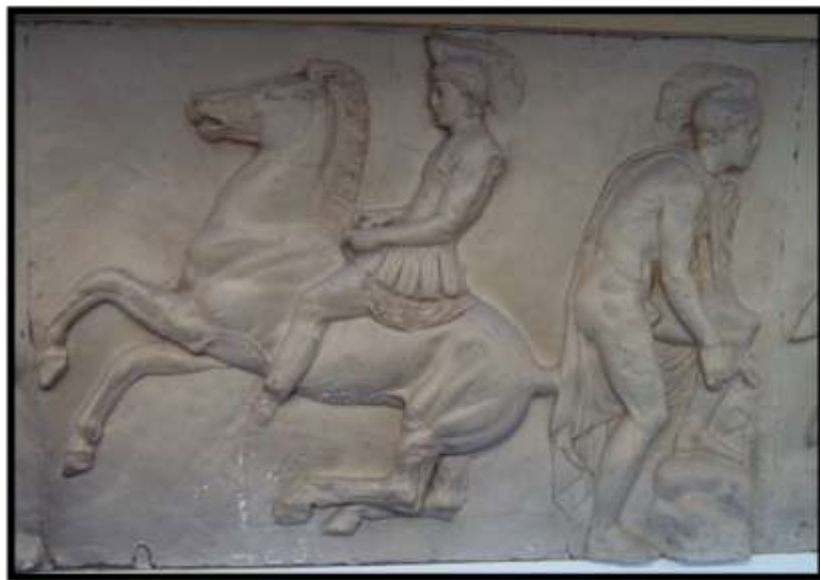
PANEL 9

Panel before conservation

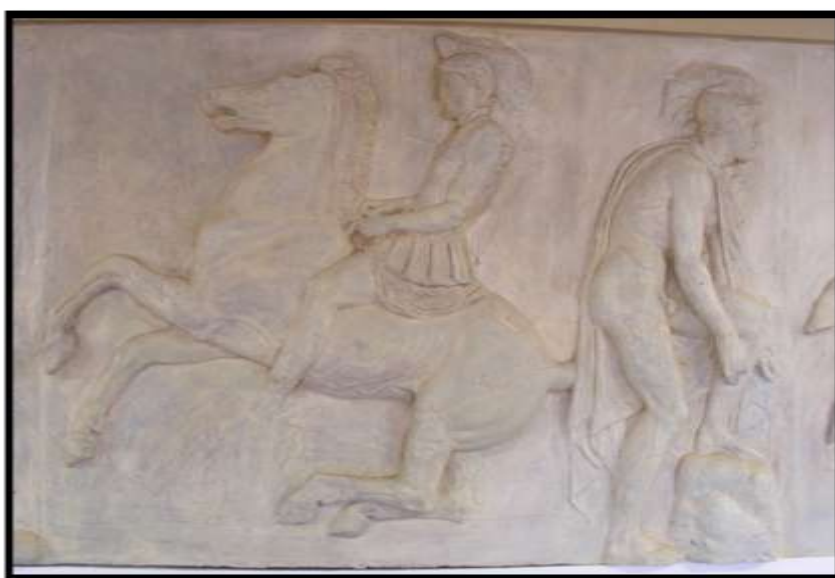
Panel after conservation

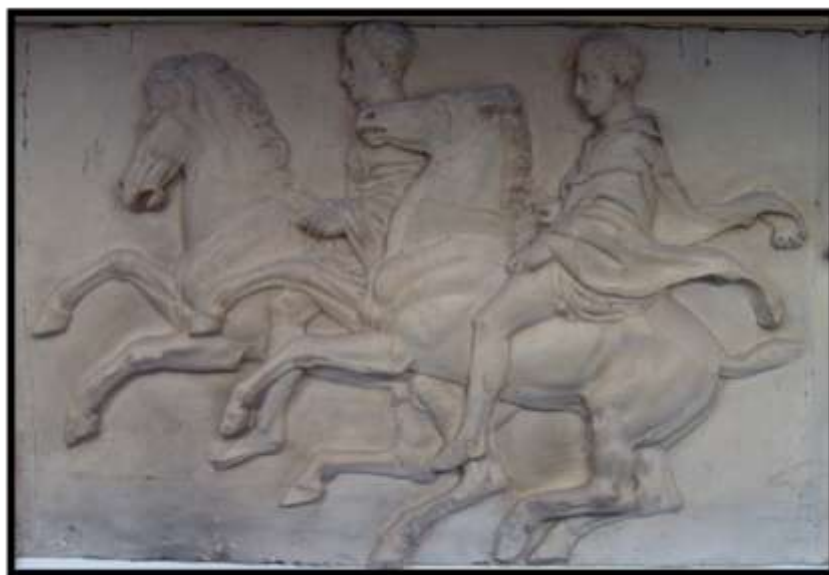
Panel before conservation

STRUCTURAL STABILITY: Fair. Open cracks running alongside joints on both sides of the panel; small cracks around fixing by top and lower edges of the panel

VISIBLE PAINT LAYERS/UNSIGHTLY MARKINGS: layer of cream-yellow paint/varnish on surface of the cast; the surface polychrome is discoloured and damaged on the lower part of the panel probably by the strip of lights which used to run just under the Frieze along the South and North walls of the Ground Floor Gallery; small spots of paint splash scattered on surface of the panel.

CHIPS AND LOSSES: missing areas associated with the cracks; flaking and missing paint area on lower part of the panel

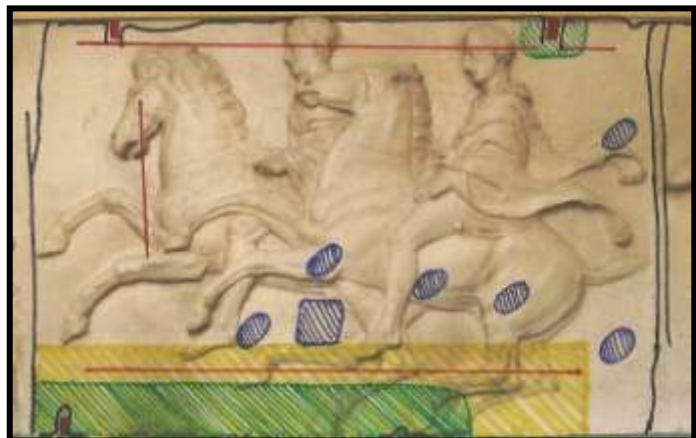
Cracks

Chips, abrasions and missing surfaces

Paint splashes

Flaking paint

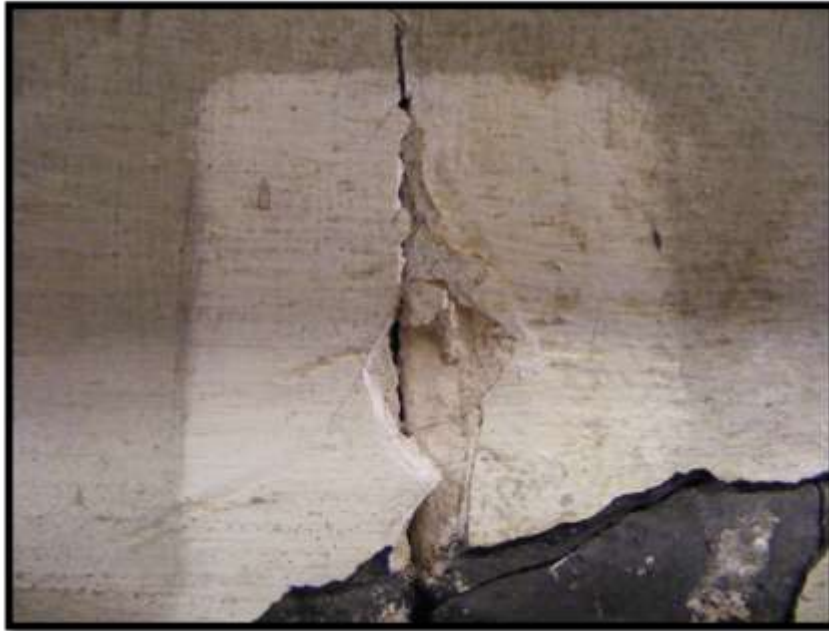
A mortar analysis was carried out by Mr Bill Revie of CMC on samples of the pointing material found between the Panel 10 and 11 on Ground Floor Galley North Wall. The mortar was found to be a thick layer of lime putty, gypsum plaster and fine sand and hair, followed by a thin layer of gypsum plaster and lime putty; and finally a layer of varnish. This final layer of varnish is found over the entire two floors of the North and South Walls and yet, interestingly, for some unknown reason, it was not applied to the slabs on the East Wall.

Samples of mortar were taken for analysis

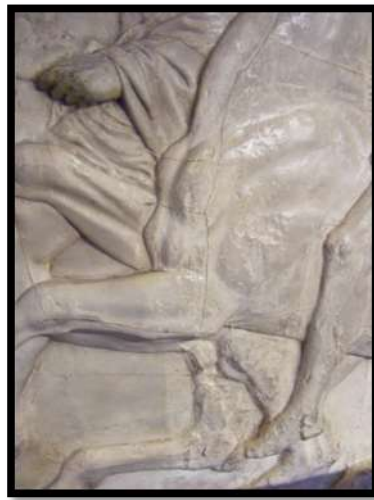
Panel during wet cleaning

- Prior to any conservation treatment the cast was photographed. This photographic documentation was continued throughout all conservation processes.
- Initially, the cast was dry cleaned with soft brushes and Wishab Sponges with a rubber hosed vacuum to pick up loose dust and dirt.
- Following wet cleaning spot tests on **Panel 1 in Upper Gallery South Wall**, the surface of the cast was cleaned with 5% Vulpex Liquid Soap in de-ionised water, using cotton wool swabs.

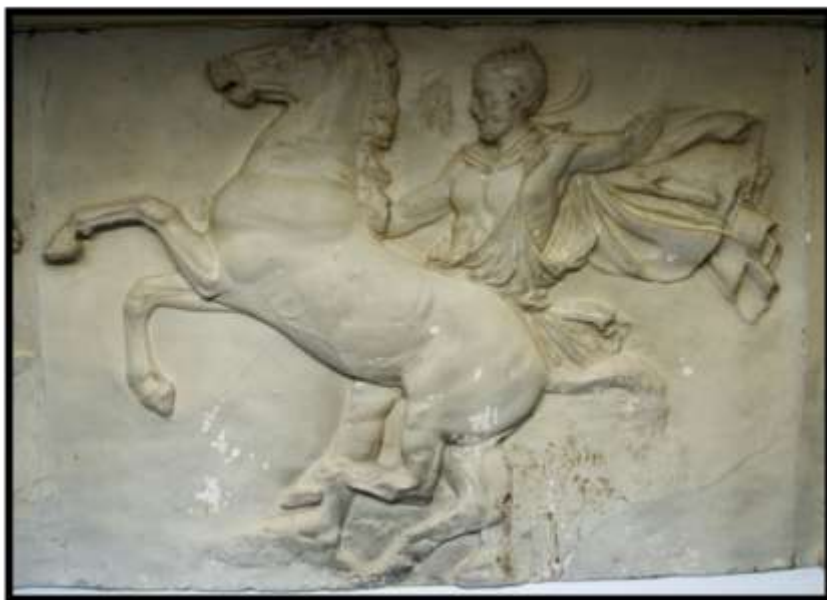
Panel before conservation

STRUCTURAL STABILITY: Fair. Open cracks running alongside joints on both sides of the panel, alongside top edge and in lower sinister corner; small cracks around fixing in three corner areas of the panel.

VISIBLE PAINT LAYERS/UNSIGHTLY MARKINGS: layer of cream-yellow paint/varnish on surface of the cast; the surface polychrome is discoloured and damaged on the lower part of the panel probably by the strip of lights which used to run just under Frieze along the South and North walls of the Ground Floor Gallery; small spots of paint splash scattered on the surface of the panel; large splash mark, from unknown substance, possibly food, at middle lower part of the cast.

CHIPS AND LOSSES: missing areas associated with the cracks; area of flaking and missing paint on lower part of the panel.

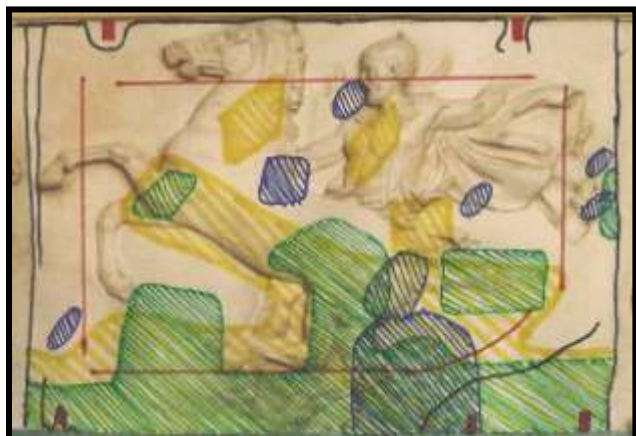
Cracks

Chips, abrasions and missing surfaces

Paint splashes

Flaking paint

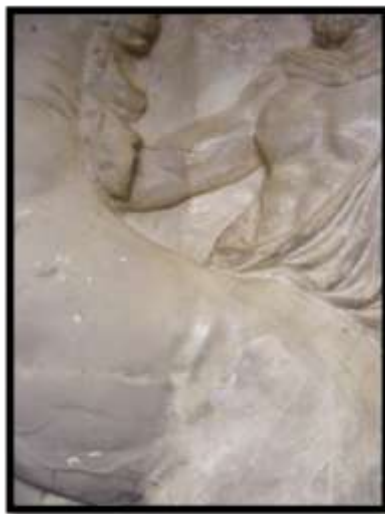
Panel during wet cleaning

- Prior to any conservation treatment the cast was photographed. This photographic documentation was continued throughout all conservation processes.
- Initially, the cast was dry cleaned with soft brushes and Wishab Sponges with a rubber hosed vacuum to pick up loose dust and dirt.
- Following wet cleaning spot tests on **Panel 1 in Upper Gallery South Wall**, the surface of the cast was cleaned with 5% Vulpex Liquid Soap in de-ionised water, using cotton wool swabs.

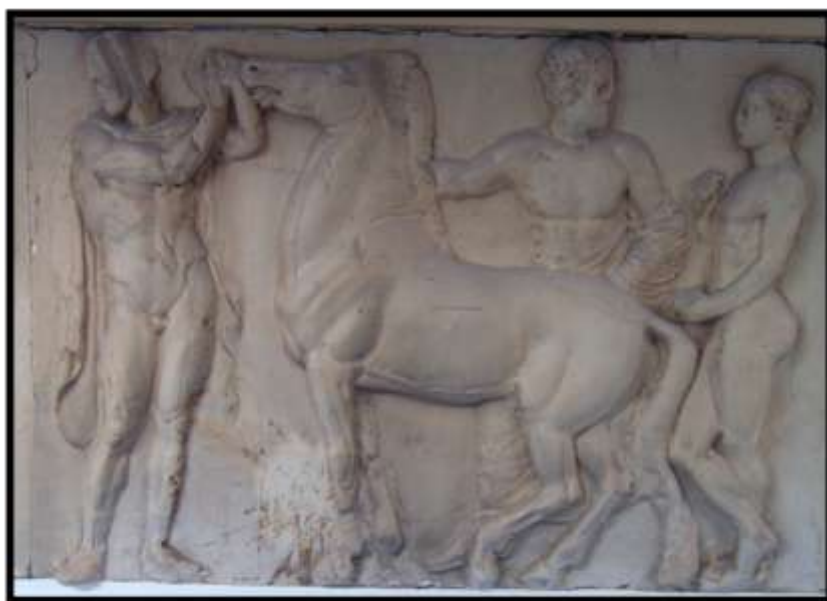
Panel before conservation

STRUCTURAL STABILITY: Fair. Open cracks running alongside joints on both sides of the panel and alongside top edge; small cracks around fixing in corners of the panel.

VISIBLE PAINT LAYERS/UNSIGHTLY MARKINGS: layer of cream-yellow paint/varnish on surface of the cast; the surface polychrome is discoloured and damaged on the lower part of the panel probably by the strip of lights which used to run just under the Frieze along the South and North walls of the Ground Floor Gallery; small spots of paint splash scattered on the surface of the panel; large splash mark, from unknown substance, possibly food, in middle lower part of the cast.

CHIPS AND LOSSES: missing areas associated with the cracks; flaking and missing paint in lower area of the panel.

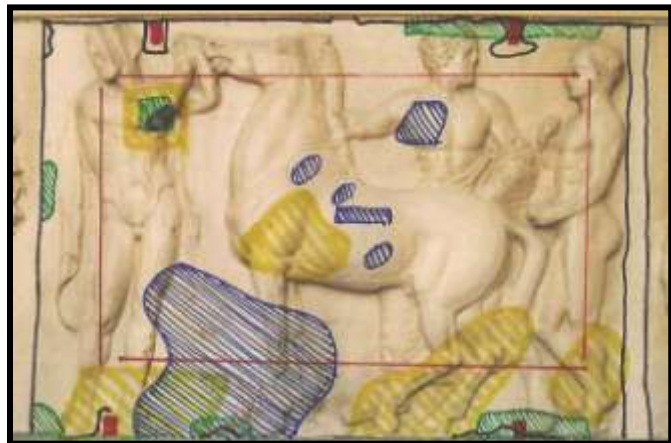
Cracks

Chips, abrasions and missing surfaces

Paint splashes

Flaking paint

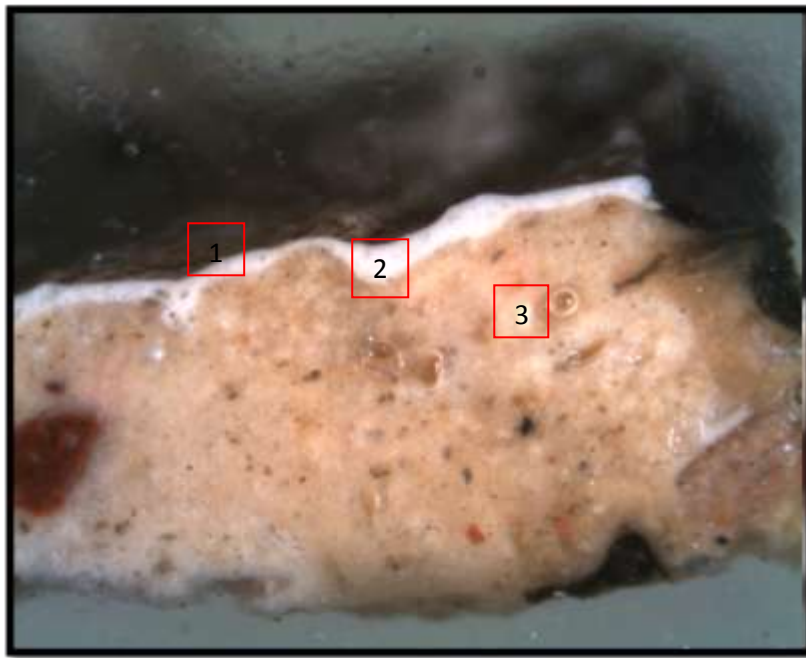
Parthenon Frieze, Lower Gallery South Wall, Panel 12 – Cross section

Photograph of a Cross-section of Sample from Panel 12

The sample seems to consist largely of one orange-cream layer containing white and pale orange/brown and black particles. There is a thin bright white paint layer at the top of the section, as photographed, covered in dirt and possibly blackened lead white. Also at the left, as photographed, is a large brown inclusion. The brown inclusion appeared completely black under UV, showing no fluorescence, whereas the bright white paint layer fluoresced a yellow colour indicating that it may contain zinc white.

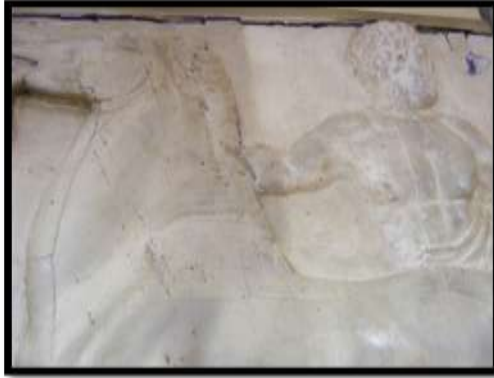
Panel during wet cleaning

- Following wet cleaning spot tests on **Panel 1 in Upper Gallery South Wall**, the surface of the cast was cleaned with 5% Vulpex Liquid Soap in de-ionised water, using cotton wool swabs.

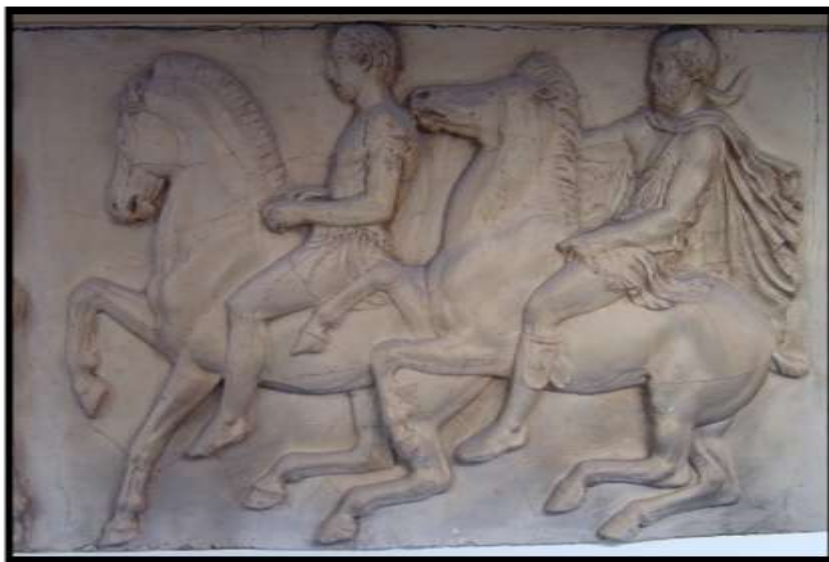
Panel before conservation

STRUCTURAL STABILITY: Fair. Open cracks running alongside joints on both sides of the panel and alongside top edge; small cracks around fixing by the upper edge of the panel.

VISIBLE PAINT LAYERS/UNSIGHTLY MARKINGS: layer of cream-yellow paint/varnish on the surface of the cast; the surface polychrome is discoloured and damaged on the lower part of the panel probably by the strip of lights which used to run just under the Frieze along the South and North walls of the Ground Floor Gallery; small spots of paint splash scattered on the surface of the panel.

CHIPS AND LOSSES: missing areas associated with the cracks; area of flaking and missing paint in lower part of the panel

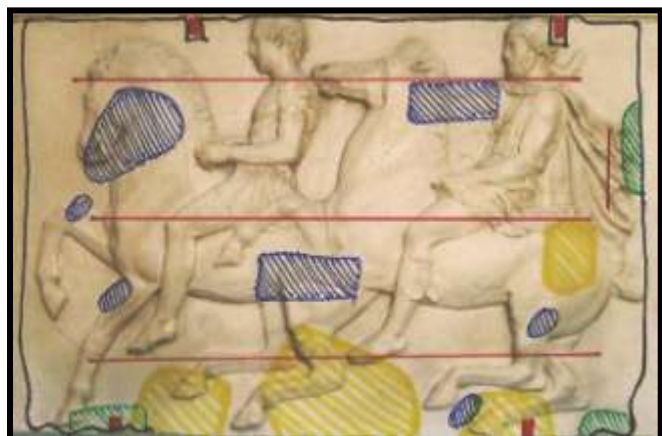
Cracks

Chips, abrasions and missing surfaces

Paint splashes

Flaking paint

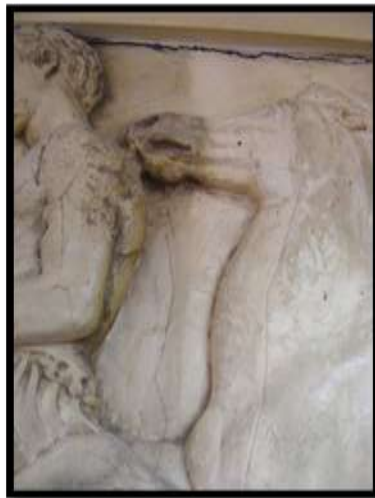
Panel during wet cleaning

- Prior to any conservation treatment the cast was photographed. This photographic documentation was continued throughout all conservation processes.
- Initially, the cast was dry cleaned with soft brushes and Wishab Sponges with a rubber-nozzled vacuum to pick up loose dust and dirt.
- Following wet cleaning spot tests on **Panel 1 on Upper Gallery South Wall**, the surface of the cast was cleaned with 5% Vulpex Liquid Soap in de-ionised water, using cotton wool swabs.

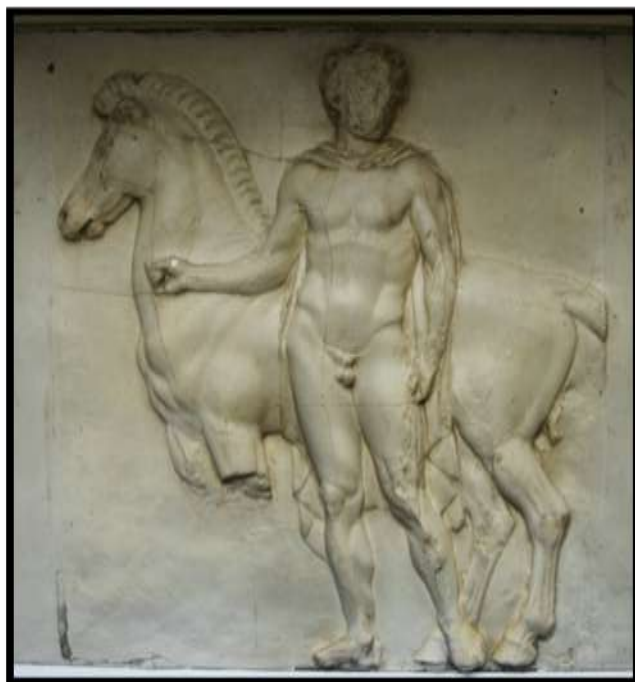
Panel before conservation

STRUCTURAL STABILITY: Fair. Open cracks running alongside joints on both sides of the panel and alongside top edge; small cracks around fixing by top and lower edge of the panel.

VISIBLE PAINT LAYERS/UNSIGHTLY MARKINGS: layer of cream-yellow paint/varnish on surface of the cast; the surface polychrome is discoloured and damaged on the lower part of the panel probably by the strip of lights which used to run just under the Frieze along the South and North walls of the Ground Floor Gallery; small spots of paint splash scattered on the surface of the panel.

CHIPS AND LOSSES: missing areas associated with the cracks; area of flaking and missing paint in lower part of the panel.
