1. PARTHENON FRIEZE

1.3 SCULPTURE COURT LOWER GALLERY SOUTH WALL

PANEL 1

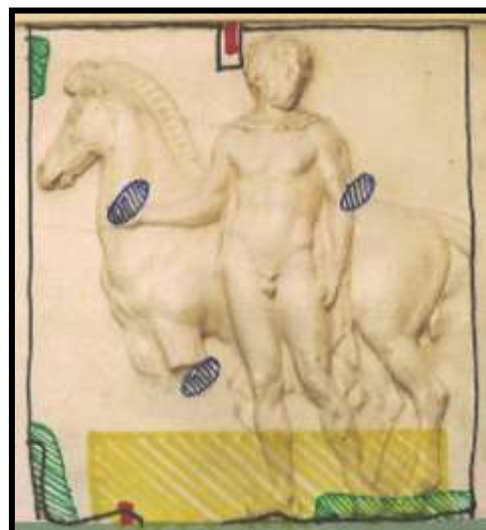
Cracks

Chips, abrasions and missing surfaces

Paint splashes

Flaking paint

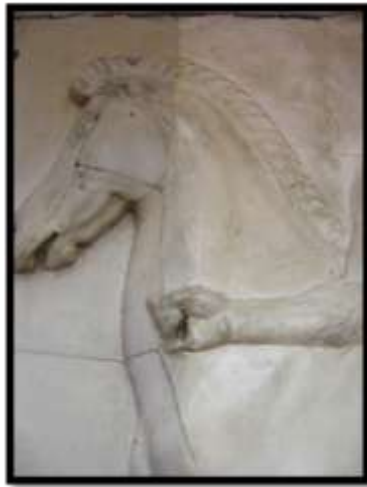
Panel during wet cleaning

- Prior to any conservation treatment the cast was photographed. This photographic documentation was continued throughout all conservation processes.
- Initially, the cast was dry cleaned with soft brushes and Wishab Sponges with a rubber hosed vacuum to pick up loose dust and dirt.
- Following wet cleaning spot tests on **Panel 1 on Upper Gallery South Wall**, the surface of the cast was cleaned with 5% Vulpex Liquid Soap in de-ionised water, using cotton wool swabs.

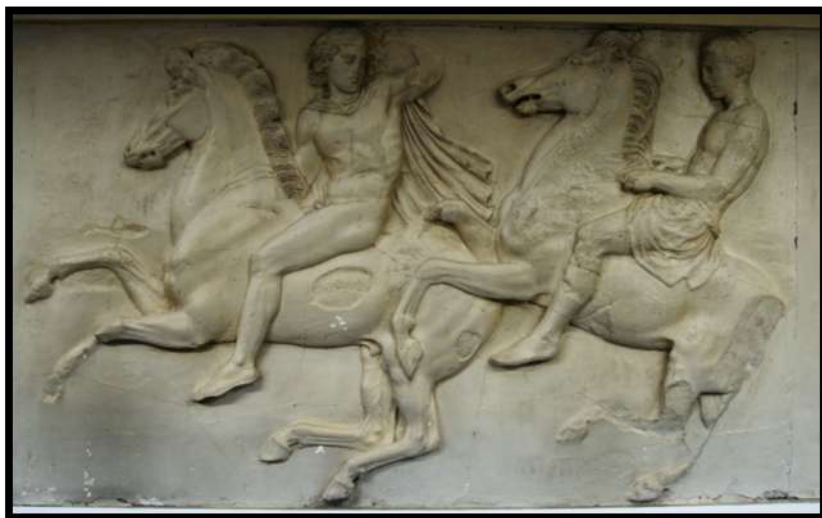
Panel before conservation

STRUCTURAL STABILITY: Stable. Open cracks running alongside joints on both sides of the panel, and alongside top edge, small cracks around fixings by top and lower edge of the cast.

VISIBLE PAINT LAYERS/UNSIGHTLY MARKINGS: layer of cream-yellow paint/varnish on surface of the cast; the surface polychrome is discoloured and damaged on the lower part of the panel probably by the strip of lights which used to run just under the Frieze along the South and North walls of the Ground Floor Gallery; small spots of paint splash scattered on the surface of the panel.

CHIPS AND LOSSES: missing areas associated with the cracks; area of flaking and missing paint in lower part of the panel.

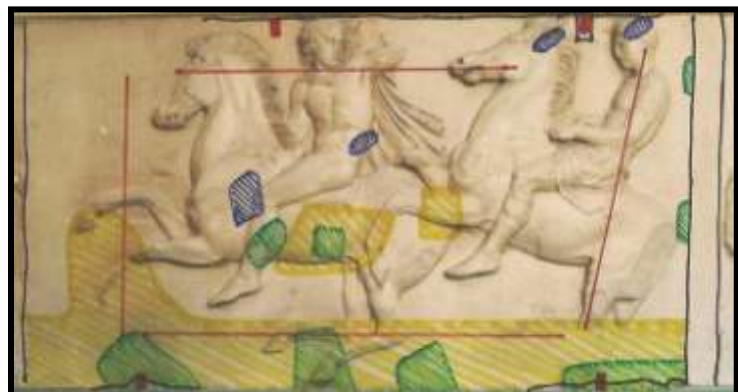
Cracks

Chips, abrasions and missing surfaces

Paint splashes

Flaking paint

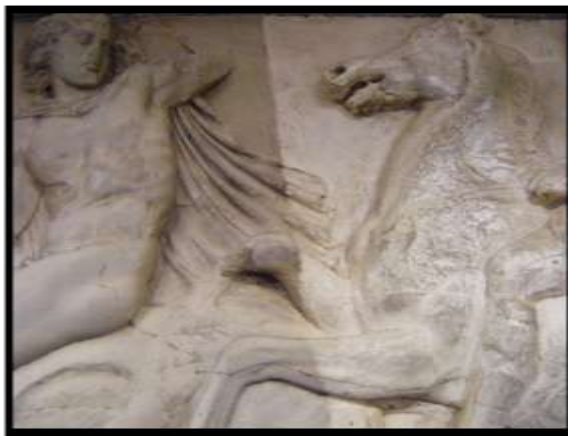
Panel during wet cleaning

- Prior to any conservation treatment the cast was photographed. This photographic documentation was continued throughout all conservation processes.
- Initially, the cast was dry cleaned with soft brushes and Wishab Sponges with a rubber-nozzled vacuum to pick up loose dust and dirt.
- Following wet cleaning spot tests on **Panel 1 in Upper Gallery South Wall**, the surface of the cast was cleaned with 5% Vulpex Liquid Soap in de-ionised water, using cotton wool swabs.

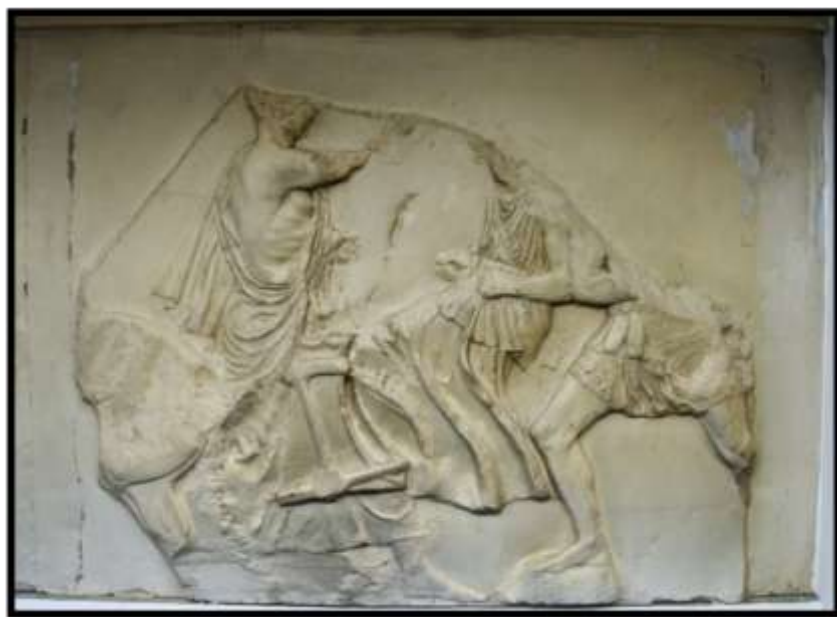
Panel before conservation

STRUCTURAL STABILITY: Stable. Open cracks running alongside joints on both sides of the panel; small crack around fixings by the top and lower edge of the cast.

CHIPS AND LOSSES: missing areas associated with the cracks; area of flaking and missing paint in lower part of the panel.

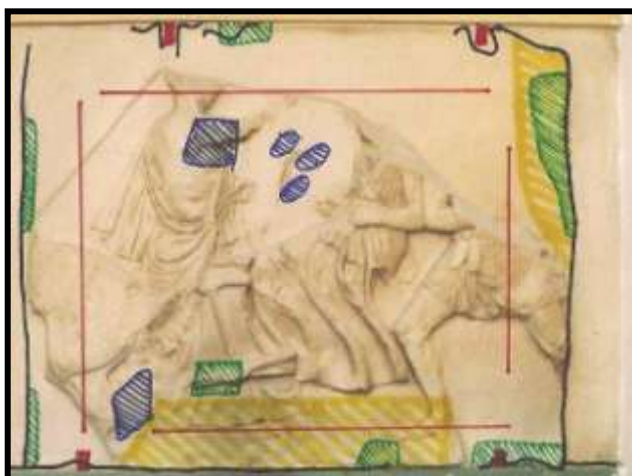
Paint splashes

Flaking paint

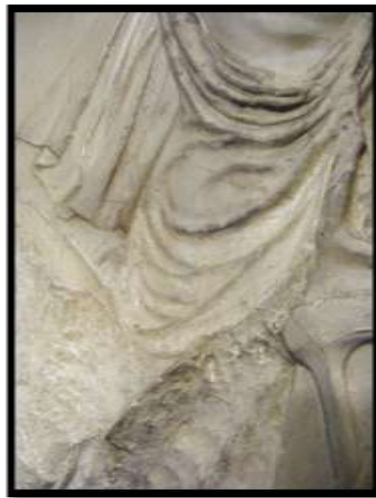
Panel during wet cleaning

- Prior to any conservation treatment the cast was photographed. This photographic documentation was continued throughout all conservation processes.
- Initially, the cast was dry cleaned with soft brushes and Wishab Sponges with a rubber-nozzled vacuum to pick up loose dust and dirt.
- Following wet cleaning spot tests on **Panel 1 in Upper Gallery South Wall**, the surface of the cast was cleaned with 5% Vulpex Liquid Soap in de-ionised water, using cotton wool swabs.
