1. PARTHENON FRIEZE

1.4 SCULPTURE COURT LOWER GALLERY NORTH WALL

PANEL 1

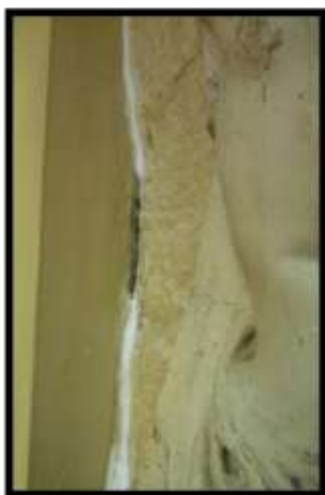
Details of fill repairs

- Areas of flaking paint were consolidated with 5% Primal B60A in de-ionised water.
- All areas of raw plaster were given an application of 10% Paraloid B72 in acetone to provide an isolating layer between the original plaster and the repairs.
- Exposed metal fixings were treated with 5% Tannic Acid so as to stabilise the corrosion, and covered with a protective layer of 20% Paraloid B72 in acetone.
- Areas of loss, open joints and cracks were filled with white micro-balloons mixed with 12% Paraloid B72 in acetone. Larger areas of loss around the screws were filled with an inert filler to provide extra strength.

- All the fills and areas of discoloured paint were then toned out with acrylics, mixed with matting agent, to match the surrounding patina.
- Finally, the entire cast was given an application of micro-crystalline wax so as to protect the surface.

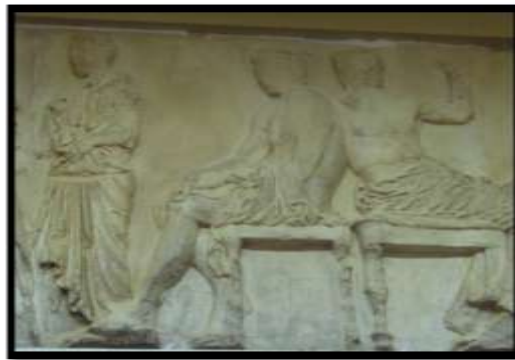
Panel during fill repairs

- Exposed metal fixings were treated with 5% Tannic Acid so as to stabilise the corrosion, and covered with a protective layer of 20% Paraloid B72 in acetone.

- Areas of loss, open joints and cracks were filled with white micro-balloons with 12% Paraloid B72 in acetone. Larger areas of loss around the screws were filled with an inert filler to provide extra strength.

- The loose top of the figure's head was reattached with polyester resin.
- All the fills and areas of discoloured paint were then toned out with acrylics, mixed with matting agent, to match the surrounding patina.
- Finally, the entire cast was given an application of micro-crystalline wax so as to protect the surface.
