1. PARTHENON FRIEZE

1.5 SCULPTURE COURT LOWER EAST WALL

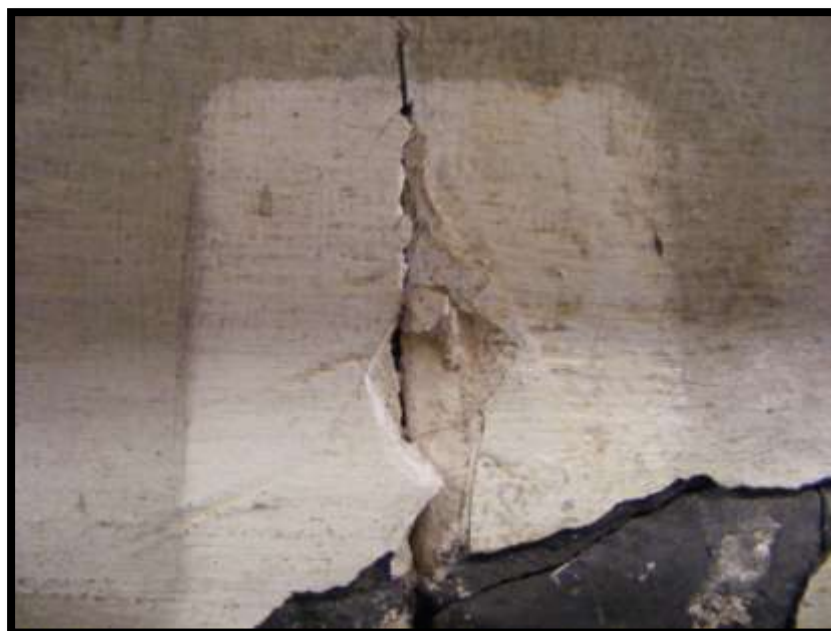
A mortar analysis was carried out by Mr Bill Revie of CMC on samples of the pointing material found between the Panel 10 and 11 on Ground Floor Galley North Wall. The mortar was found to be a thick layer of lime putty, gypsum plaster and fine sand and hair, followed by a thin layer of gypsum plaster and lime putty; and finally a layer of varnish. This final layer of varnish is found over the entire two floors of the North and South Walls and yet, interestingly, for some unknown reason, it was not applied to the slabs on the East Wall.

Samples of mortar were taken for analysis
