1.6 PARTHENONE FRIEZE SLAB IN STUDIO C3

1.6.1 DESCRIPTION OF THE OBJECT

TITLE: Parthenon Frieze, copy of the panel from Parthenon Frieze from Temple of Athena – Parthenon in Acropolis in Athens, Greece, between 443 and 438 B.C.

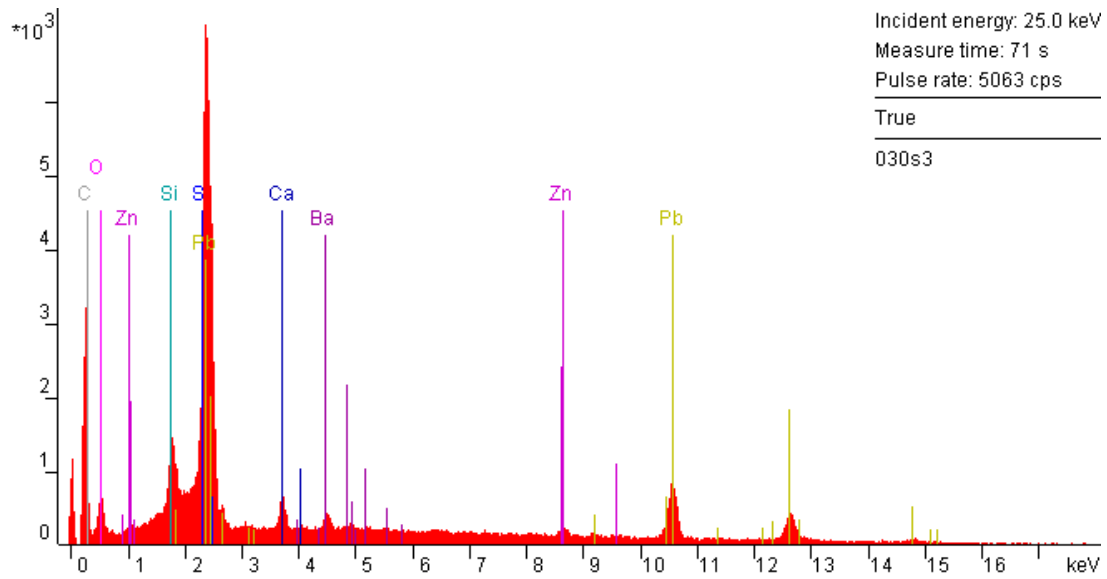
Spectrum 8 sample 030 spot 3

The layer below was analysed at spot 3 and was found to contain mainly lead (spectrum 8), indicating that the main pigment in this layer is lead white. There are small amounts of silicon and calcium, indicating silica and chalk extenders and trace amounts of zinc and barium which may be from the layer above.

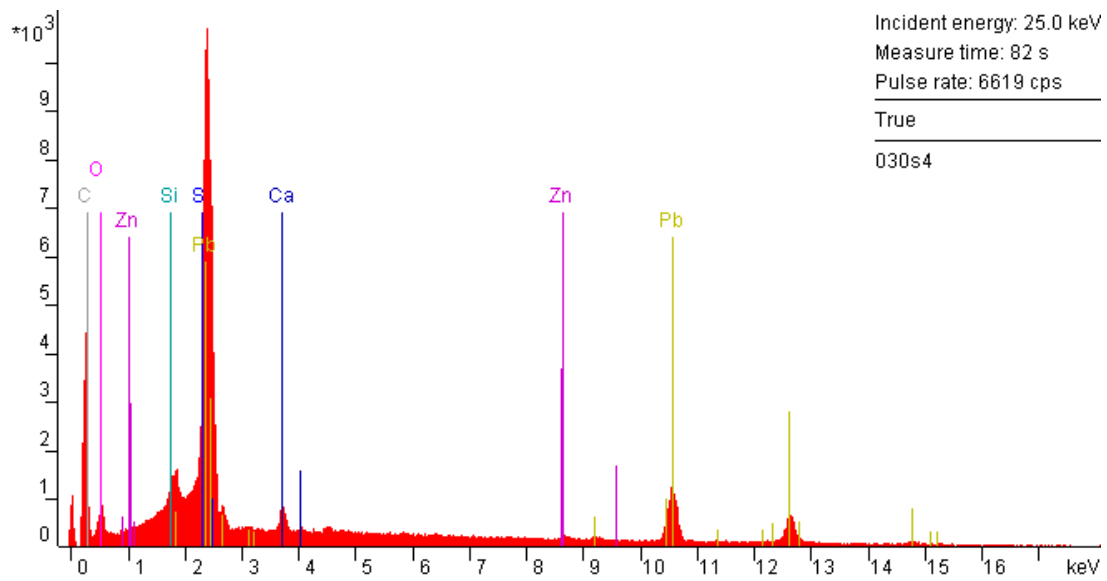
Spectrum 9 sample 030 spot 4

The lowest paint layer was analysed at spot 4 and was found to contain mainly lead (spectrum 9), indicating that the main pigment in this layer is lead white. There are small amounts of silicon and calcium, indicating silica and chalk extenders. It differs from spectrum 8 in that there is virtually no zinc and barium is absent.
