### 3. METOPES

#### 3.1 METOPE P010 in Studio C4

**TITLE:** Metope of Parthenon, copy of metope from Temple of Athena – Parthenon in Acropolis in Athens, Greece(443-438 BC)

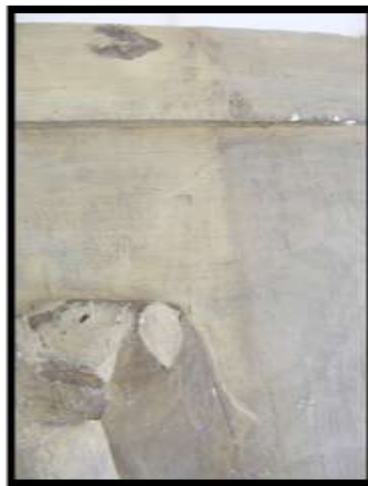
*Cast during wet cleaning*

- Prior to any conservation treatment, the cast was photographed. This photographic documentation was continued throughout all conservation processes.
- Initially, the cast was dry cleaned with soft brushes and Wishab Sponges with a rubber-nozzled vacuum to pick up the loose dust and dirt.
- Following a variety of wet cleaning spot tests, the surface of the panel was cleaned with 2-5% Vulpex Liquid Soap in de-ionised water, using cotton wool swabs.

- All areas of raw plaster were given an application of 10% Paraloid B72 in acetone to provide an isolating layer between the original plaster and the repairs.
- The areas of flaking paint were consolidated with an application of 5% Primal B60A in de-ionised water.

- Areas of loss, open joints and cracks were filled with white micro-balloons mixed with 12% Paraloid B72 in acetone. Larger areas of loss and around the screws were filled with an inert filler to provide extra strength.

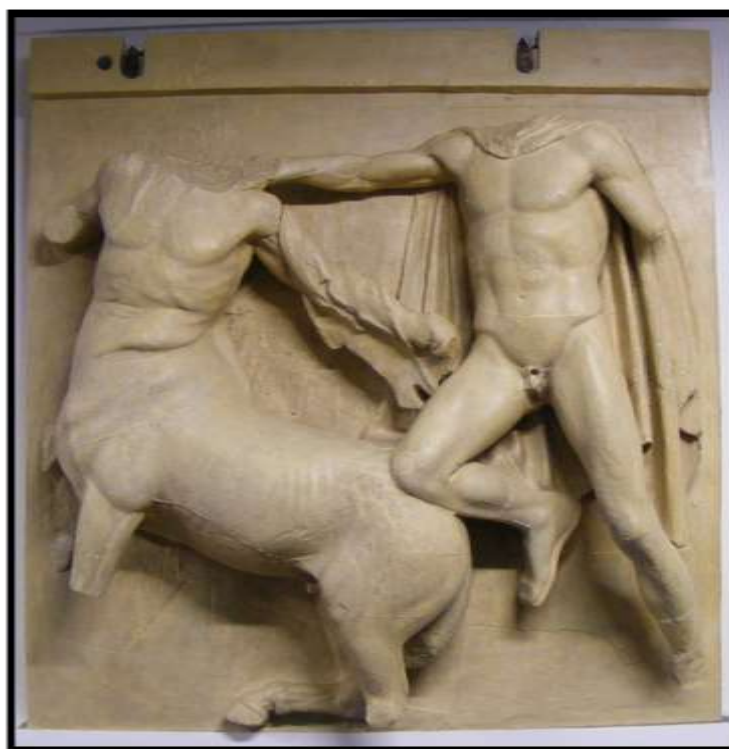
*Panel after conservation*

**STRUCTURAL STABILITY:** Good, but crack at dexter side of the cast.

**CHIPS AND LOSSES:** Areas of loss associated with cracks; small crack and loose fragment around fixing in lower sinister corner of the cast.

- Prior to any conservation treatment, the cast was photographed. This photographic documentation was continued throughout all conservation processes.
- Initially, the cast was dry cleaned with soft brushes and Wishab Sponges with a rubber-nozzled vacuum to pick up the loose dust and dirt.
- Following a variety of wet cleaning spot tests, the surface of the panel was cleaned with 2-5% Vulpex Liquid Soap in de-ionised water, using cotton wool swabs.

- All areas of raw plaster were given an application of 10% Paraloid B72 in acetone to provide an isolating layer between the original plaster and the repairs.

- Areas of loss, open joints and cracks were filled with white micro-balloons mixed with 12% Paraloid B72 in acetone. Larger areas of loss and around the screws were filled with an inert filler to provide extra strength.

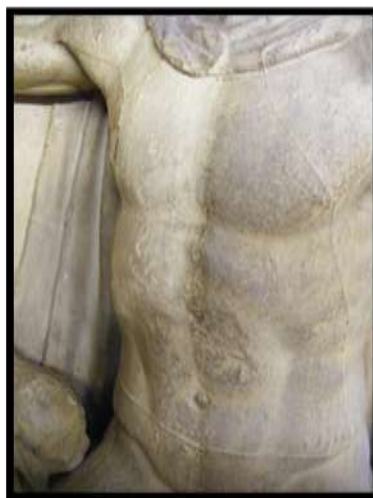
*Cast during wet cleaning*

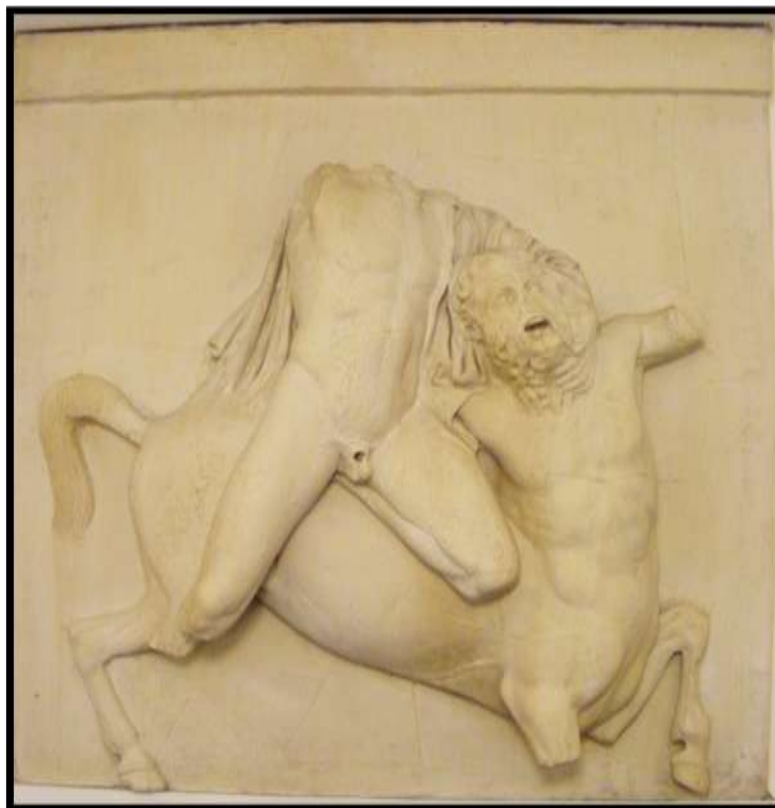
*Panel after conservation*

**STRUCTURAL STABILITY:** Good, but crack at sinister top corner of the cast.

**CHIPS AND LOSS:** Areas of loss associated with crack in corner of the cast; small crack and loose fragment around fixing in lower sinister corner of the cast.

- Prior to any conservation treatment, the cast was photographed. This photographic documentation was continued throughout all conservation processes.
- Initially, the cast was dry cleaned with soft brushes and Wishab Sponges with a rubber-nozzled vacuum to pick up the loose dust and dirt.
- The areas of flaking paint were consolidated with an application of 5% Primal B60A in de-ionised water.
- Following wet cleaning spot tests, the surface of the cast was cleaned with Anjusil. The application of Anjusil was repeated in places if necessary.

- All areas of raw plaster were given an application of 10% Paraloid B72 in acetone to provide an isolating layer between the original plaster and the repairs.
- Areas of loss, open joints and cracks were filled with white micro-balloons mixed with 12% Paraloid B72 in acetone. Larger areas of loss and around the screws were filled with an inert filler to provide extra strength.
- All the fills were then toned out with acrylics, mixed with matting agent, to match the surrounding patina.

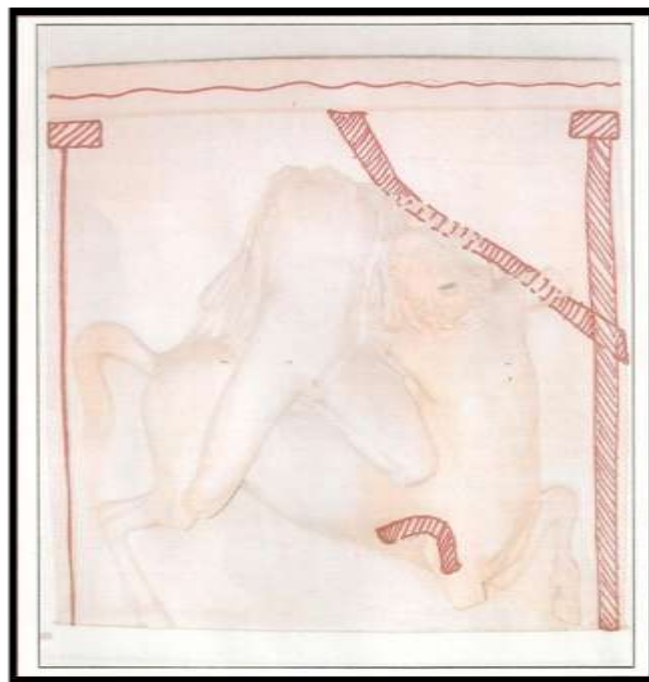
Metope P012 was examined by W. A. Revie from Construction Materials Consultants employing Infrared Thermography and cover meter. There were several differing armatures found in the plaster:

- Wire along the top
- Two large fixings at either side
- One thin bar down the sinister side
- One large flat bar running down dexter side
- One fixing that appears to run through entire length of the crack in plaster cast
- One fixing in the protruding leg of the centaur

## Thermographic Inspection

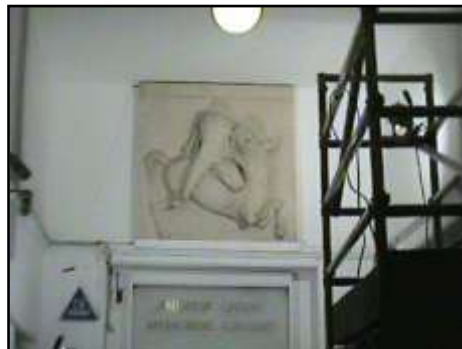
Following the Infrared Thermographic examination of the cast, both the cast and adjacent wall were examined visually and a metal detector used to scan the areas indicated to contain fixings and, possibly, past repairs. The later was carried out to establish if the fixings or straps were metallic or non-metallic in composition. No open cracks were observed on the basis of the visual examination, however, light levels were low and very fine cracks would not be seen. However, indications of past repairs were apparent and it may be that the crack paths indicated in the Infrared were also the sites of past repairs.

The apparent 'patch' in the upper part of the cast was bounded by the borders of features that were stated to relate to the form that the cast mould was prepared. However, given its intensity in the infrared it is still considered that there may be a variation in thickness, or the presence of a form of reinforcement, or other backing material at this location.

The fixings were indicated from the scan with the detector to be metallic, possibly ferrous, and be connected to a wire or small diameter bar, on the left side of the cast but a flat bar on the right side of the cast. This would require further investigation to clarify the actual dimensions and the actual composition of the fixings.

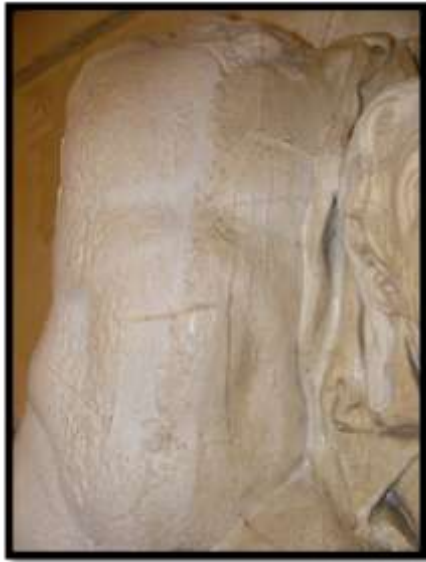
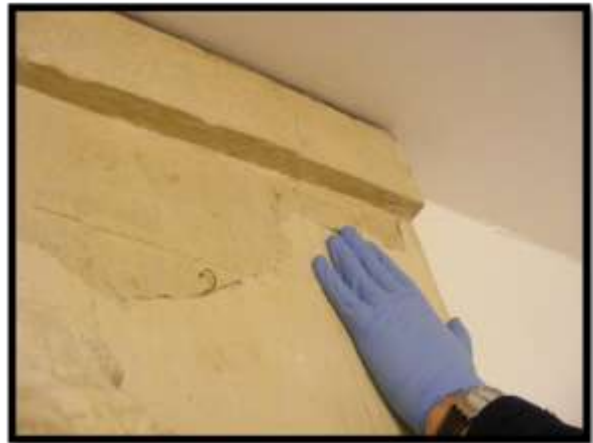
*Cast during wet cleaning*

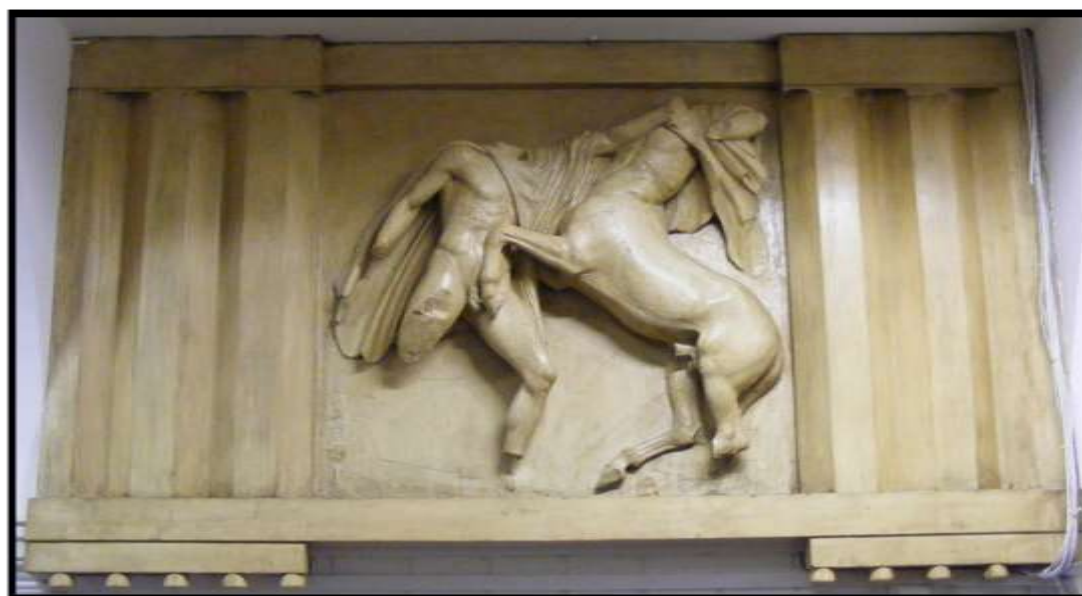
*Panel after conservation*

**STRUCTURAL STABILITY:** Good, but crack at dexter side of the cast by joint with wooden triglyphs; cracks at lower corners of the triglyphs.

**CHIPS AND LOSS:** Areas of loss associated with cracks; small chips on male figure.

- Prior to any conservation treatment, the cast was photographed. This photographic documentation was continued throughout all conservation processes.
- Initially, the cast was dry cleaned with soft brushes and Wishab Sponges with a rubber-nozzled vacuum to pick up the loose dust and dirt. .
- Following a variety of wet cleaning spot tests, the surface of the panel was cleaned with 2-5% Vulpex Liquid Soap in de-ionised water, using cotton wool swabs.

- All areas of raw plaster were given an application of 10% Paraloid B72 in acetone to provide an isolating layer between the original plaster and the repairs.

- Areas of loss, open joints and cracks were filled with white micro-balloons mixed with 12% Paraloid B72 in acetone. Larger areas of loss and around the screws were filled with an inert filler to provide extra strength.
- All the fills were then toned out with acrylics, mixed with matting agent, to match the surrounding patina.
- Finally, the entire cast was given an application of micro-crystalline wax so as to protect the surface.

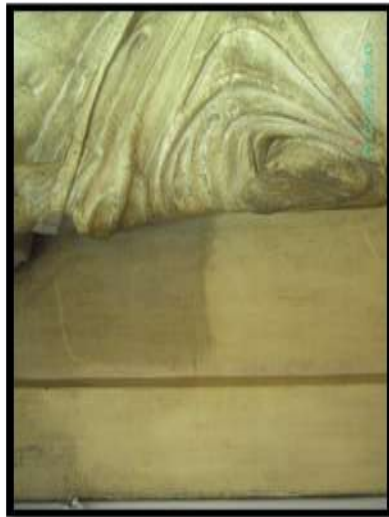
*Cast during wet cleaning*

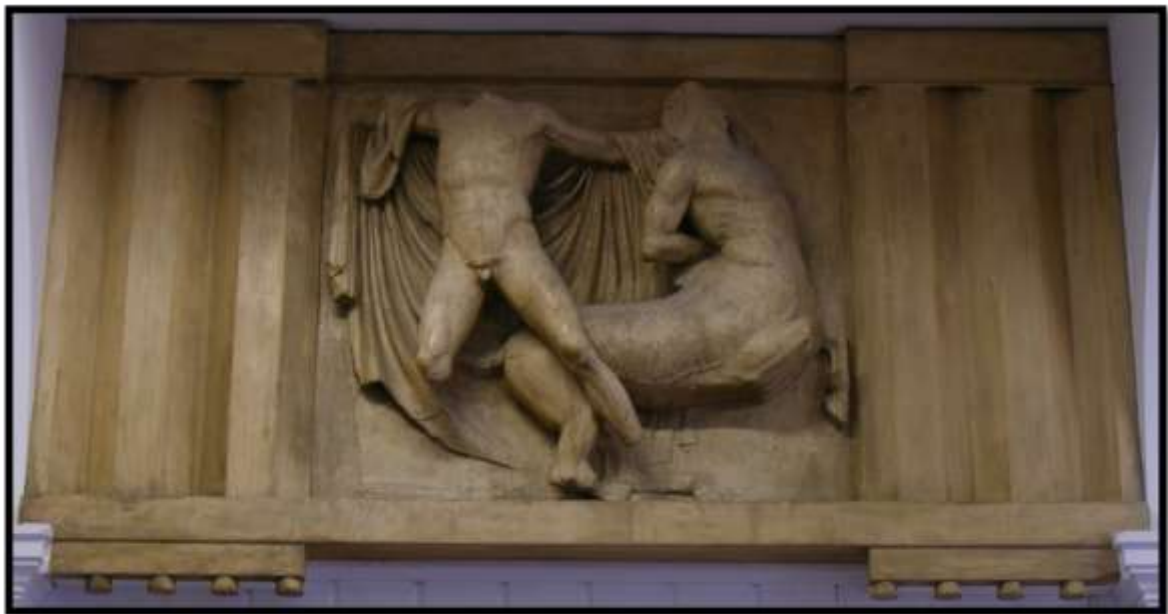
*Panel after conservation*

**STRUCTURAL STABILITY:** Good, but crack at sinister side of the cast by joint with wooden triglyphs; cracks in bottom corners of the triglyphs and on lower and upper parts on both sides.

**CHIPS AND LOSS:** Areas of loss associated with cracks.

- Prior to any conservation treatment, the cast was photographed. This photographic documentation was continued throughout all conservation processes.
- Initially, the cast was dry cleaned with soft brushes and Wishab Sponges with a rubber-nozzled vacuum to pick up the loose dust and dirt.
- Following a variety of wet cleaning spot tests, the surface of the panel was cleaned with 2-5% Vulpex Liquid Soap in de-ionised water, using cotton wool swabs.

- The areas of flaking paint were consolidated with an application of 5% Primal B60A in de-ionised water.
- All areas of raw plaster were given an application of 10% Paraloid B72 in acetone to provide an isolating layer between the original plaster and the repairs.

- Areas of loss, open joints and cracks were filled with white micro-balloons mixed with 12% Paraloid B72 in acetone. Larger areas of loss and around the screws were filled with an inert filler to provide extra strength.
- All the fills were then toned out with acrylics, mixed with matting agent, to match the surrounding patina.
- Finally, the entire cast was given an application of micro-crystalline wax so as to protect the surface.

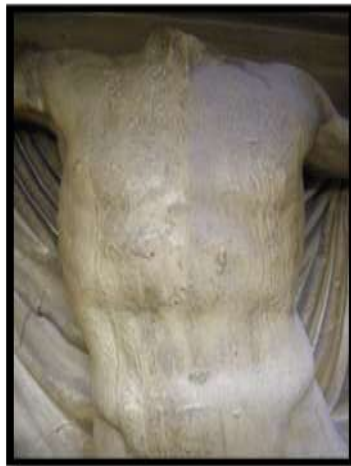
*Cast during wet cleaning*

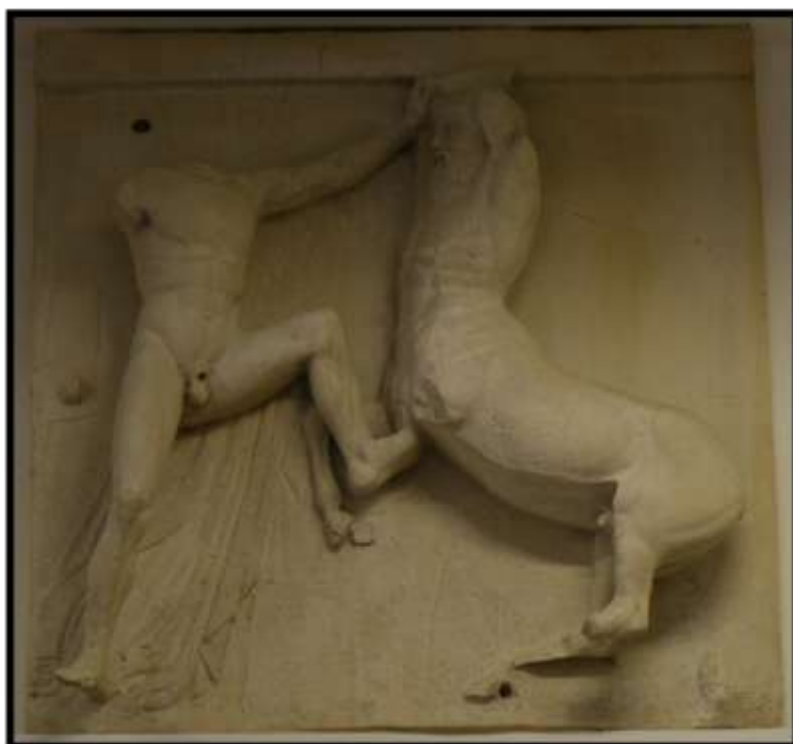
*Panel after conservation*

**STRUCTURAL STABILITY:** Good, but crack at corners and edges of the cast.

**CHIPS AND LOSS:** Areas of loss and loose fragments associated with cracks.

- Prior to any conservation treatment, the cast was photographed. This photographic documentation was continued throughout all conservation processes.
- Initially, the cast was dry cleaned with soft brushes and Wishab Sponges with a rubber-nozzled vacuum to pick up the loose dust and dirt.
- Following wet cleaning spot tests the surface of the cast was cleaned with Anjusil. The application of Anjusil was repeated in places if necessary.

- All areas of raw plaster were given an application of 10% Paraloid B72 in acetone to provide an isolating layer between the original plaster and the repairs.
- All loose fragments were reattached with HMG adhesive.
- Areas of loss, open joints and cracks were filled with white micro-balloons mixed with 12% Paraloid B72 in acetone. Larger areas of loss and around the screws were filled with an inert filler to provide extra strength.

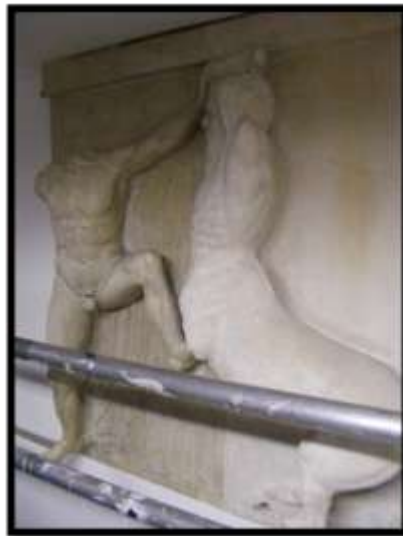
*Cast during wet cleaning*

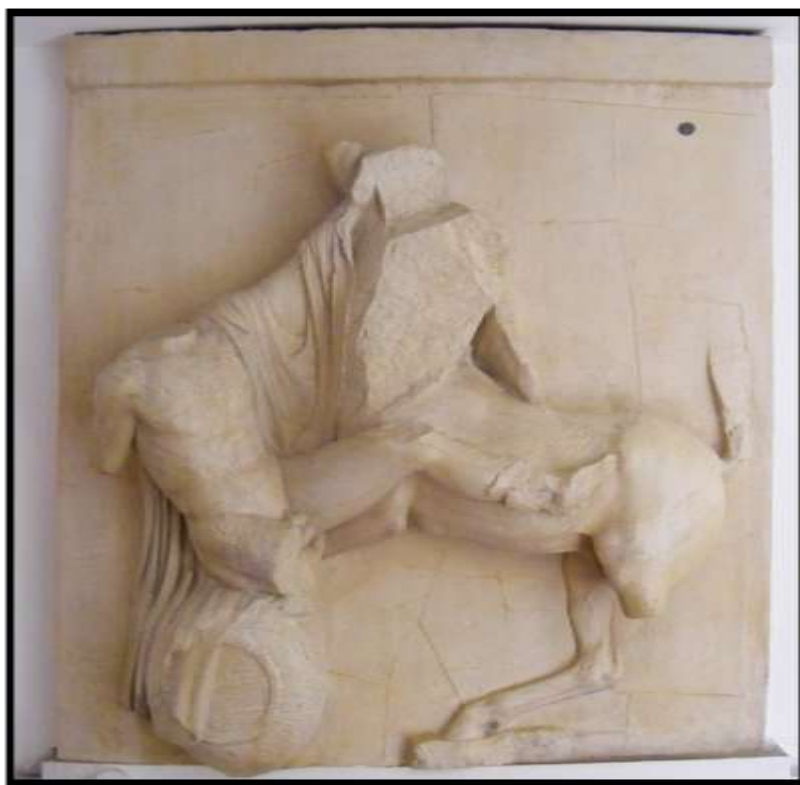
*Panel after conservation*

**STRUCTURAL STABILITY:** Good, some small cracks by fixings and on edges.

**CHIPS AND LOSS:** Areas of loss associated with cracks and at arm of centaur.

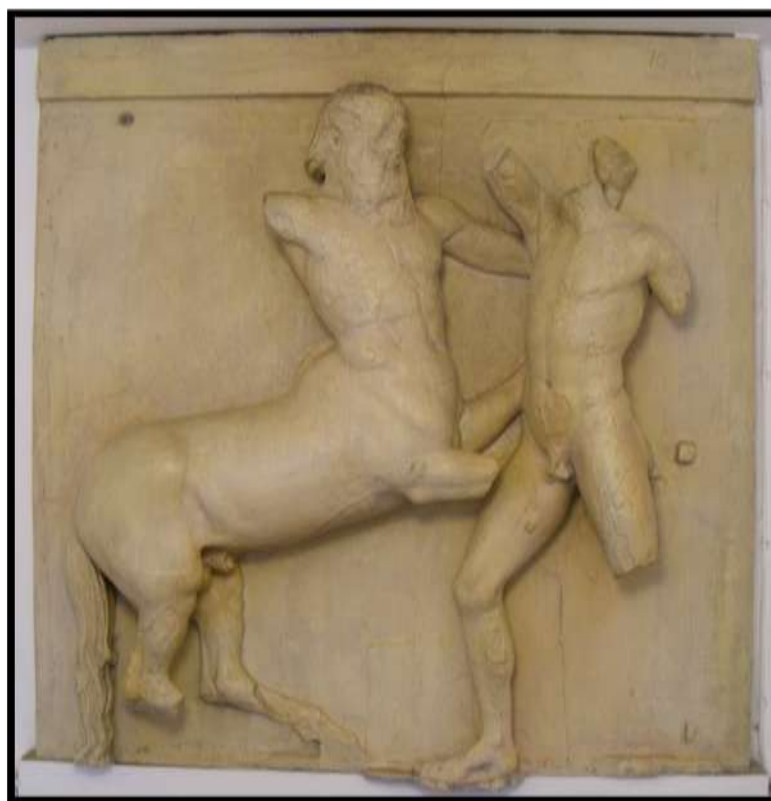
*Panel after conservation*

**CHIPS AND LOSS:** Areas of loss associated with cracks; small chip in top dexter section of the cast.

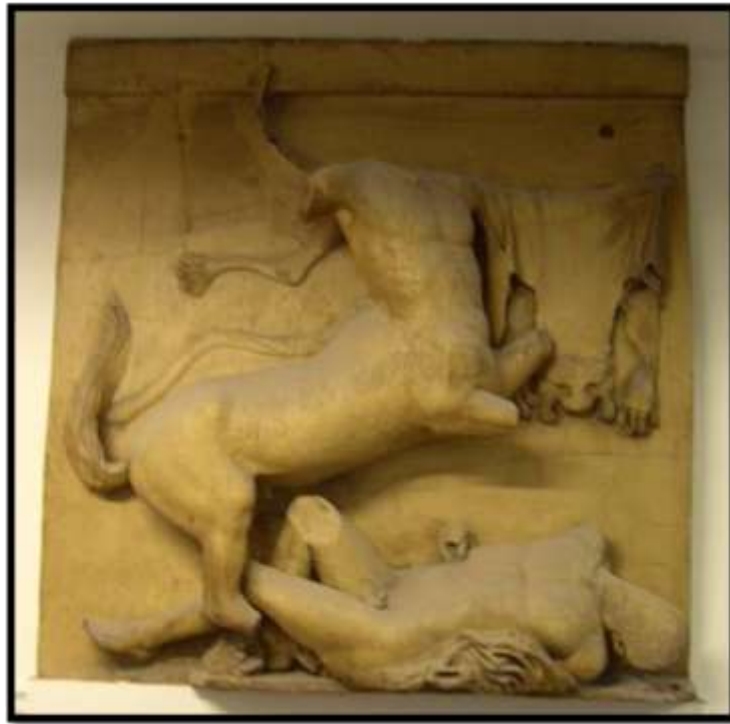
*Panel before conservation*

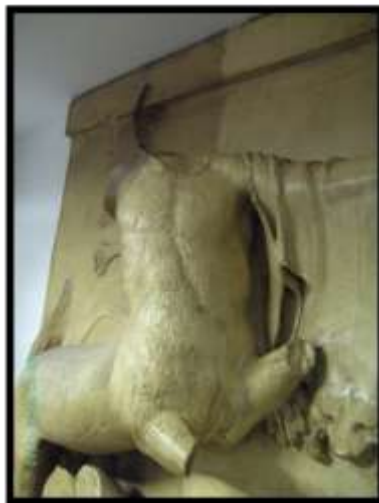
*Cast during wet cleaning*

- Prior to any conservation treatment, the cast was photographed. This photographic documentation was continued throughout all conservation processes.
- Initially, the cast was dry cleaned with soft brushes and Wishab Sponges with a rubber-nozzled vacuum to pick up the loose dust and dirt.
- Following a variety of wet cleaning spot tests, the surface of the panel was cleaned with 2-5% Vulpex Liquid Soap in de-ionised water, using cotton wool swabs.

- The areas of flaking paint were consolidated with an application of 5% Primal B60A in de-ionised water.

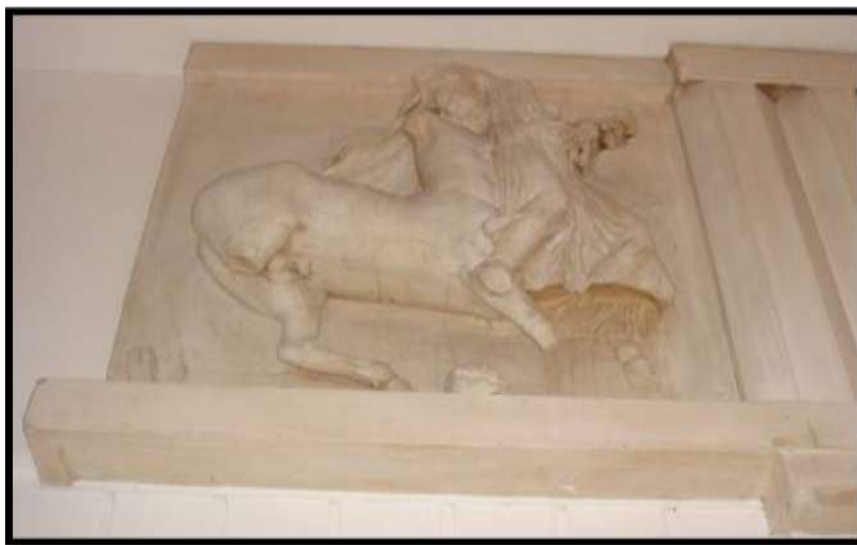
*Panel before conservation*

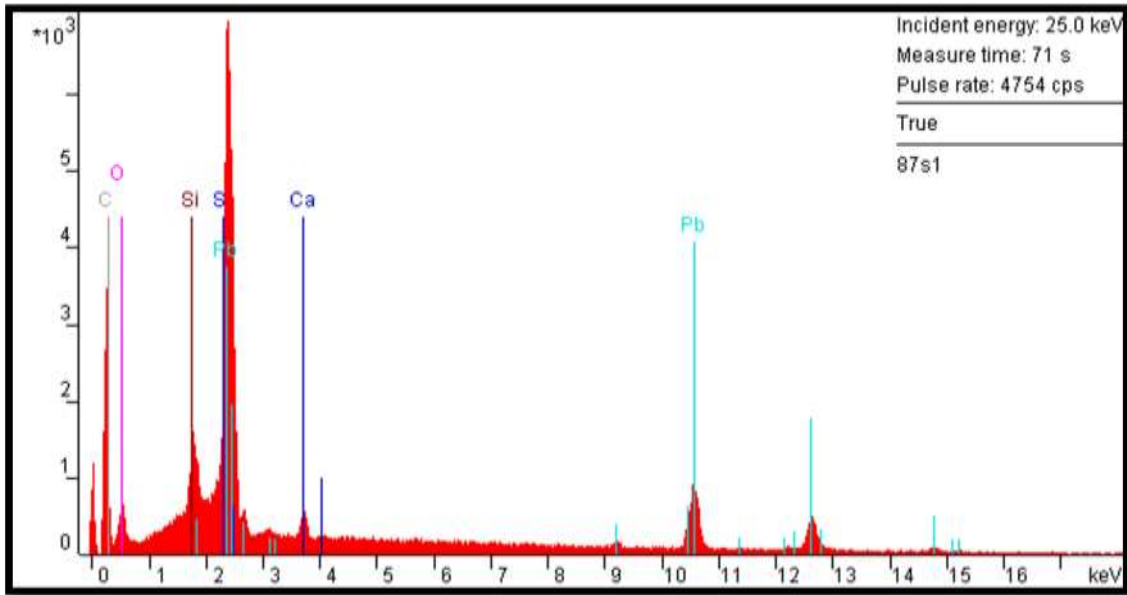
*Spectrum 4 sample Metope P019 spot 1*

The sample from Metope P019 seems to contain a thick plaster layer containing white particles and an orange / brown substance which may be discoloured glue size or oil or resin. There are what appear to be two bright white paint layers at the top of the section, as photographed, and also towards the bottom is a large brown inclusion. The brown inclusion appeared black under UV, showing no fluorescence, unusual for old glue, or old oil or resin and may be due to an iron oxide pigment. Both the bright white paint layers fluoresced blue-white indicating that they may contain lead white. The electron micrograph indicated a thin incomplete layer on top of the two thicker white layers EDX analysis at spot 1 in this thin, uppermost upper paint layer gave a spectrum containing mainly lead (spectrum 4), indicating the presence of mostly lead white, with a trace of silicon and calcium indicating the presence of some silica, eg. quartz and chalk. Analysis of the two main layers at spots 2 and 3 gave similar spectra, indicating that these paint layers consist mainly of lead white with some chalk and silica extenders. The plaster was analysed at spot 4 (Figure 9) and gave a spectrum similar to that of spectrum 3 above, containing mainly calcium and sulphur indicating that the plaster is gypsum.

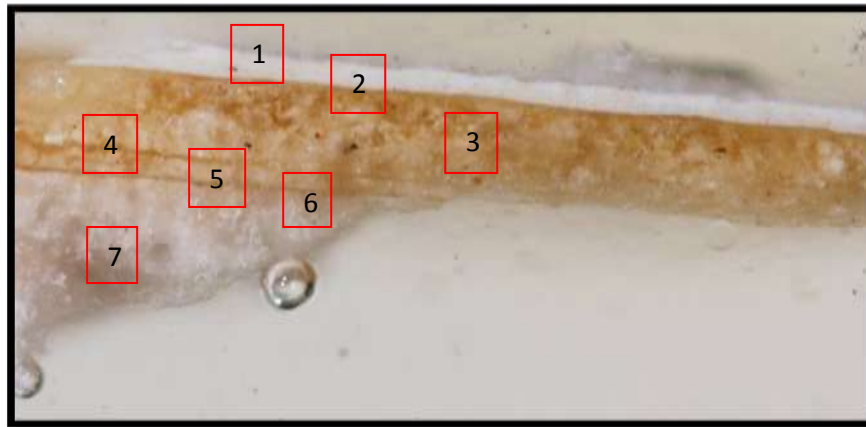
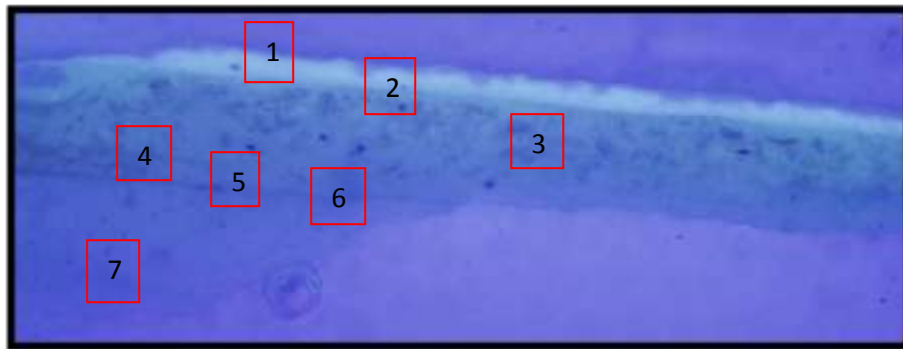
*Photograph of the cross-section sample from Triglyph in between Metope P019 and P020*

*Photograph of the cross-section sample from Triglyph in between Metope P019 and P020 –  
in UV light*

In the cross-section there seem to be two layers of paint, one bright white, lacking fluorescence which may be titanium white or chalk, and the lower paint layer is a slightly creamy white which has a bright blue fluorescence which may be lead white. EDX analysis may be required here in order to identify the pigments in each layer.

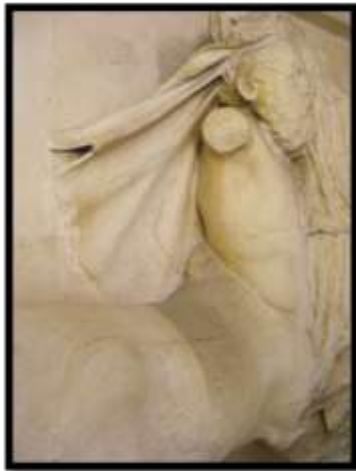
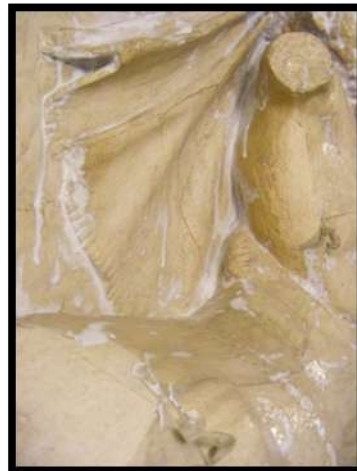
*Cast during wet cleaning*

- Prior to any conservation treatment, the cast was photographed. This photographic documentation was continued throughout all conservation processes.
- Initially, the cast was dry cleaned with soft brushes and Wishab Sponges with a rubber-nozzled vacuum to pick up the loose dust and dirt.
- Following wet cleaning spot tests the surface of the cast was cleaned with Anjusil. The application of Anjusil was repeated in places if necessary.

- The areas of flaking paint were consolidated with an application of 5% Primal B60A in de-ionised water.
- All areas of raw plaster were given an application of 10% Paraloid B72 in acetone to provide an isolating layer between the original plaster and the repairs.
- The loose fragment by the bottom edge of the cast was reattached using Perspex dowels and polyester resin.

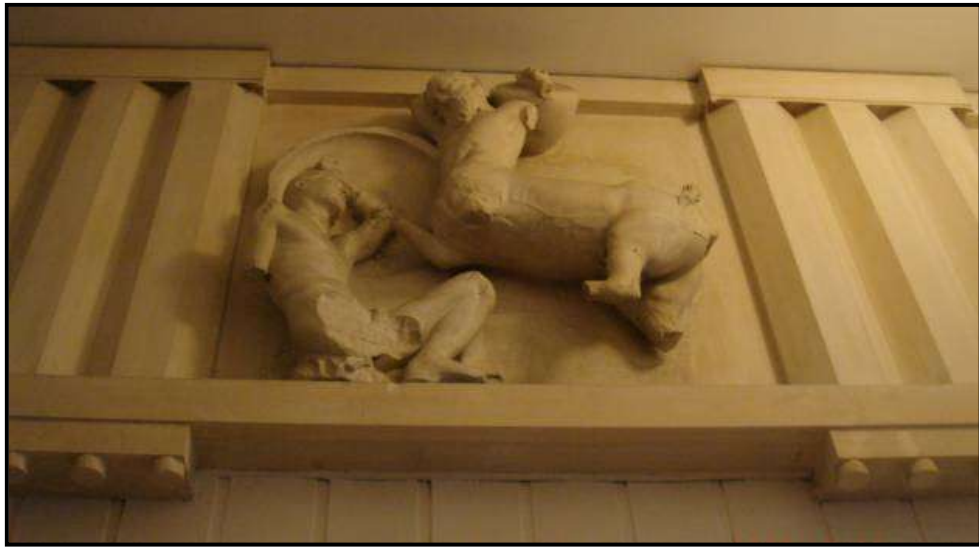
*Panel before conservation*

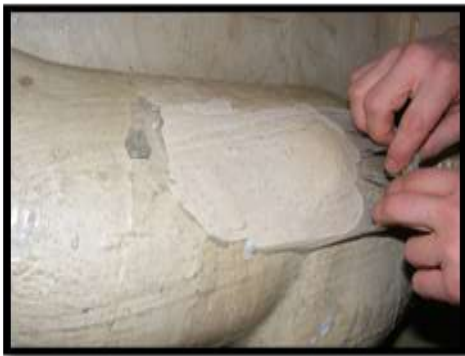
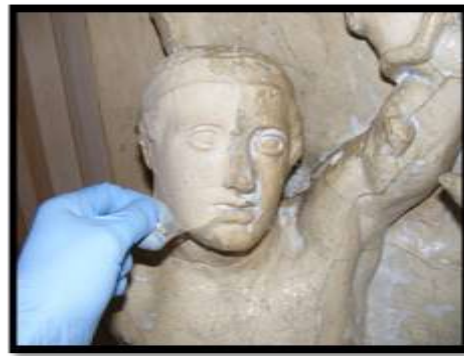
*Cast during cleaning*

- Prior to any conservation treatment, the cast was photographed. This photographic documentation was continued throughout all conservation processes.
- Initially, the cast was dry cleaned with soft brushes and Wishab Sponges with a rubber-nozzled vacuum to pick up the loose dust and dirt.
- Following wet cleaning spot tests the surface of the cast was cleaned with Anjusil. The application of Anjusil was repeated in places if necessary.

- The areas of flaking paint were consolidated with an application of 5% Primal B60A in de-ionised water.
- All areas of raw plaster were given an application of 10% Paraloid B72 in acetone to provide an isolating layer between the original plaster and the repairs.

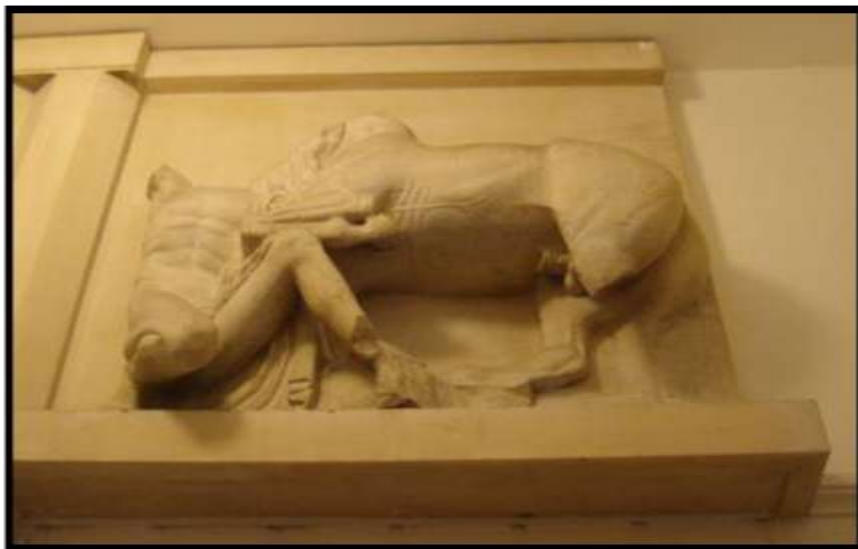
*Panel before conservation*
