1. PARTHENON FRIEZE

1.4 SCULPTURE COURT LOWER GALLERY NORTH WALL

PANEL 1

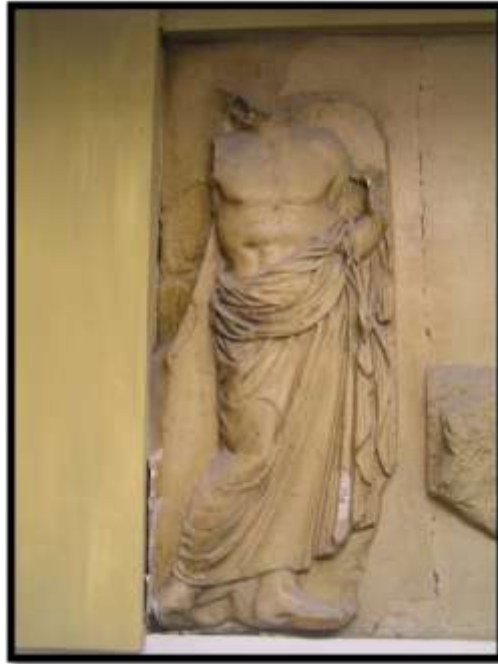
Panel before conservation

STRUCTURAL STABILITY: Fair. Open crack running alongside joint on both sides of the panel; small cracks at lower sinister corner.

SURFACE DUST AND DIRT: Severe, 100% coverage.

VISIBLE PAINT LAYERS/UNSIGHTLY MARKINGS: Layer of cream-yellow paint/varnish on surface of the cast; the surface polychrome is discoloured and damaged on lower part of the panel probably by the strip lights which used to run under the Frieze along the South and North walls of the Ground Floor Gallery; small spots of paint splash scattered on the surface of the cast; area of flaking and missing paint on lower part of the panel.

CHIPS AND LOSS: Missing areas associated with the cracks; large missing chips in middle section of dexter edge, on lower part of drapery and on sinister foot of the figure.

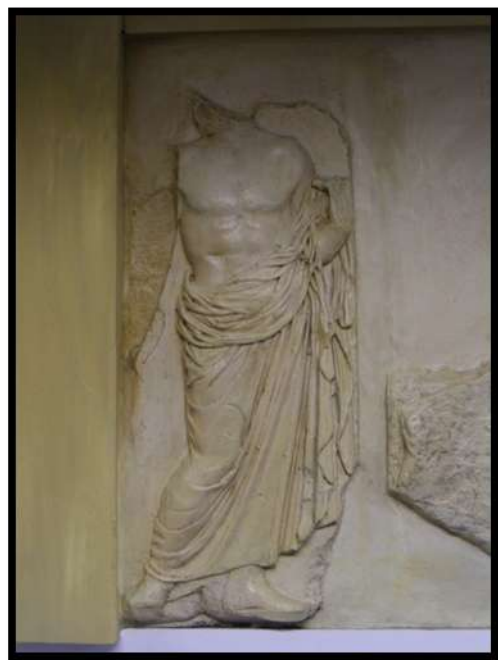
Panel after conservation

- Areas of flaking paint were consolidated with 5% Primal B60A in de-ionised water.
- All areas of raw plaster were given an application of 10% Paraloid B72 in acetone to provide an isolating layer between the original plaster and the repairs.
- Exposed metal fixings were treated with 5% Tannic Acid so as to stabilise the corrosion, and covered with a protective layer of 20% Paraloid B72 in acetone.
- Areas of loss, open joints and cracks were filled with white micro-balloons mixed with 12% Paraloid B72 in acetone. Larger areas of loss around the screws were filled with an inert filler to provide extra strength.

- All the fills and areas of discoloured paint were then toned out with acrylics, mixed with matting agent, to match the surrounding patina.
- Finally, the entire cast was given an application of micro-crystalline wax so as to protect the surface.

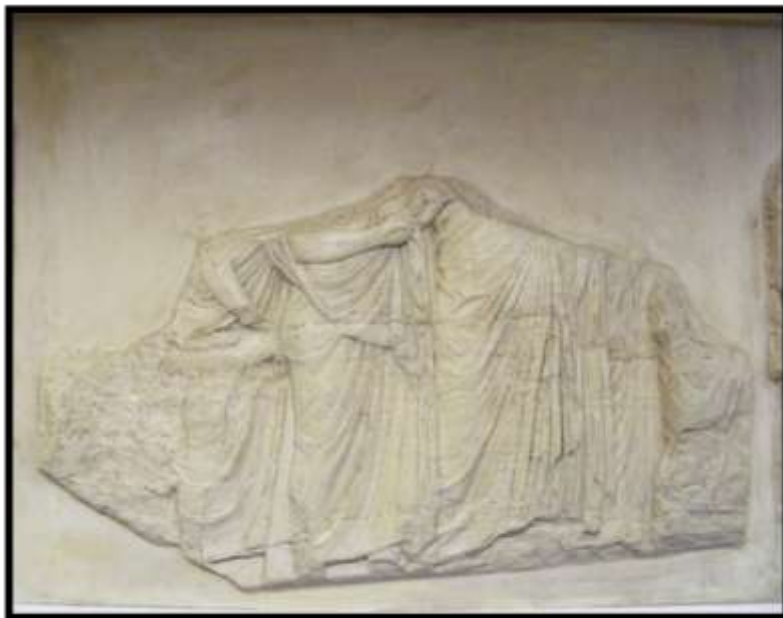
Panel after conservation

- Areas of flaking paint were consolidated with 5% Primal B60A in de-ionised water.
- All areas of raw plaster were given an application of 10% Paraloid B72 in acetone to provide an isolating layer between the original plaster and the repairs.

- Exposed metal fixings were treated with 5% Tannic Acid so as to stabilise the corrosion, and covered with a protective layer of 20% Paraloid B72 in acetone.

- Areas of loss, open joints and cracks were filled with white micro-balloons mixed with 12% Paraloid B72 in acetone. Larger areas of loss around the screws were filled with an inert filler to provide extra strength.

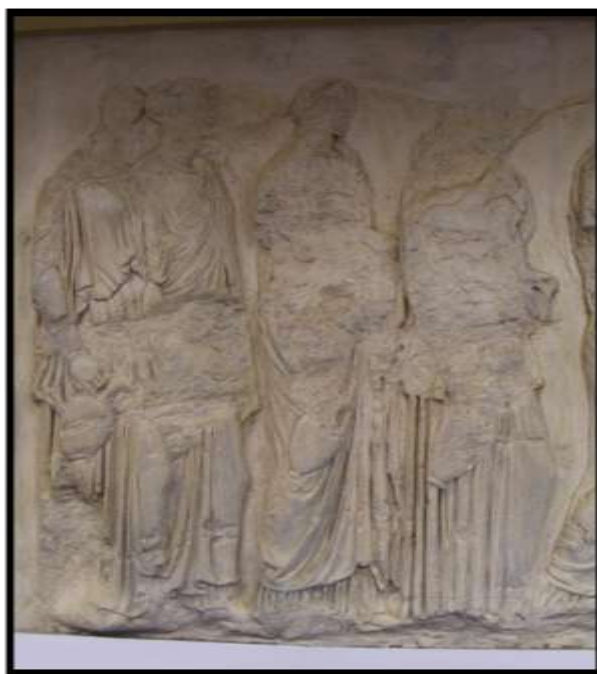
Panel after conservation

- Areas of flaking paint were consolidated with 5% Primal B60A in de-ionised water.
- All areas of raw plaster were given an application of 10% Paraloid B72 in acetone to provide an isolating layer between the original plaster and the repairs.

- Exposed metal fixings were treated with 5% Tannic Acid so as to stabilise the corrosion, and covered with a protective layer of 20% Paraloid B72 in acetone.

- Areas of loss, open joints and cracks were filled with white micro-balloons with 12% Paraloid B72 in acetone. Larger areas of loss around the screws were filled with an inert filler to provide extra strength.

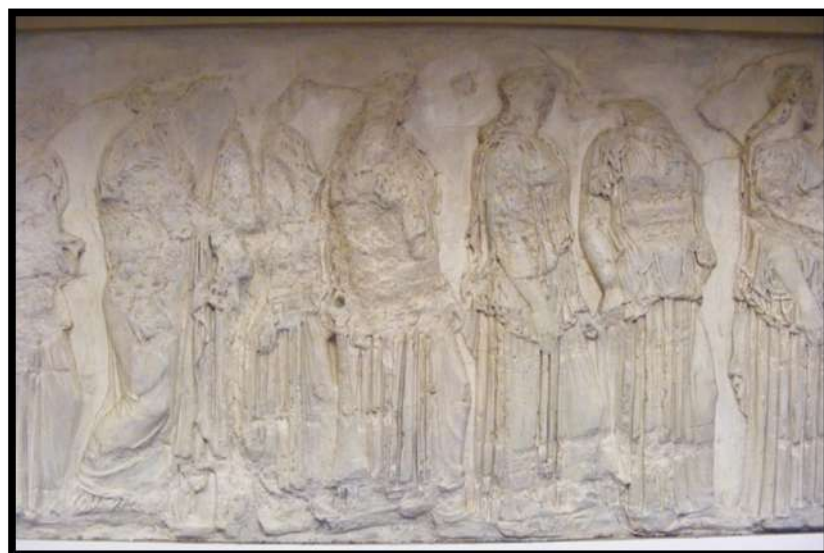
Panel after conservation

- Areas of flaking paint were consolidated with 5% Primal B60A in de-ionised water.
- All areas of raw plaster were given an application of 10% Paraloid B72 in acetone to provide an isolating layer between the original plaster and the repairs.
- Exposed metal fixings were treated with 5% Tannic Acid so as to stabilise the corrosion, and covered with a protective layer of 20% Paraloid B72 in acetone.
- Areas of loss, open joints and cracks were filled with white micro-balloons with 12% Paraloid B72 in acetone. Larger areas of loss around the screws were filled with an inert filler to provide extra strength.
- All the fills and areas of discoloured paint were then toned out with acrylics, mixed with matting agent, to match the surrounding patina.
- Finally, the entire cast was given an application of micro-crystalline wax so as to protect the surface.

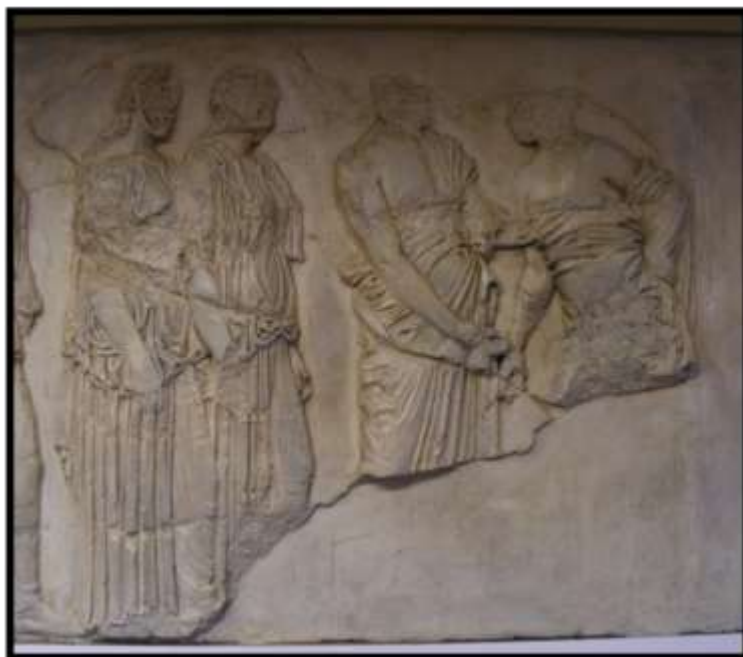
Panel after conservation

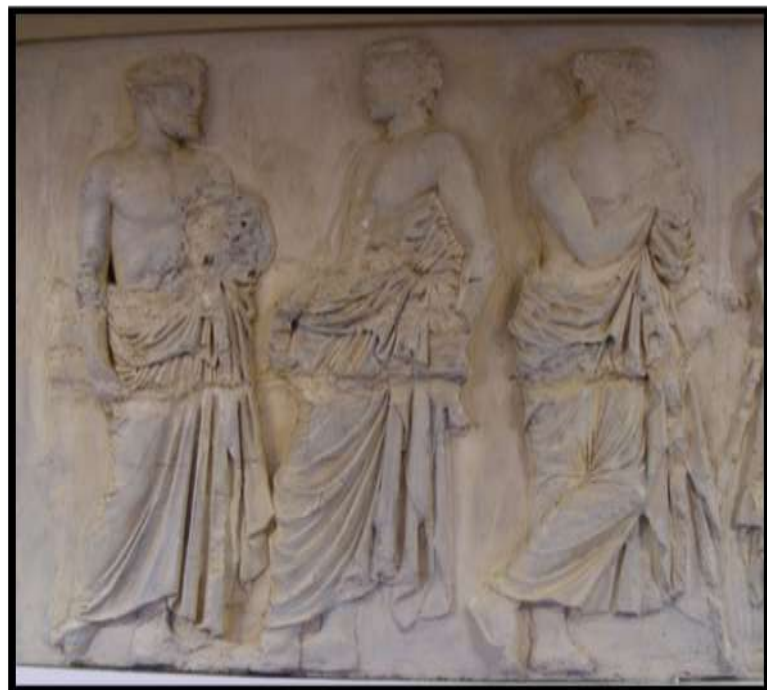
Panel after conservation

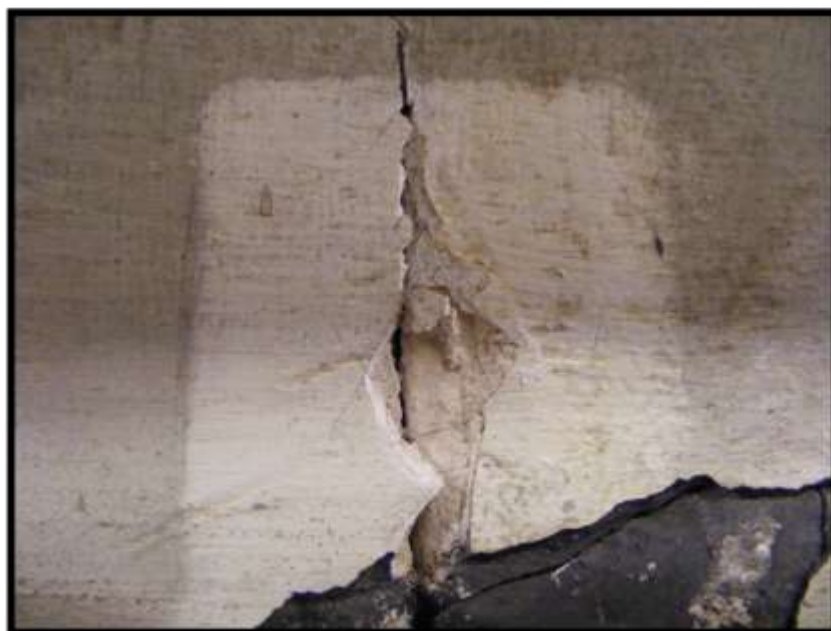
A mortar analysis was carried out by Mr Bill Revie of CMC on samples of the pointing material found between the Panel 10 and 11 on Ground Floor Galley North Wall. The mortar was found to be a thick layer of lime putty, gypsum plaster and fine sand and hair, followed by a thin layer of gypsum plaster and lime putty; and finally a layer of varnish. This final layer of varnish is found over the entire two floors of the North and South Walls and yet, interestingly, for some unknown reason, it was not applied to the slabs on the East Wall.

Samples of mortar were taken for analysis

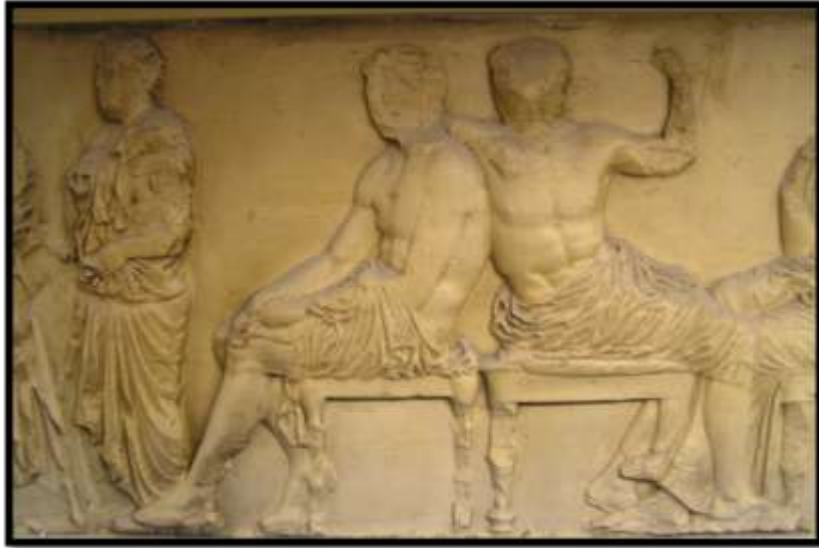
PANEL 7

Panel before conservation

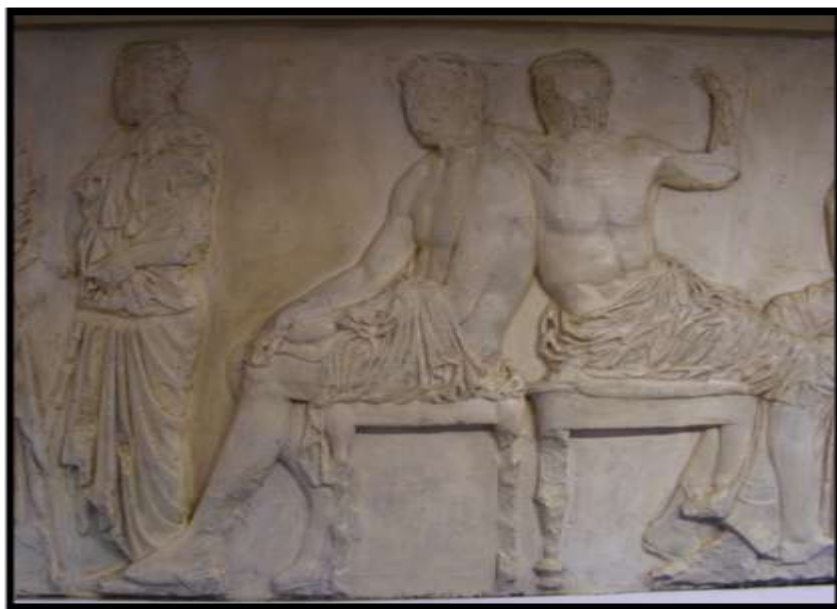
Panel after conservation

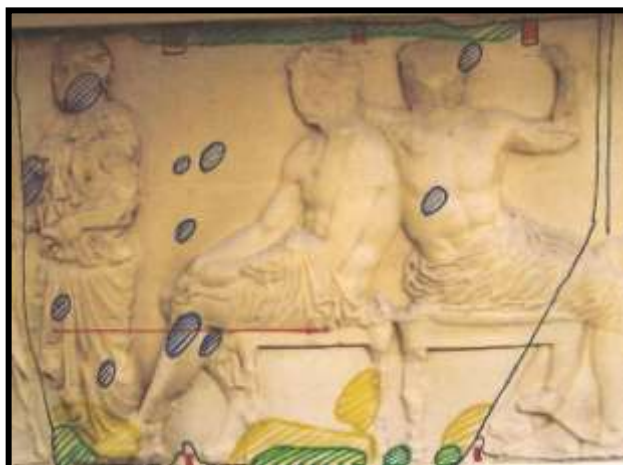
Paint splashes

Flaking paint

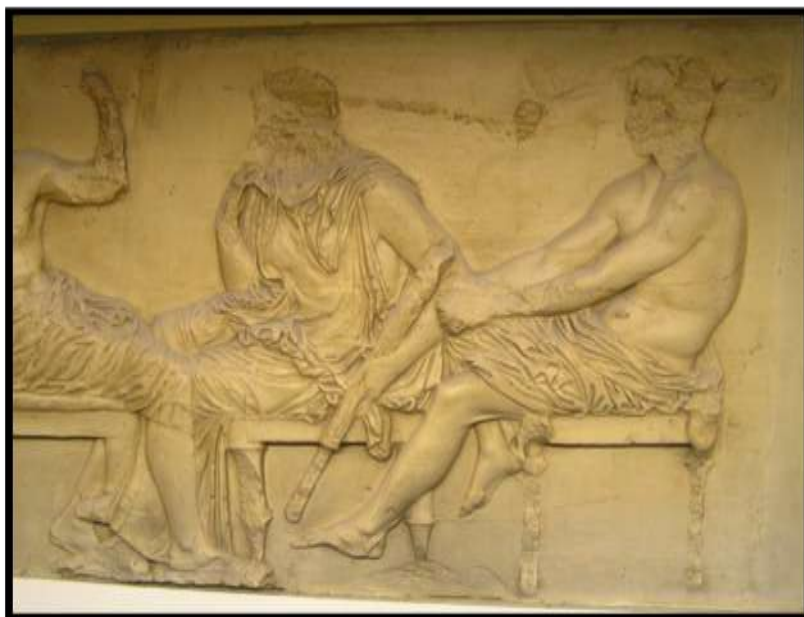
PANEL 8

Panel before conservation

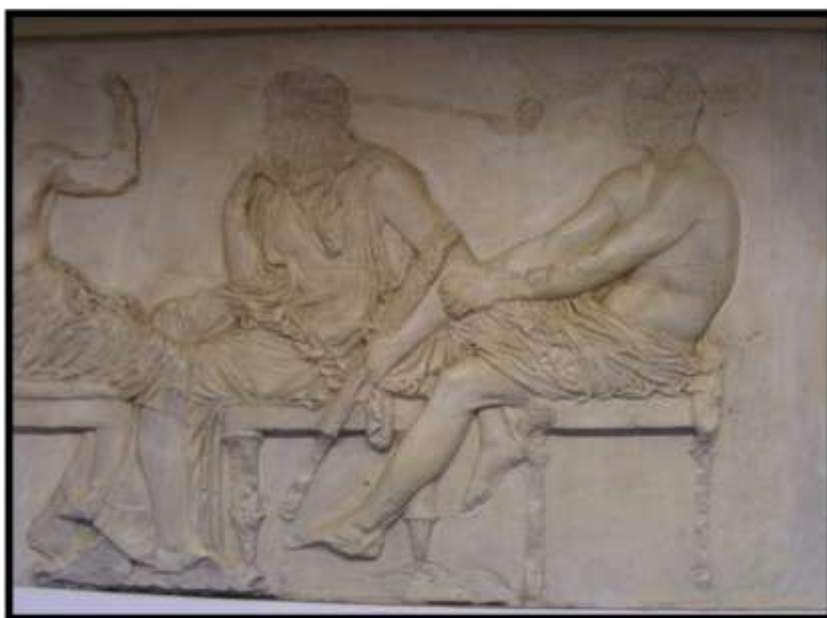
Panel after conservation

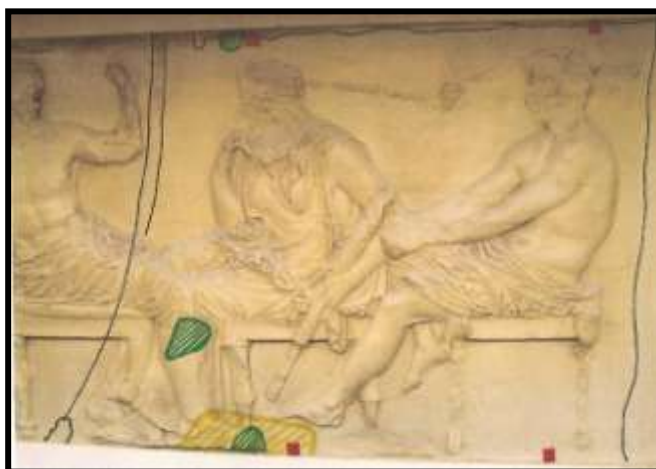
Paint splashes

Flaking paint

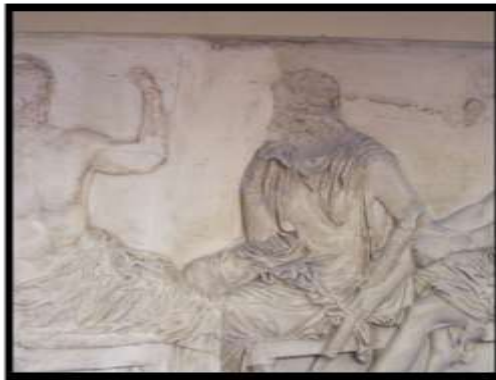
Panel during wet cleaning

- Prior to any conservation treatment the cast was photographed. This photographic documentation was continued throughout all conservation processes.
- Initially, the cast was dry cleaned with soft brushes and Wishab Sponges with a rubber-nozzled vacuum to pick up loose dust and dirt.
- Following wet cleaning spot tests on **Panel 1 on Upper Gallery South Wall**, the surface of the cast was cleaned with 2-5% Vulpex Liquid Soap in de-ionised water, using cotton wool swabs.

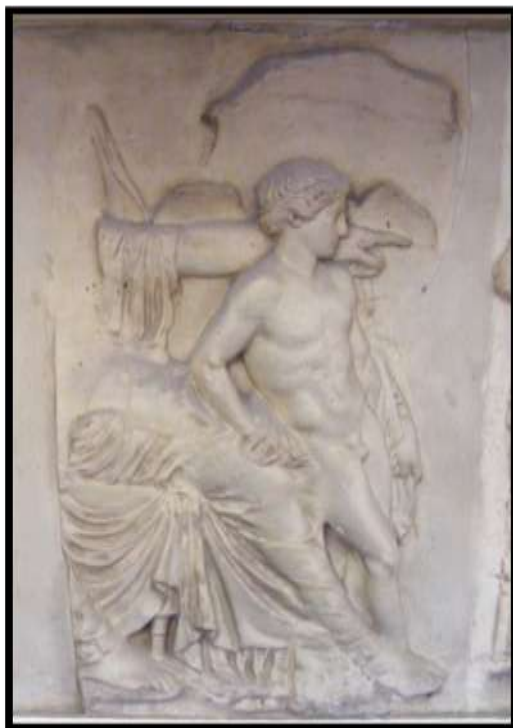
PANEL 9

Panel before conservation

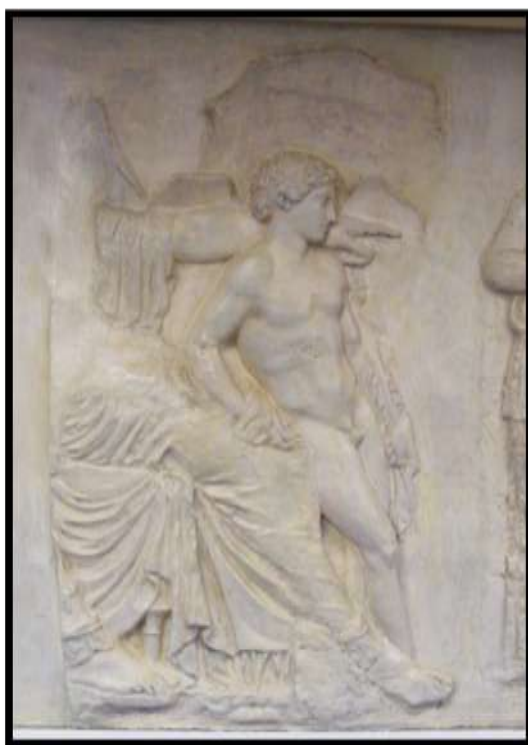
Panel after conservation

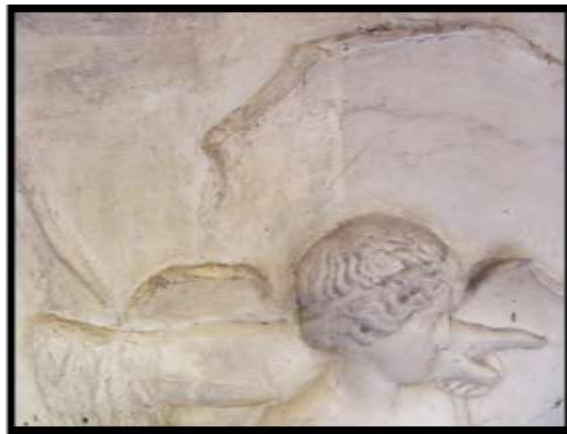
Panel during wet cleaning

- Prior to any conservation treatment the cast was photographed. This photographic documentation was continued throughout all conservation processes.
- Initially, the cast was dry cleaned with soft brushes and Wishab Sponges with a rubber-nozzled vacuum to pick up loose dust and dirt.
- Following wet cleaning spot tests on **Panel 1 on Upper Gallery South Wall**, the surface of the cast was cleaned with 2-5% Vulpex Liquid Soap in de-ionised water, using cotton wool swabs.

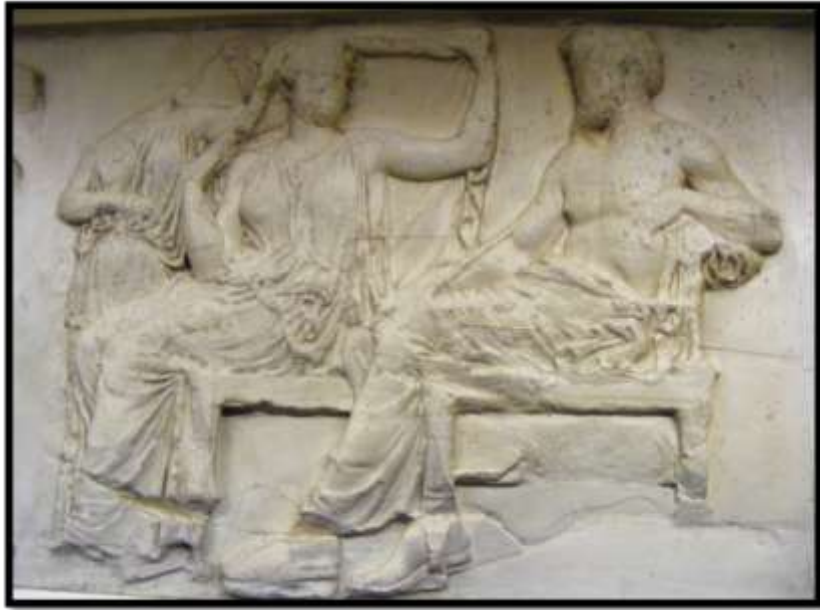
PANEL 10

Panel before conservation

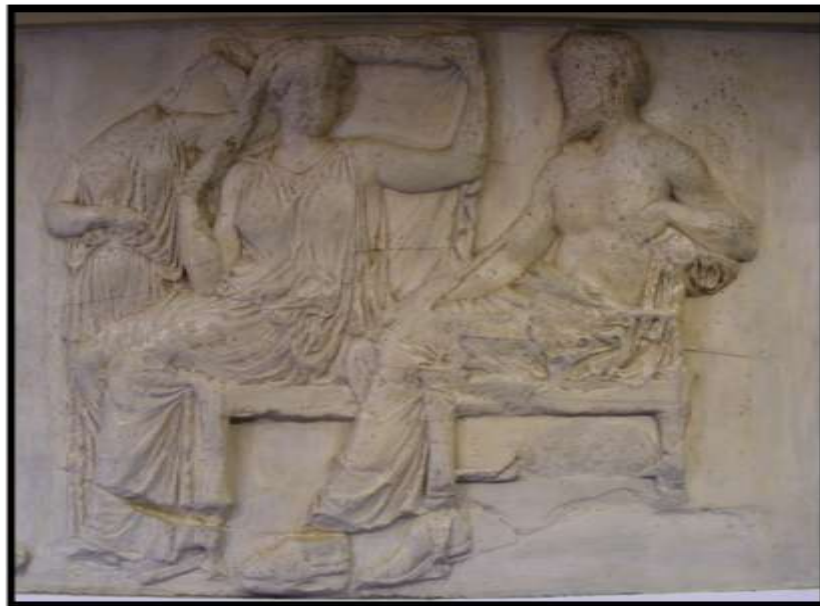
Panel after conservation

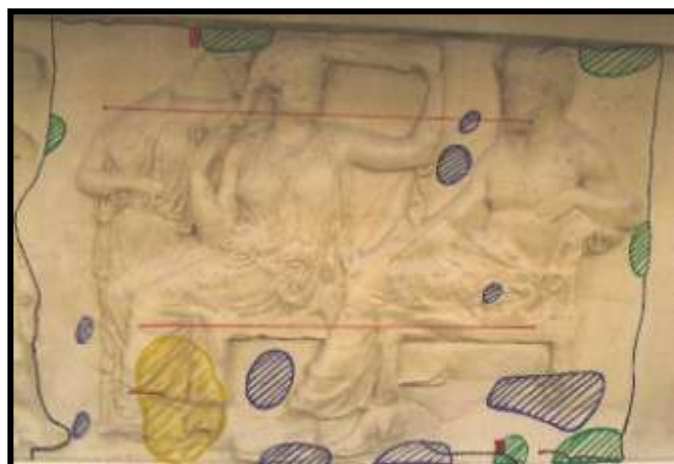
Paint splashes

Flaking paint

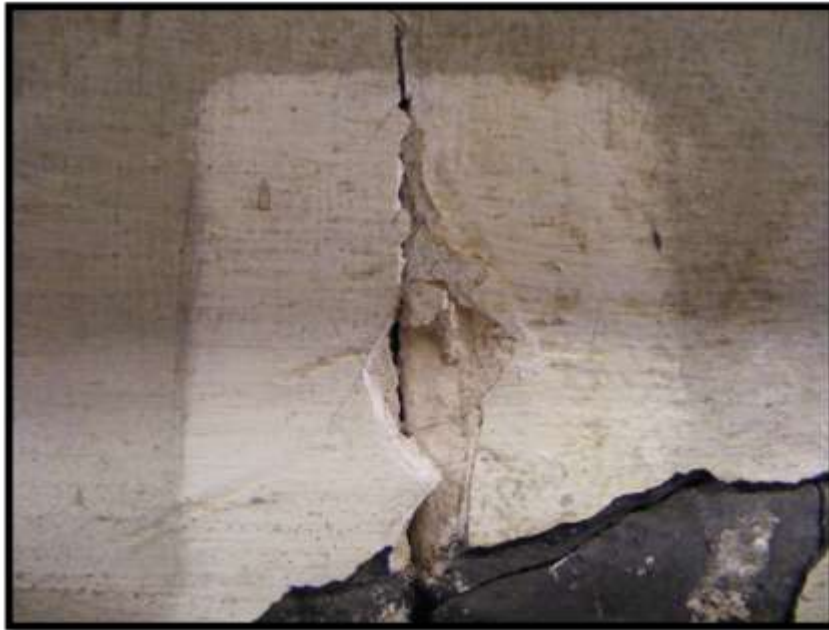
A mortar analysis was carried out by Mr Bill Revie of CMC on samples of the pointing material found between the Panel 10 and 11 on Ground Floor Galley North Wall. The mortar was found to be a thick layer of lime putty, gypsum plaster and fine sand and hair, followed by a thin layer of gypsum plaster and lime putty; and finally a layer of varnish. This final layer of varnish is found over the entire two floors of the North and South Walls and yet, interestingly, for some unknown reason, it was not applied to the slabs on the East Wall.

Samples of mortar were taken for analysis

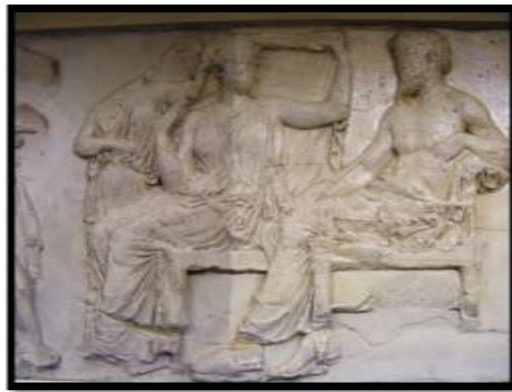
Panel during wet cleaning

- Prior to any conservation treatment the cast was photographed. This photographic documentation was continued throughout all conservation processes.
- Initially, the cast was dry cleaned with soft brushes and Wishab Sponges with a rubber hosed vacuum to pick up loose dust and dirt.
- Following wet cleaning spot tests on **Panel 1 on Upper Gallery South Wall**, the surface of the cast was cleaned with 2-5% Vulpex Liquid Soap in de-ionised water, using cotton wool swabs.

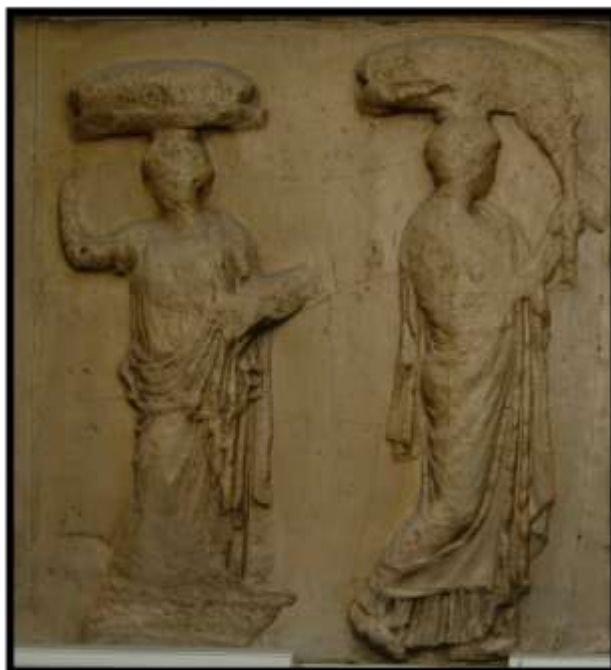
PANEL 11

Panel before conservation

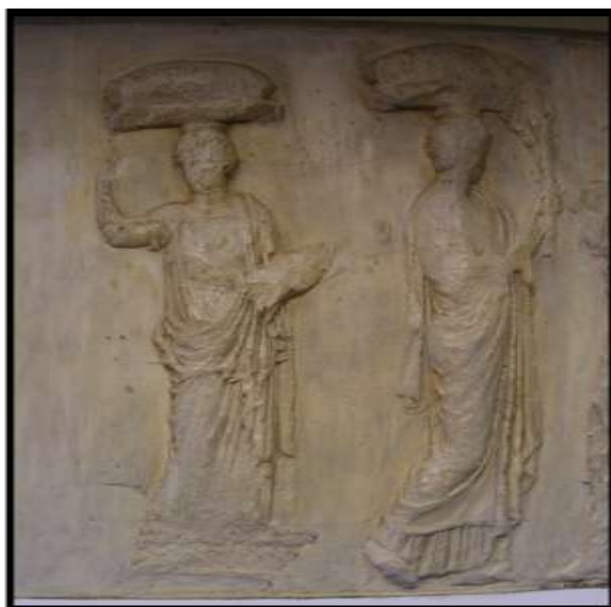
Panel after conservation

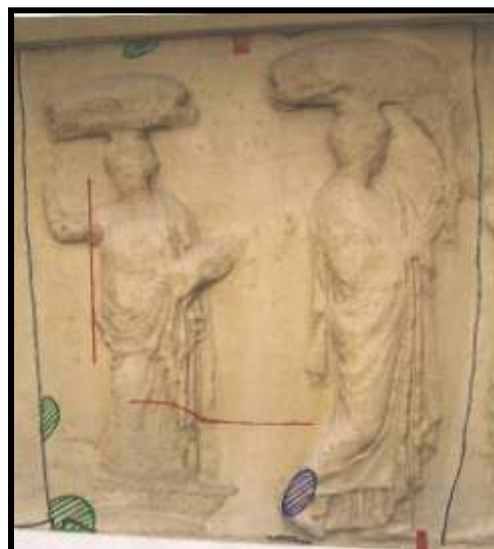
Chips, abrasions and missing surfaces

Paint splashes

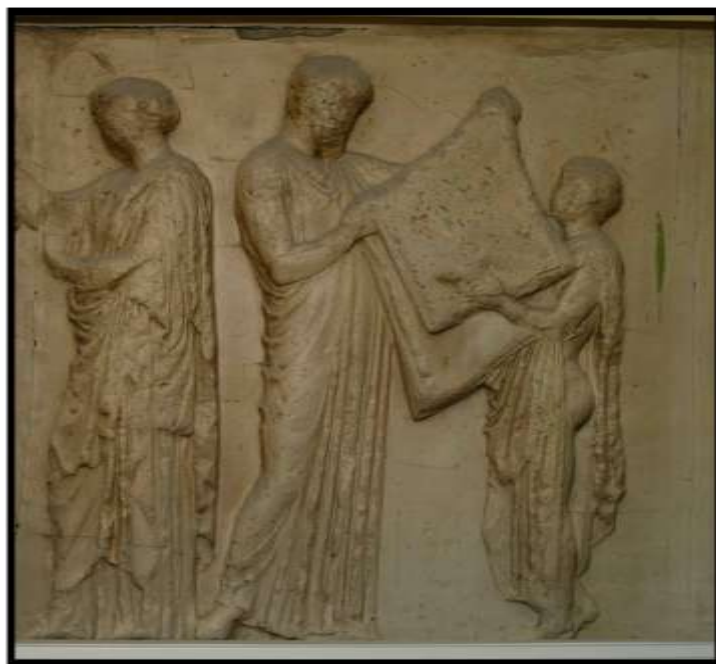
PANEL 12

Panel before conservation

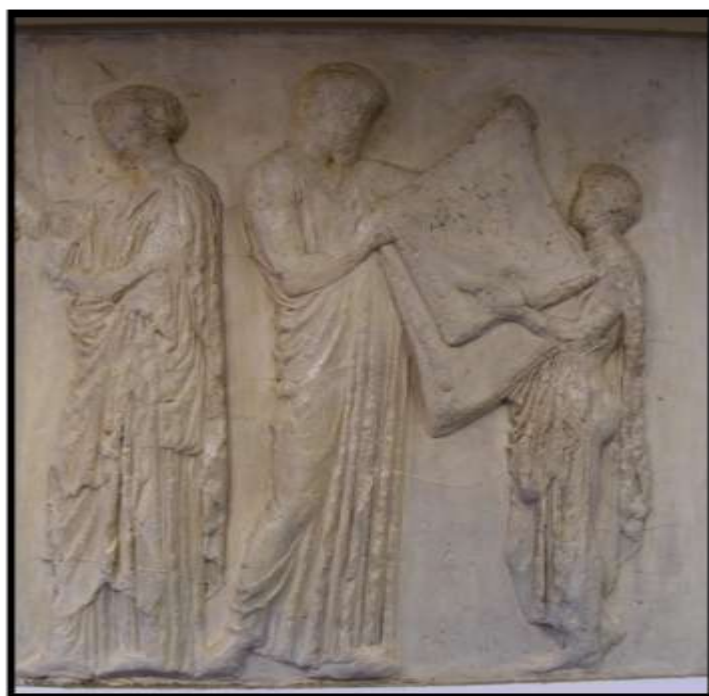
Panel after conservation

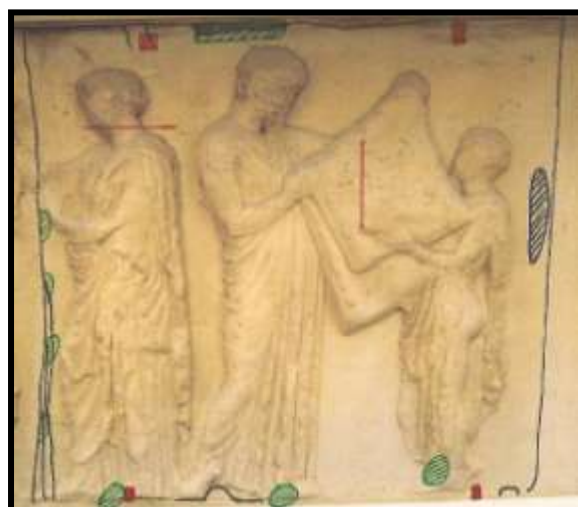
Chips, abrasions and missing surfaces

Paint splashes

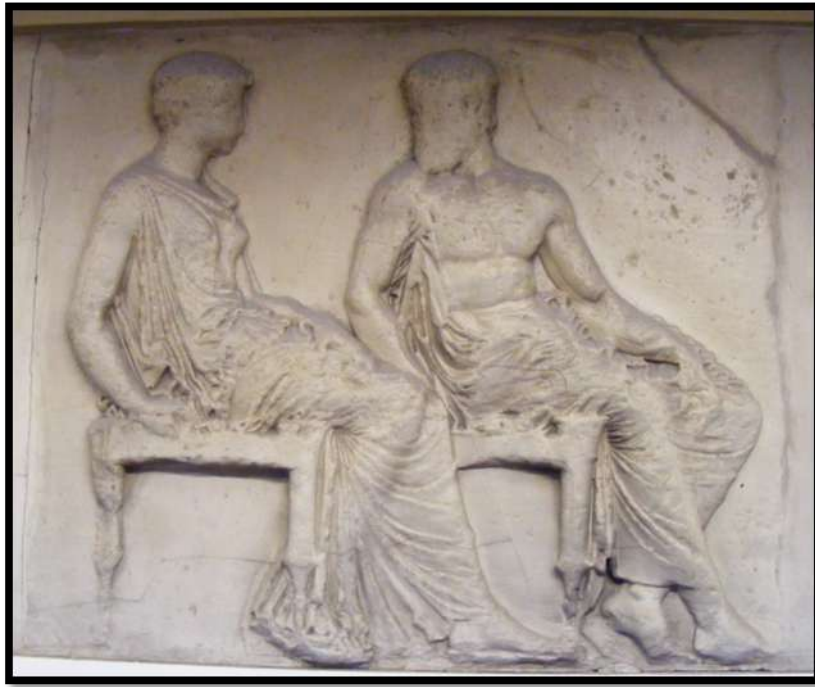
PANEL 13

Panel before conservation

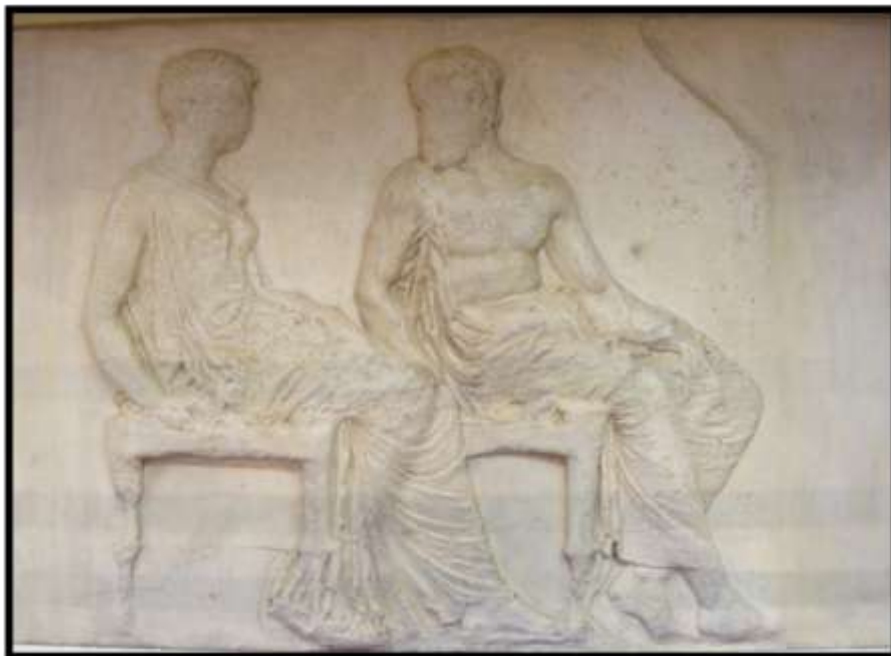
Panel after conservation

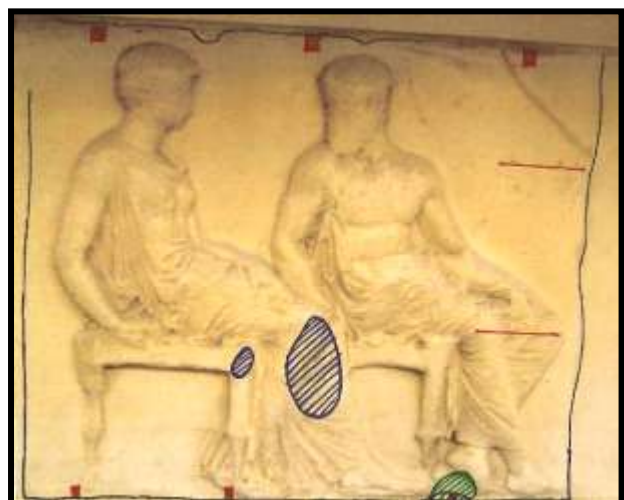
Chips, abrasions and missing surfaces

Paint splashes

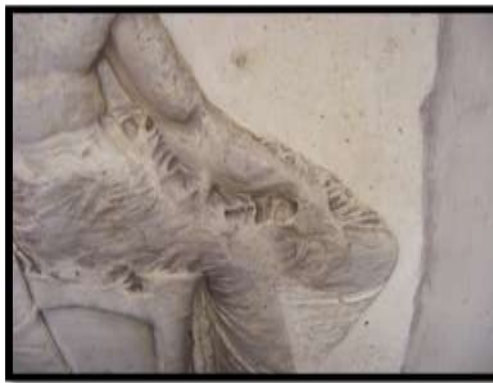
Panel during wet cleaning

- Prior to any conservation treatment the cast was photographed. This photographic documentation was continued throughout all conservation processes.
- Initially, the cast was dry cleaned with soft brushes and Wishab Sponges with a rubber-nozzled vacuum to pick up loose dust and dirt.
- Following wet cleaning spot tests on **Panel 1 on Upper Gallery South Wall**, the surface of the cast was cleaned with 2-5% Vulpex Liquid Soap in de-ionised water, using cotton wool swabs.

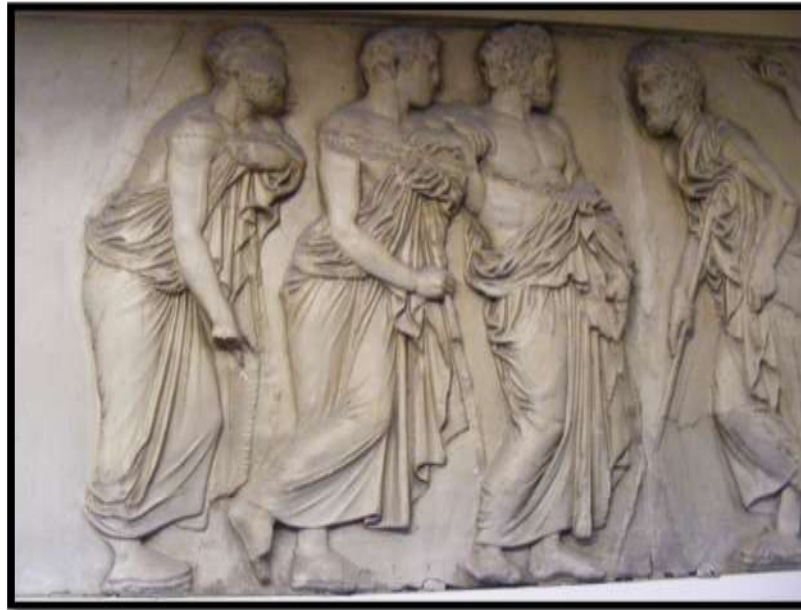
PANEL 14

Panel before conservation

STRUCTURAL STABILITY: Fair. Open cracks running alongside joints on both sides of the panel and along the top and bottom edges.

VISIBLE PAINT LAYERS/UNSIGHTLY MARKINGS: Layer of cream-yellow paint/varnish on surface of the cast; the surface polychrome is discoloured and damaged on the lower part of the panel probably by the strip lights which used to run under the Frieze along the South and North walls of the Ground Floor Gallery; area of flaking and missing paint in lower part of the panel.

CHIPS AND LOSS: Missing areas associated with the cracks.

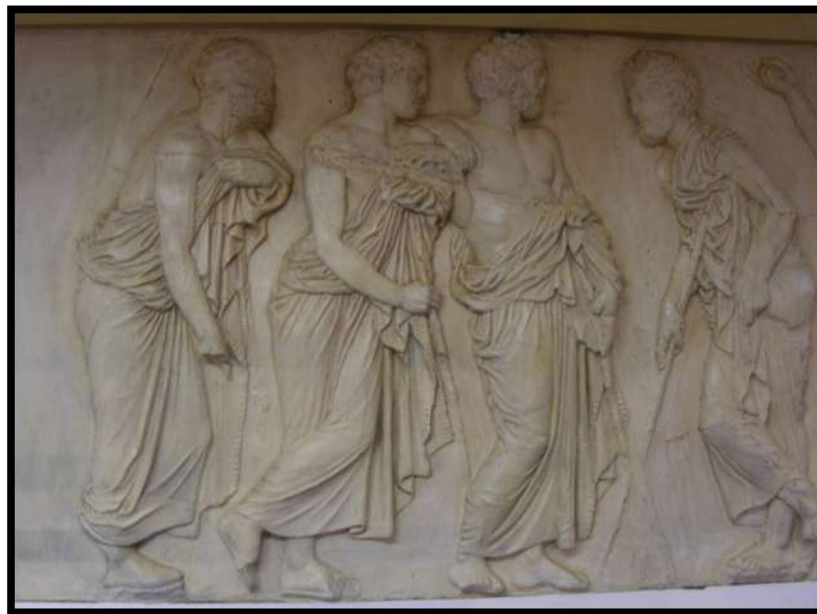
Panel after conservation

- Prior to any conservation treatment the cast was photographed. This photographic documentation was continued throughout all conservation processes.
- Initially, the cast was dry cleaned with soft brushes and Wishab Sponges with a rubber hosed vacuum to pick up loose dust and dirt.

- Areas of flaking paint were consolidated with 5% Primal B60A in de-ionised water.
- All areas of raw plaster were given an application of 10% Paraloid B72 in acetone to provide an isolating layer between the original plaster and the repairs.

- Exposed metal fixings were treated with 5% Tannic Acid so as to stabilise the corrosion, and covered with a protective layer of 20% Paraloid B72 in acetone.

- Areas of loss, open joints and cracks were filled with white micro-balloons with 12% Paraloid B72 in acetone. Larger areas of loss around the screws were filled with an inert filler to provide extra strength.

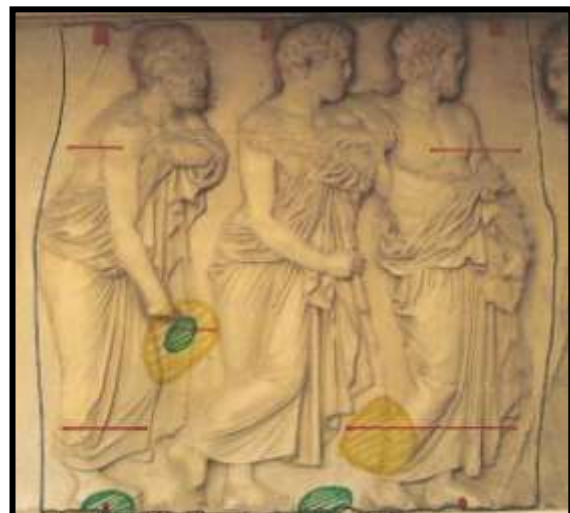
Cracks

Chips, abrasions and missing surfaces

Flaking paint

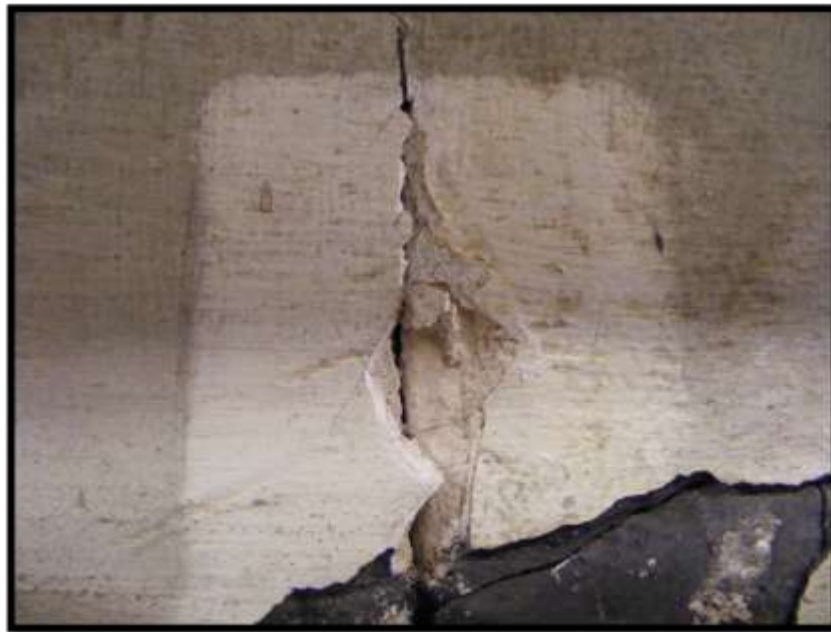
A mortar analysis was carried out by Mr Bill Revie of CMC on samples of the pointing material found between the Panel 10 and 11 on Ground Floor Galley North Wall. The mortar was found to be a thick layer of lime putty, gypsum plaster and fine sand and hair, followed by a thin layer of gypsum plaster and lime putty; and finally a layer of varnish. This final layer of varnish is found over the entire two floors of the North and South Walls and yet, interestingly, for some unknown reason, it was not applied to the slabs on the East Wall.

Samples of mortar were taken for analysis

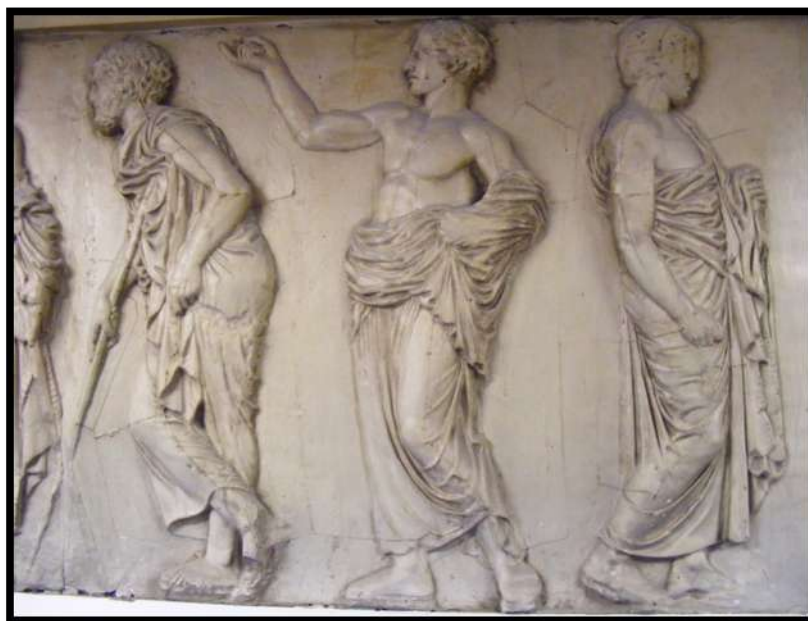
PANEL 15

Panel before conservation

STRUCTURAL STABILITY: Fair. Open cracks running alongside joints on both sides of the panel, and along the top edge; small cracks around fixings at lower edge of the cast.

VISIBLE PAINT LAYERS/UNSIGHTLY MARKINGS: Layer of cream-yellow paint/varnish on surface of the cast; the surface polychrome is discoloured and damaged on the lower part of the panel probably by the strip lights which used to run under the Frieze along the South and North walls of the Ground Floor Gallery; small spots of paint splash in bottom sinister corner of the panel; area of flaking and missing paint in lower part of the panel.

CHIPS AND LOSS: Missing areas associated with the cracks.

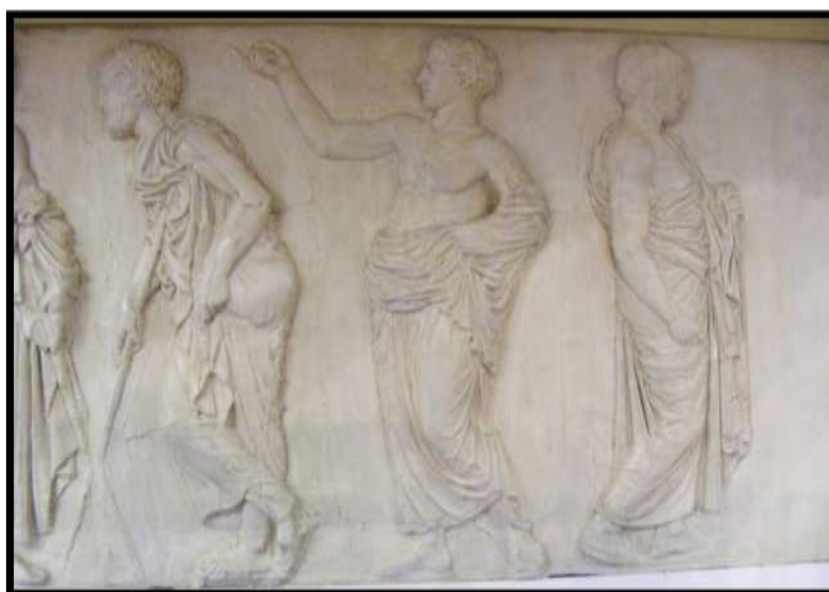
Panel after conservation

- Prior to any conservation treatment the cast was photographed. This photographic documentation was continued throughout all conservation processes.
- Initially, the cast was dry cleaned with soft brushes and Wishab Sponges with a rubber-nozzled vacuum to pick up loose dust and dirt.
- Following wet cleaning spot tests on **Panel 1 on Upper Gallery South Wall**, the surface of the cast was cleaned with 2-5% Vulpex Liquid Soap in de-ionised water, using cotton wool swabs.

- Areas of flaking paint were consolidated with 5% Primal B60A in de-ionised water.
- All areas of raw plaster were given an application of 10% Paraloid B72 in acetone to provide an isolating layer between the original plaster and the repairs.
- Areas of loss, open joints and cracks were filled with white micro-balloons with 12% Paraloid B72 in acetone. Larger areas of loss around the screws were filled with an inert filler to provide extra strength.
- Exposed metal fixings were treated with 5% Tannic Acid so as to stabilise the corrosion, and covered with a protective layer of 20% Paraloid B72 in acetone.
- All the fills and areas of discoloured paint were then toned out with acrylics, mixed with matting agent, to match the surrounding patina.
- Finally, the entire cast was given an application of micro-crystalline wax so as to protect the surface.

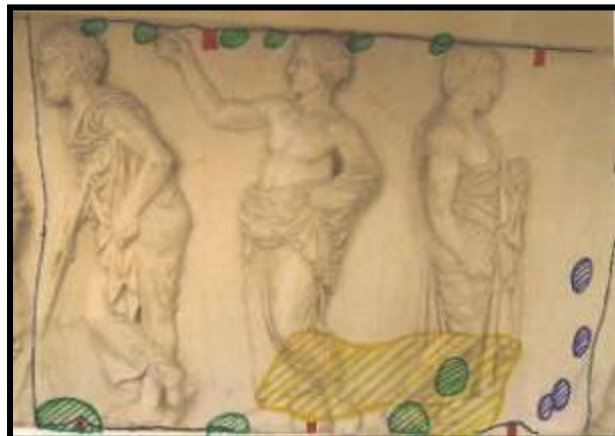
Cracks

Chips, abrasions and missing surfaces

Paint splashes

Flaking paint

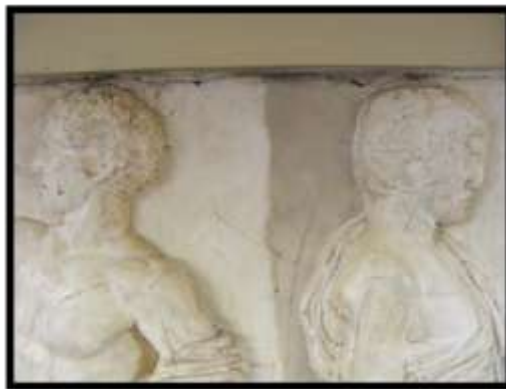
Panel during wet cleaning

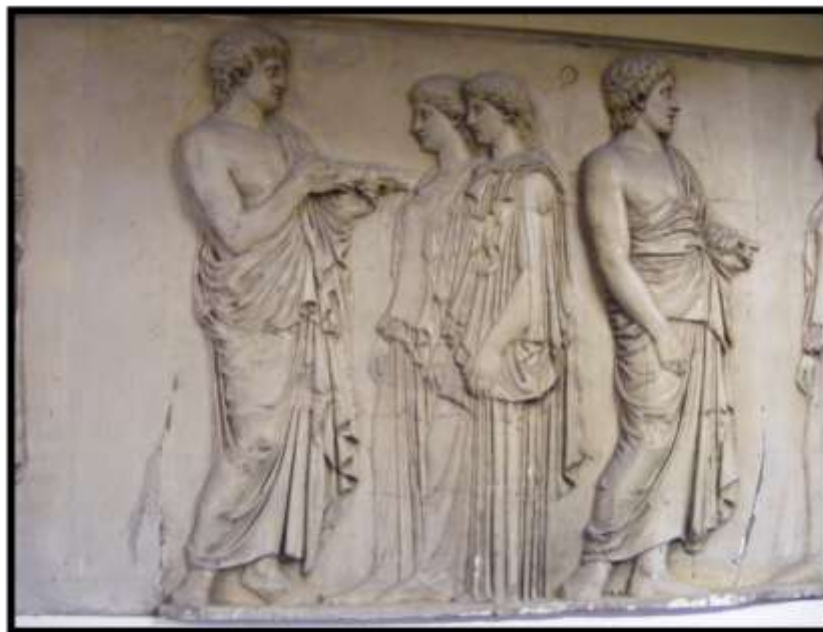
PANEL 16

Panel before conservation

STRUCTURAL STABILITY: Stable. Open cracks running alongside joints on both sides and on the top edge of the panel.

VISIBLE PAINT LAYERS/UNSIGHTLY MARKINGS: Layer of cream-yellow paint/varnish on surface of the cast; the surface polychrome is discoloured and damaged on the lower part of the panel probably by the strip lights which used to run under the Frieze along the South and North walls of the Ground Floor Gallery; area of flaking and missing paint in lower part of the panel.

CHIPS AND LOSS: Missing areas associated with the cracks.

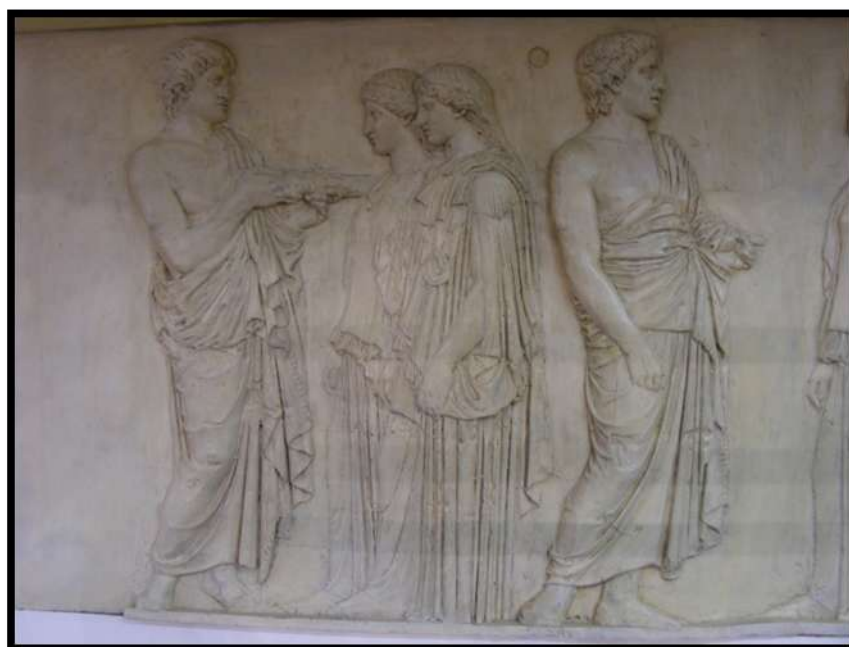
Panel after conservation

- Prior to any conservation treatment the cast was photographed. This photographic documentation was continued throughout all conservation processes.
- Initially, the cast was dry cleaned with soft brushes and Wishab Sponges with a rubber-nozzled vacuum to pick up loose dust and dirt.
- Following wet cleaning spot tests on **Panel 1 on Upper Gallery South Wall**, the surface of the cast was cleaned with 2-5% Vulpex Liquid Soap in de-ionised water, using cotton wool swabs.

- Areas of flaking paint were consolidated with 5% Primal B60A in de-ionised water.
- All areas of raw plaster were given an application of 10% Paraloid B72 in acetone to provide an isolating layer between the original plaster and the repairs.
- Exposed metal fixings were treated with 5% Tannic Acid so as to stabilise the corrosion, and covered with a protective layer of 20% Paraloid B72 in acetone.
- Areas of loss, open joints and cracks were filled with white micro-balloons with 12% Paraloid B72 in acetone. Larger areas of loss around the screws were filled with an inert filler to provide extra strength.
- All the fills and areas of discoloured paint were then toned out with acrylics, mixed with matting agent, to match the surrounding patina.

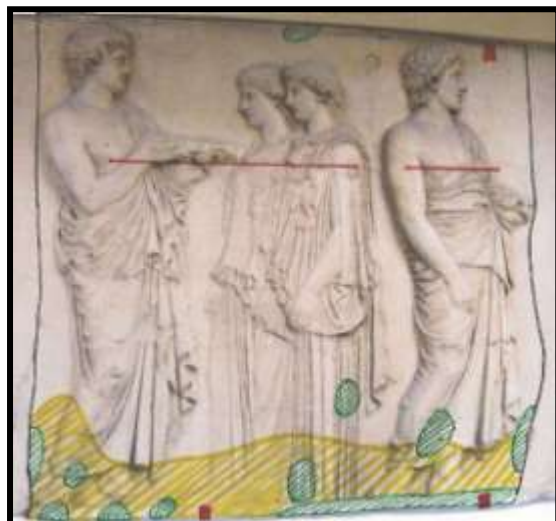
Cracks

Chips, abrasions and missing surfaces

Flaking paint

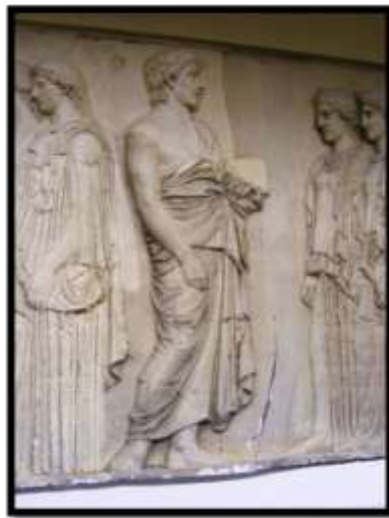
Panel during wet cleaning

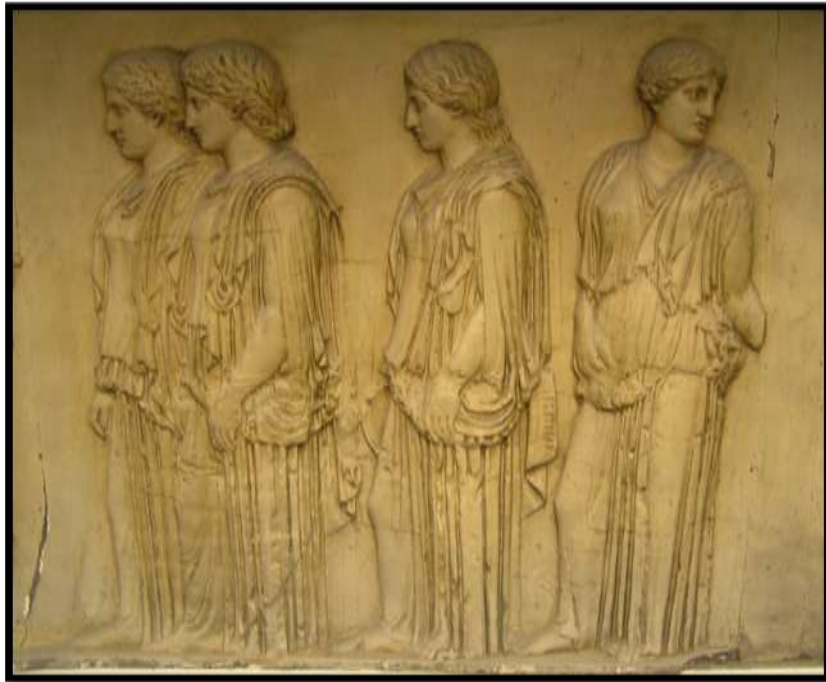
PANEL 17

Panel before conservation

STRUCTURAL STABILITY: Fair. Open cracks running alongside joints on both sides of the panel and at top sinister corner through the middle of the panel to the lower edge.

VISIBLE PAINT LAYERS/UNSIGHTLY MARKINGS: Layer of cream-yellow paint/varnish on surface of the cast; the surface polychrome is discoloured and damaged on the lower part of the panel probably by the strip lights which used to run under the Frieze along the South and North walls of the Ground Floor Gallery; area of missing and flaking paint in lower part of the cast.

CHIPS AND LOSS: Missing areas associated with the cracks.
