1. PARTHENON FRIEZE

1.4 SCULPTURE COURT LOWER GALLERY NORTH WALL

PANEL 1

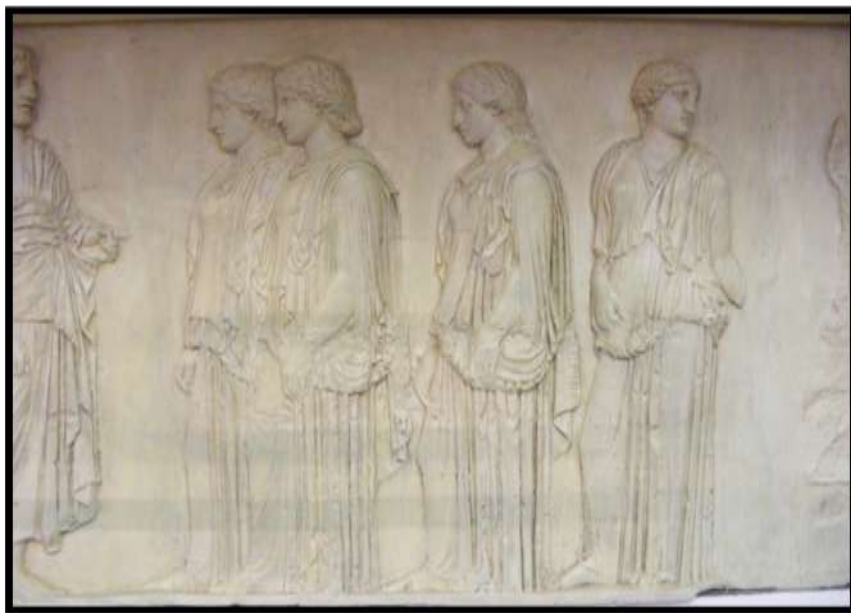
Panel after conservation

- Prior to any conservation treatment the cast was photographed. This photographic documentation was continued throughout all conservation processes.
- Initially, the cast was dry cleaned with soft brushes and Wishab Sponges with a rubber-nozzled vacuum to pick up loose dust and dirt.
- Following wet cleaning spot tests on **Panel 1 on Upper Gallery South Wall**, the surface of the cast was cleaned with 2-5% Vulpex Liquid Soap in de-ionised water, using cotton wool swabs.

- Areas of flaking paint were consolidated with 5% Primal B60A in de-ionised water.
- All areas of raw plaster were given an application of 10% Paraloid B72 in acetone to provide an isolating layer between the original plaster and the repairs.
- Exposed metal fixings were treated with 5% Tannic Acid so as to stabilise the corrosion, and covered with a protective layer of 20% Paraloid B72 in acetone.
- Areas of loss, open joints and cracks were filled with white micro-balloons with 12% Paraloid B72 in acetone. Larger areas of loss around the screws were filled with an inert filler to provide extra strength.
- All the fills and areas of discoloured paint were then toned out with acrylics, mixed with matting agent, to match the surrounding patina.
- Finally, the entire cast was given an application of micro-crystalline wax so as to protect the surface.

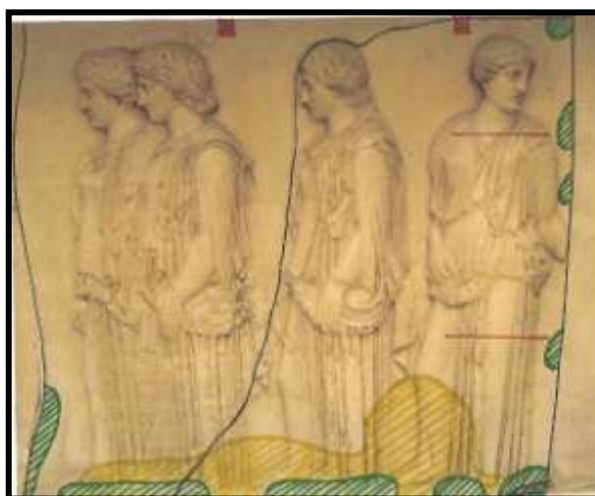
Cracks

Chips, abrasions and missing surfaces

Paint splashes

Flaking paint

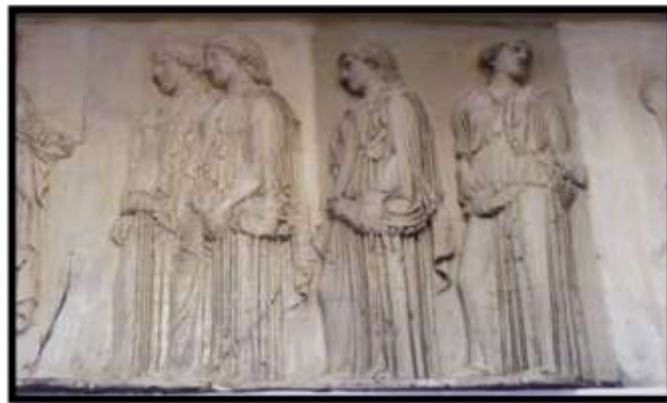
Panel during wet cleaning

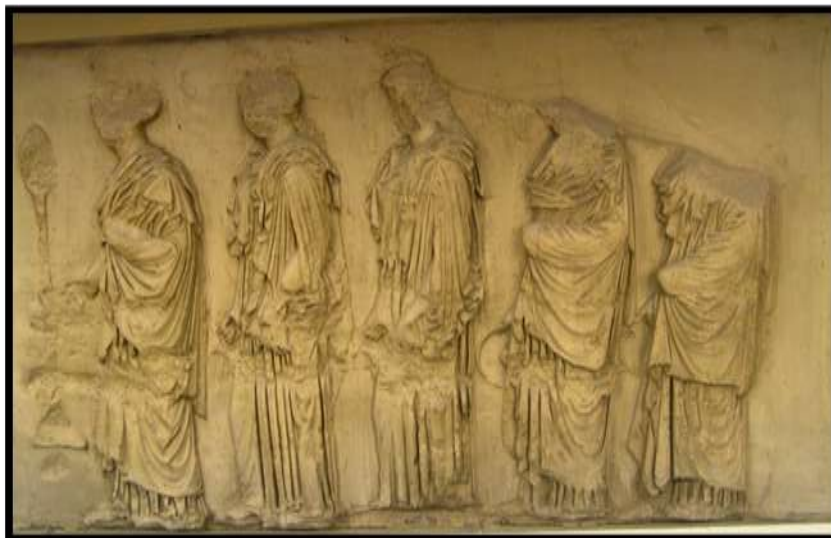
PANEL 18

Panel before conservation

STRUCTURAL STABILITY: Fair. Open cracks running alongside the joints on both sides of the panel and alongside edge; large crack running through the panel behind first figure.

VISIBLE PAINT LAYERS/UNSIGHTLY MARKINGS: Layer of cream-yellow paint/varnish on surface of the cast; the surface polychrome is discoloured and damaged on the lower part of the panel probably by the strip lights which used to run under the Frieze along the South and North walls of the Ground Floor Gallery; small spots of paint splash mainly on the dexter part of the cast; area of missing paint at lower part of the panel.

CHIPS AND LOSS: Missing areas associated with the cracks.

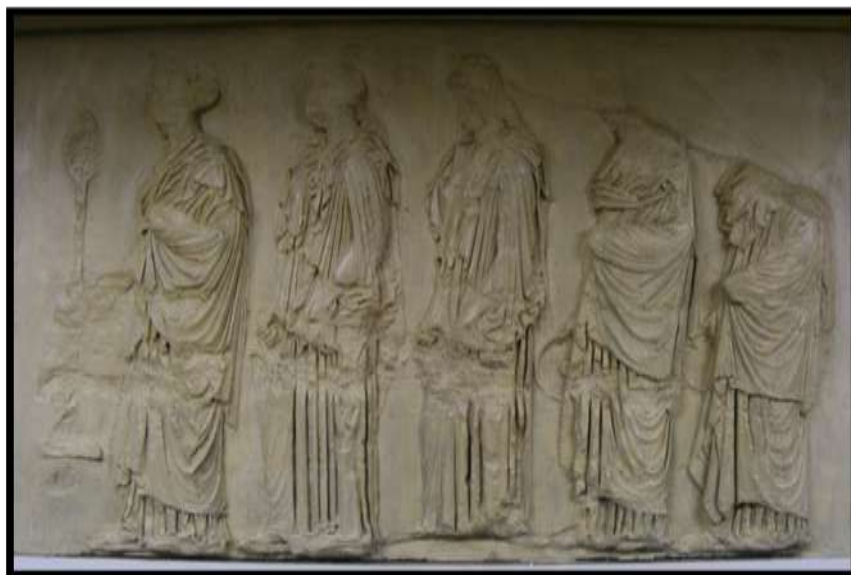
Panel after conservation

- Prior to any conservation treatment the cast was photographed. This photographic documentation was continued throughout all conservation processes.
- Initially, the cast was dry cleaned with soft brushes and Wishab Sponges with a rubber hosed vacuum to pick up loose dust and dirt.

- All areas of raw plaster were given an application of 10% Paraloid B72 in acetone to provide an isolating layer between the original plaster and the repairs.

- Exposed metal fixings were treated with 5% Tannic Acid so as to stabilise the corrosion, and covered with a protective layer of 20% Paraloid B72 in acetone.

- Areas of loss, open joints and cracks were filled with white micro-balloons with 12% Paraloid B72 in acetone. Larger areas of loss around the screws were filled with an inert filler to provide extra strength.

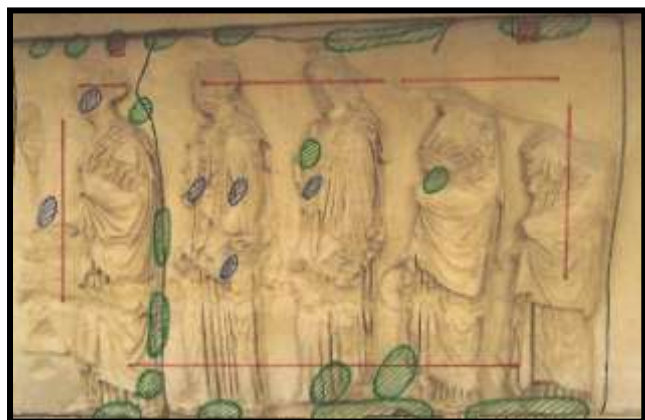
Cracks

Chips, abrasions and missing surfaces

Paint splashes

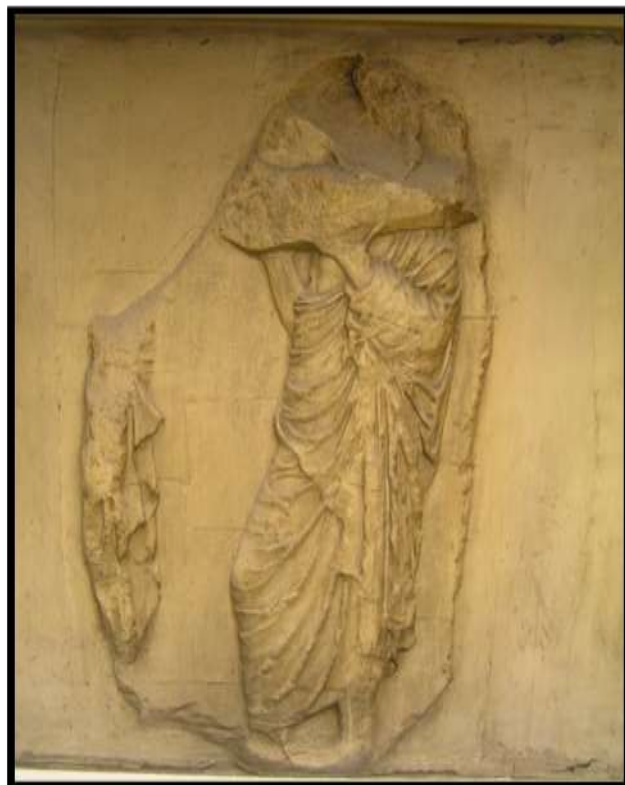
PANEL 19

Panel before conservation

STRUCTURAL STABILITY: Fair. Open cracks running alongside joints on both sides of the panel and along the top and lower edges; cracks at top corners of the cast.

CHIPS AND LOSS: Missing areas associated with the cracks.

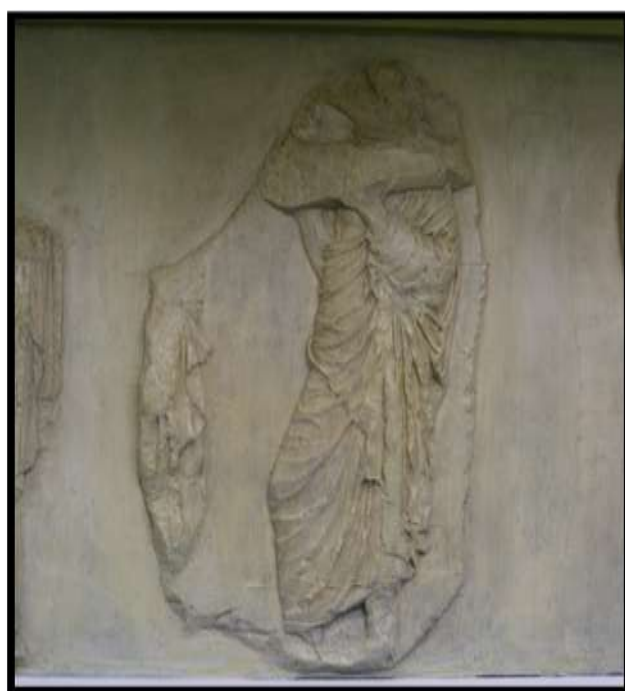
Panel after conservation

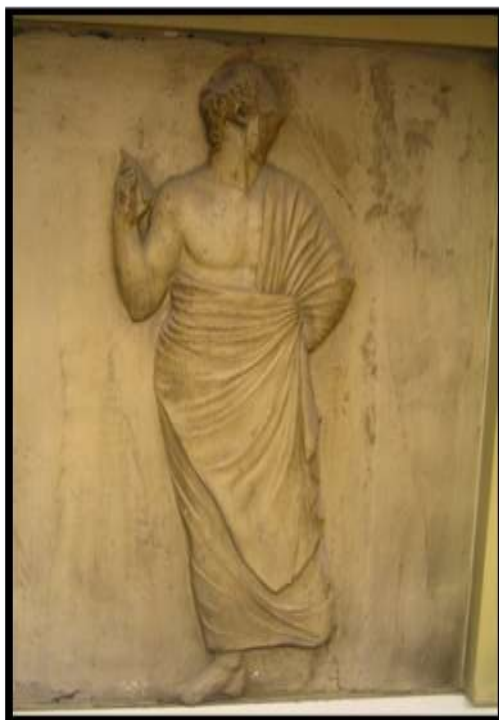
PANEL 20

Panel before conservation

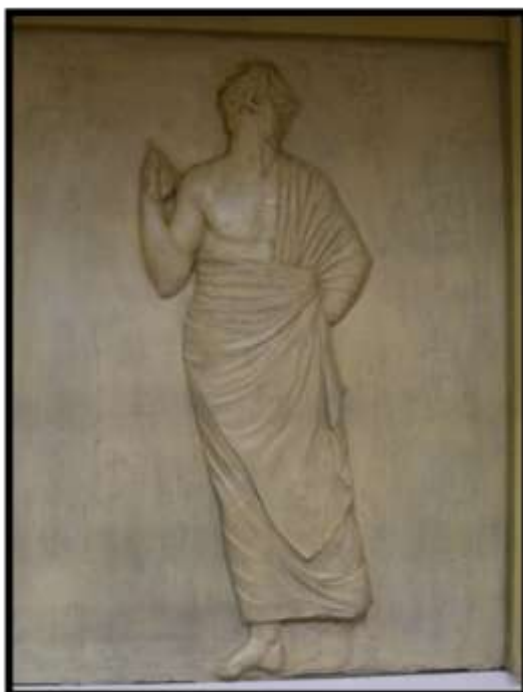
Panel after conservation

- Prior to any conservation treatment the cast was photographed. This photographic documentation was continued throughout all conservation processes.
- Initially, the cast was dry cleaned with soft brushes and Wishab Sponges with a rubber-nozzled vacuum to pick up loose dust and dirt.
- Following wet cleaning spot tests on **Panel 1 on Upper Gallery South Wall**, the surface of the cast was cleaned with 2-5% Vulpex Liquid Soap in de-ionised water, using cotton wool swabs.

- All areas of raw plaster were given an application of 10% Paraloid B72 in acetone to provide an isolating layer between the original plaster and the repairs.
- Exposed metal fixings were treated with 5% Tannic Acid so as to stabilise the corrosion, and covered with a protective layer of 20% Paraloid B72 in acetone.
- Areas of loss, open joints and cracks were filled with white micro-balloons with 12% Paraloid B72 in acetone. Larger areas of loss around the screws were filled with an inert filler to provide extra strength.
- All the fills and areas of discoloured paint were then toned out with acrylics, mixed with matting agent, to match the surrounding patina.
- Finally, the entire cast was given an application of micro-crystalline wax so as to protect the surface.

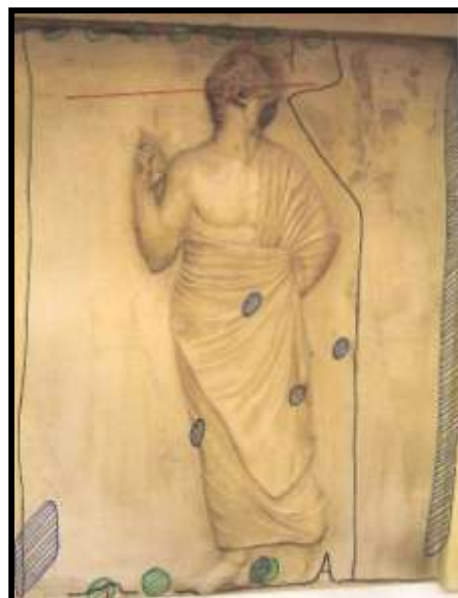
Chips, abrasions and missing surfaces

Paint splashes

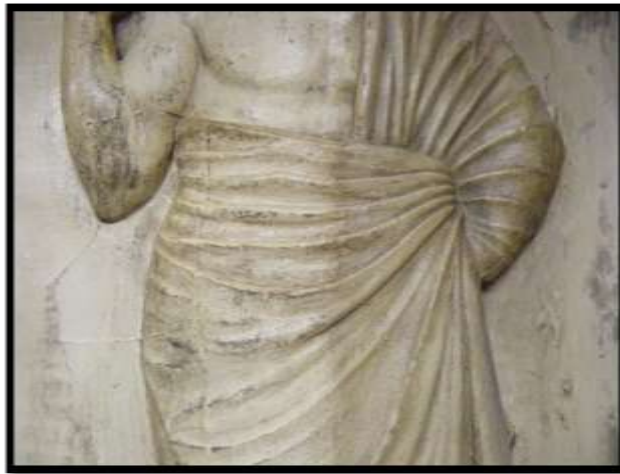
Panel during wet cleaning
